In-Flight Fire Leading to Collision with Water, Swissair Transport Limited, McDonnell Douglas MD-11 HB-IWF Peggy's Cove, Nova Scotia 5 nm SW, 2 September 1998

In-Flight Fire Leading to Collision with Water

Swissair Transport Limited
McDonnell Douglas MD-11 HB-IWF
Peggy's Cove, Nova Scotia 5 nm SW
2 September 1998

Report Number A98H0003

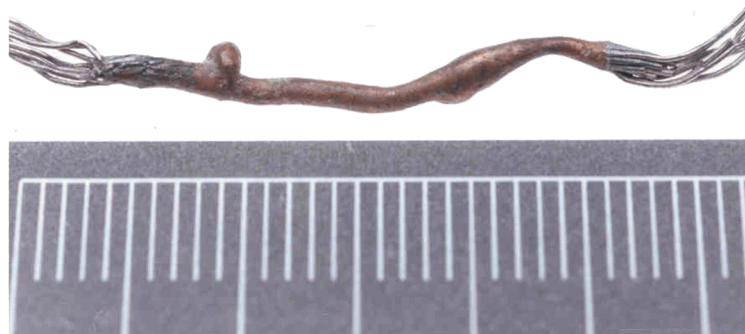
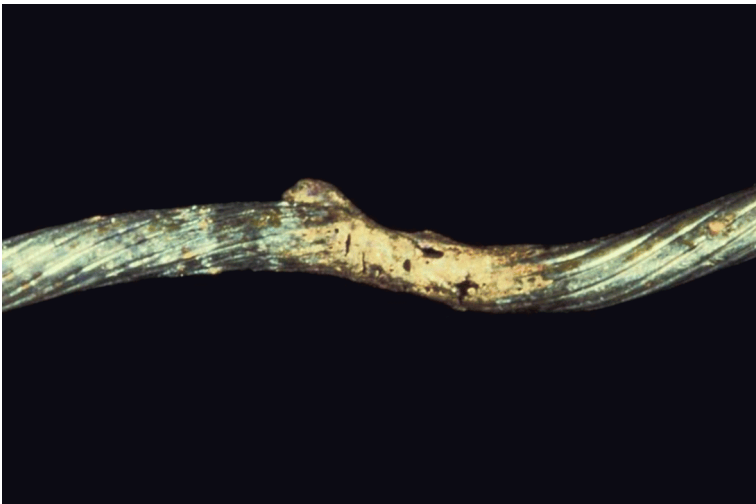
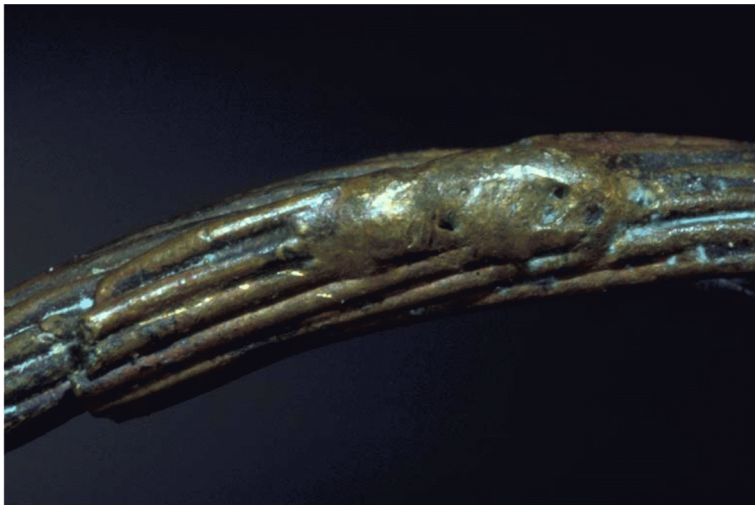
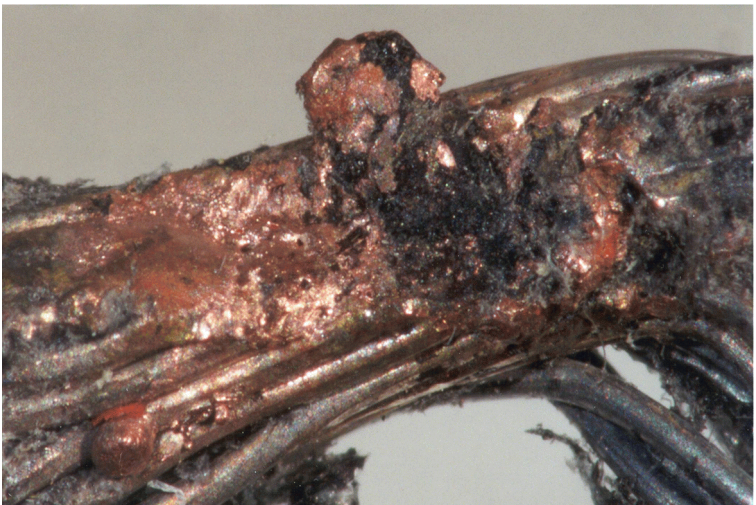
Figure 20: Wire segments with melted copper

Exhibit 1-3796, 16 AWG Wire
(scale in millimetres)

Exhibit 1-12809, 24 AWG Wire
(magnification X19)

Exhibit 1-3029, from 10 AWG Left Emergency AC Bus Feed
(magnification X10)

Exhibit 1-14723, from 12 AWG IFEN Power Cable
(magnification X22)

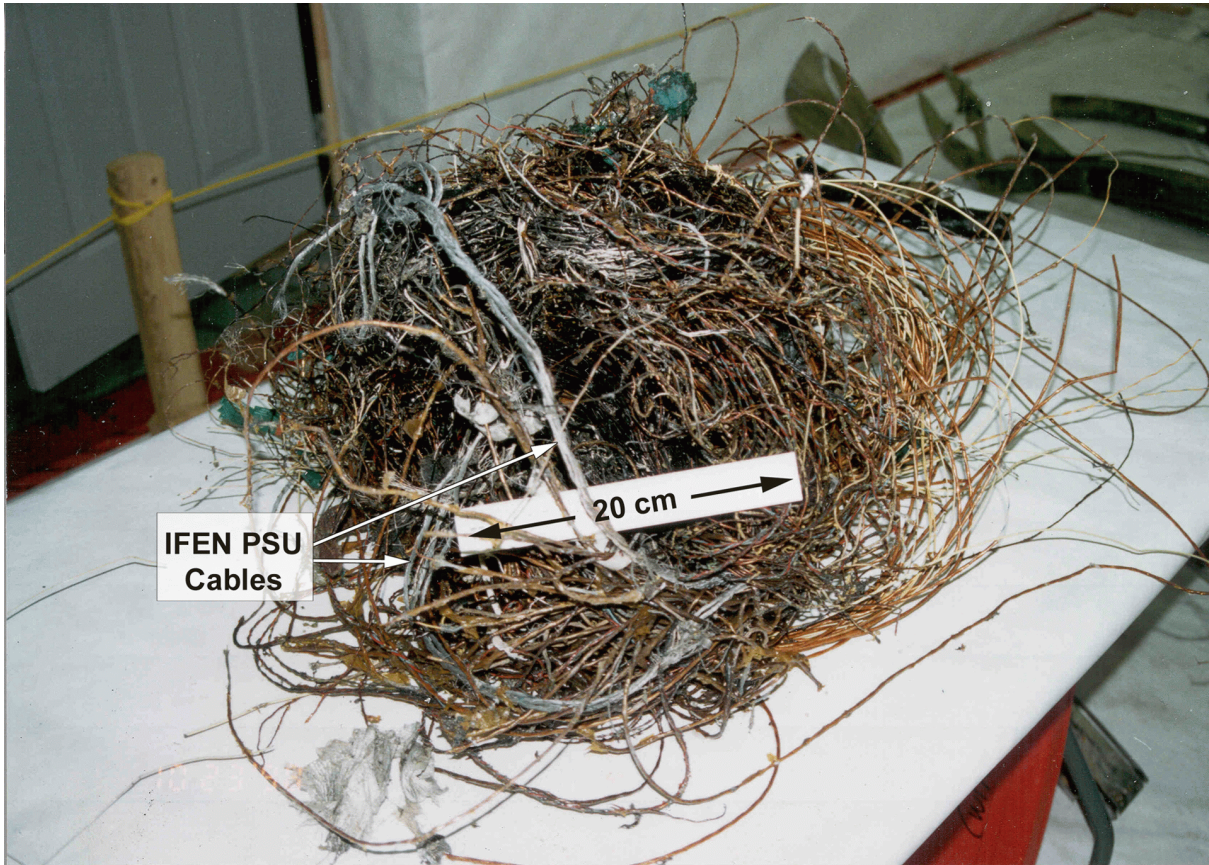
Figure 21: Exhibit 1-4372

Of the nine wire or cable segments with areas of melted copper that were recovered from Exhibit 1-4372, four were positively identified as being segments of the IFEN PSU cables (1-3790, 1-3791, 1-3792, and 1-3793) (see Figure 22). This identification was based on remnants of coloured ETFE insulation remaining attached to the wires. On each of these four segments, one end was heavily matted, or crushed together, and the opposite end was fractured and frayed. Exhibits 1-3790 and 1-3792 both had distinctive regions where the tin coating was missing from the wire strands on all three wires. Exhibits 1-3791 and 1-3793 did not have a similar region of missing tin.

Of the remaining five segments, based on adhering remnants of ETFE insulation, four (1-3794, 1-3795, 1-3788, and 1-10503) were identified as segments of the 16 AWG IFEN 28 V DC control wire used to control the PSU outputs. The total length of these four segments was 97 cm (38 inches). The fifth (1-3796) was a segment of polyimide-film-insulated, nickel-coated 16 AWG wire. This wire segment could not be associated with a specific circuit; however, because it was nickel coated, it is known that it was not from the IFEN system.

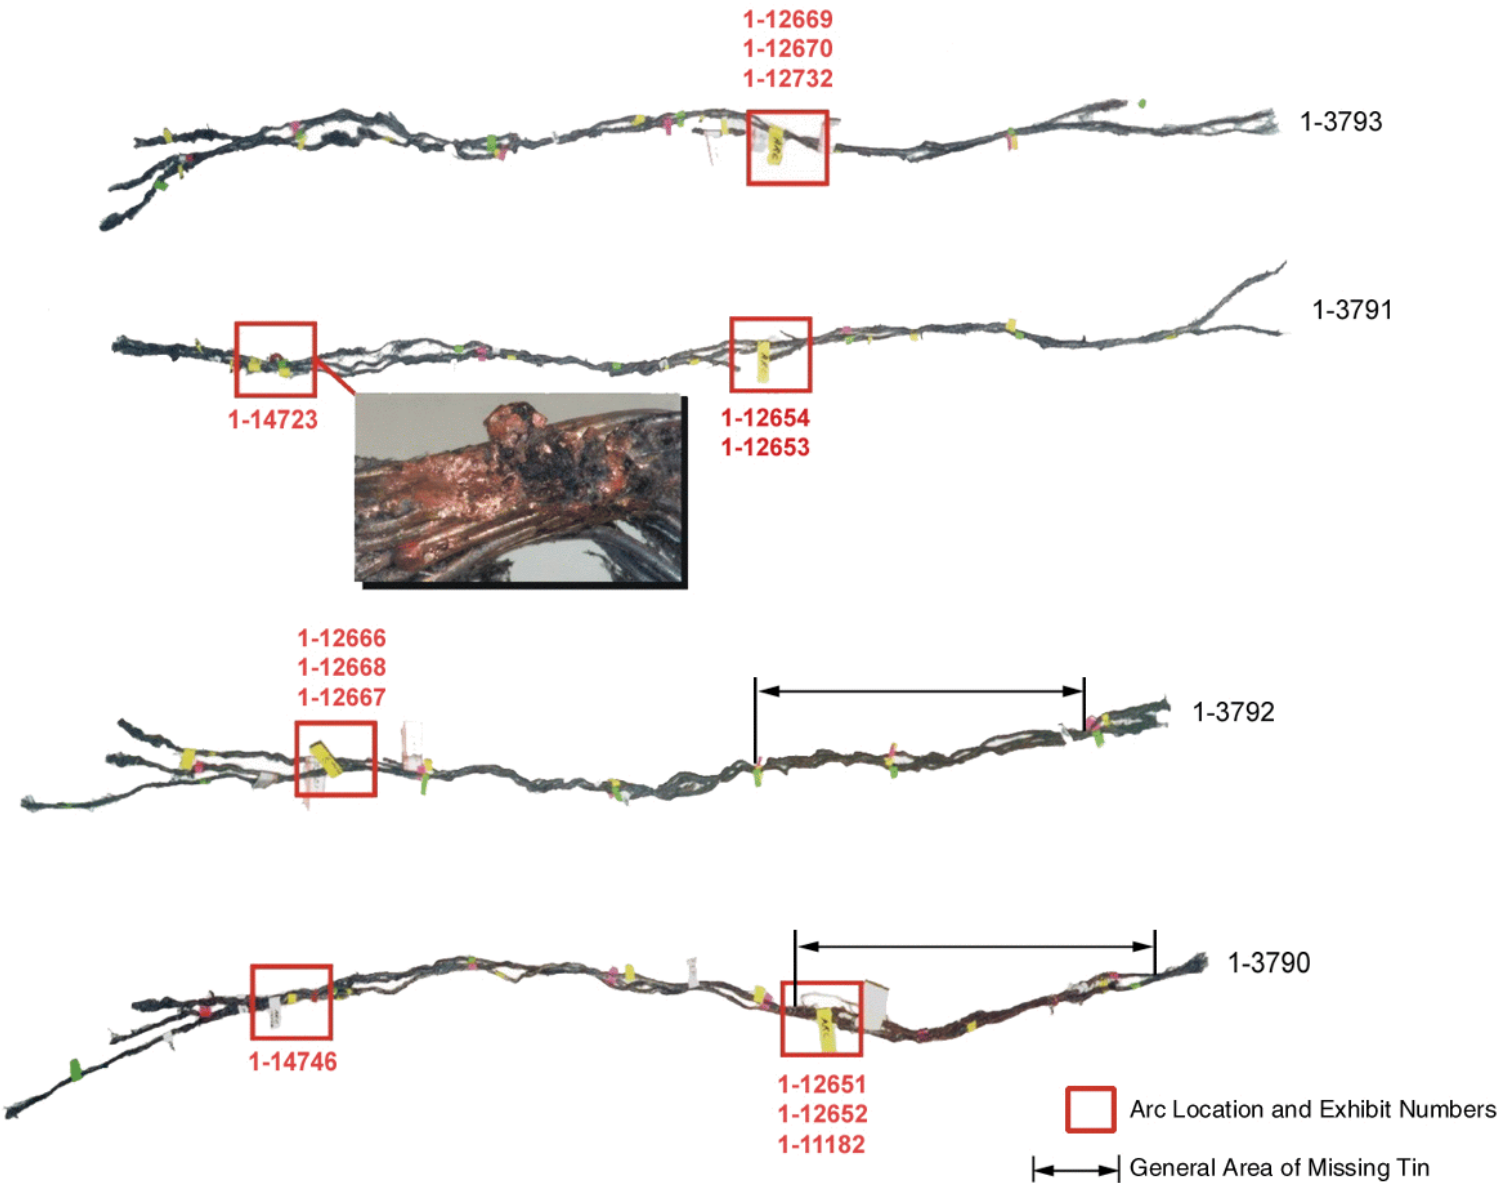
Figure 22: IFEN PSU cable segments

Exhibit 1-6976 consists of a segment of a 6 AWG nickel-coated, polyimide-insulated wire, approximately 102 cm (40 inches) long with the wire number B205-4-6 stamped on the insulation. This number identifies it as a segment of the left emergency DC bus feed wire. One end of the wire segment had two flag lugs attached that would have been connected to the left emergency DC bus bar located behind the overhead switch panel. The known location of the flag lug to bus bar connection allowed for this segment to be accurately located in the reconstruction mock-up. The end with the melted copper was located approximately 15 cm (6 inches) outside the right hole in the overhead CB panel housing. This placed it above the forward right side of the cockpit ceiling.

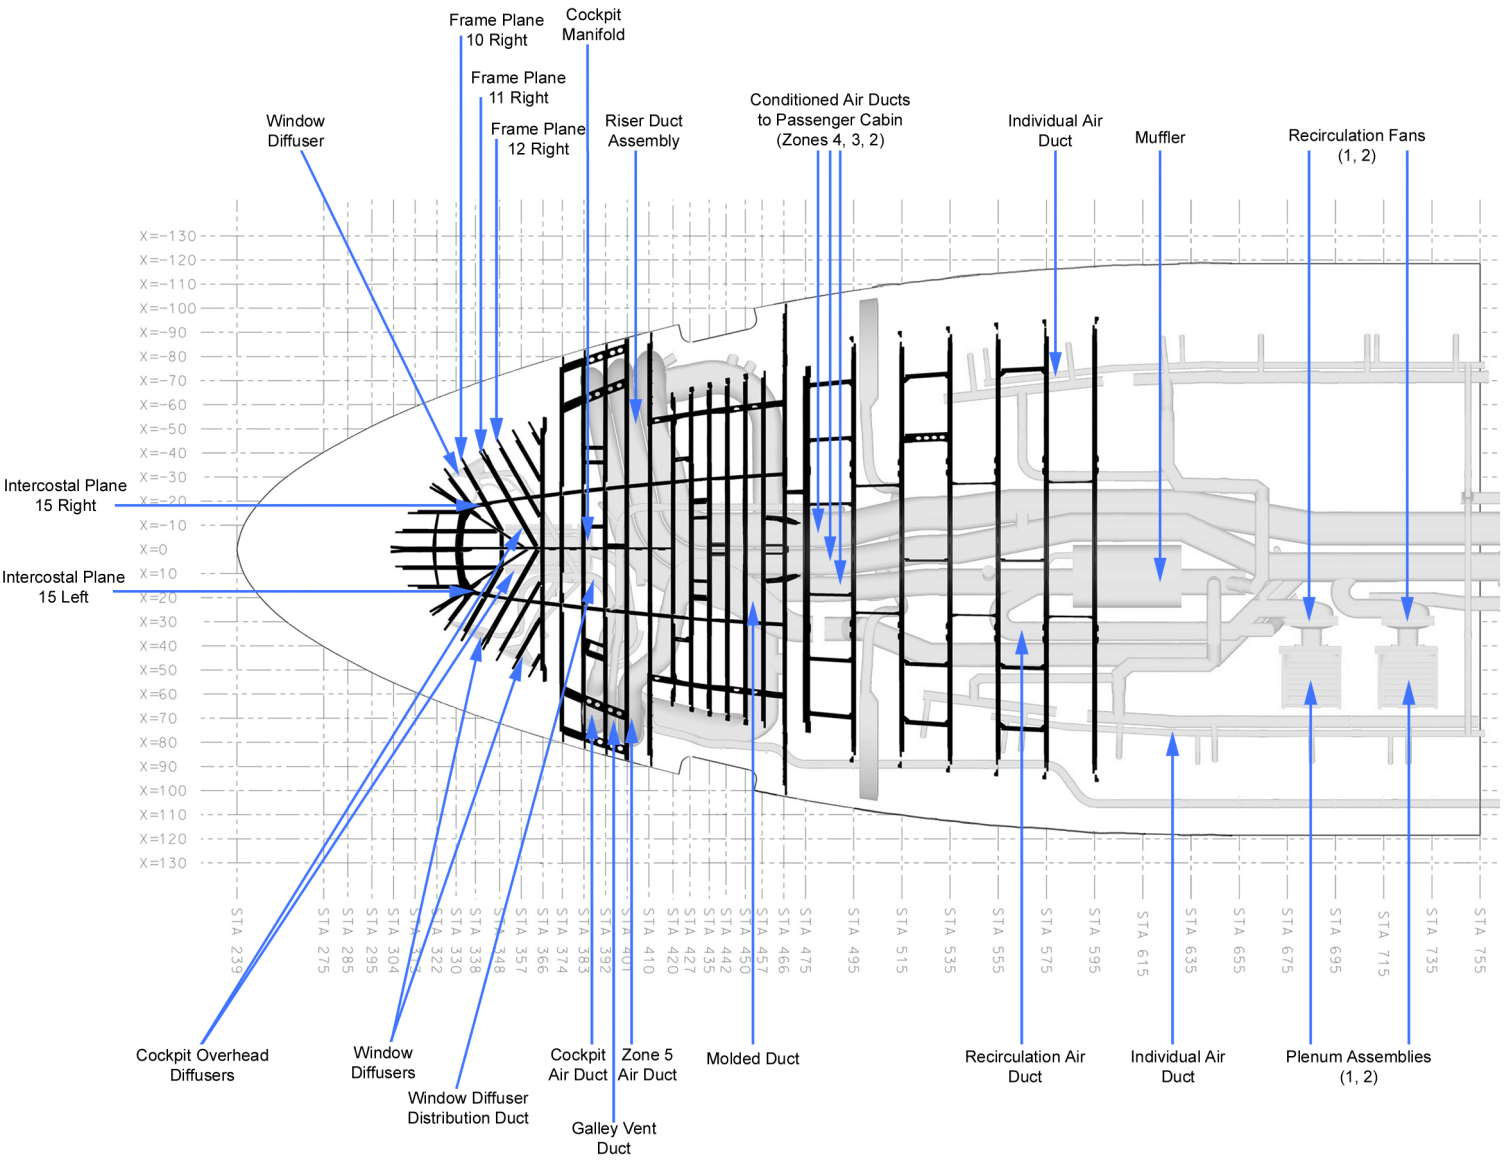
Figure 24: Airframe structure and air distribution system

Damage to the riser duct assembly ranged from no heat damage to bare-metal heat damage. The vertical portion of this assembly had no heat damage. The first area of bare-metal damage to the riser duct assembly started at intercostal plane 15 right, where the lower surface had a region of bare-metal heat damage from $X = -30$ inboard to the joint at $X = -20$. This was in the vicinity of the Galley 2 vent end cap. There was bare-metal damage from approximately STA 395 to STA 442 between $X = 25$ and $X = -10$. A section of molded duct was installed in that area from STA 420 to STA 442 between $X = 5$ and $X = 25$. No portions of this molded duct were identified in the wreckage.

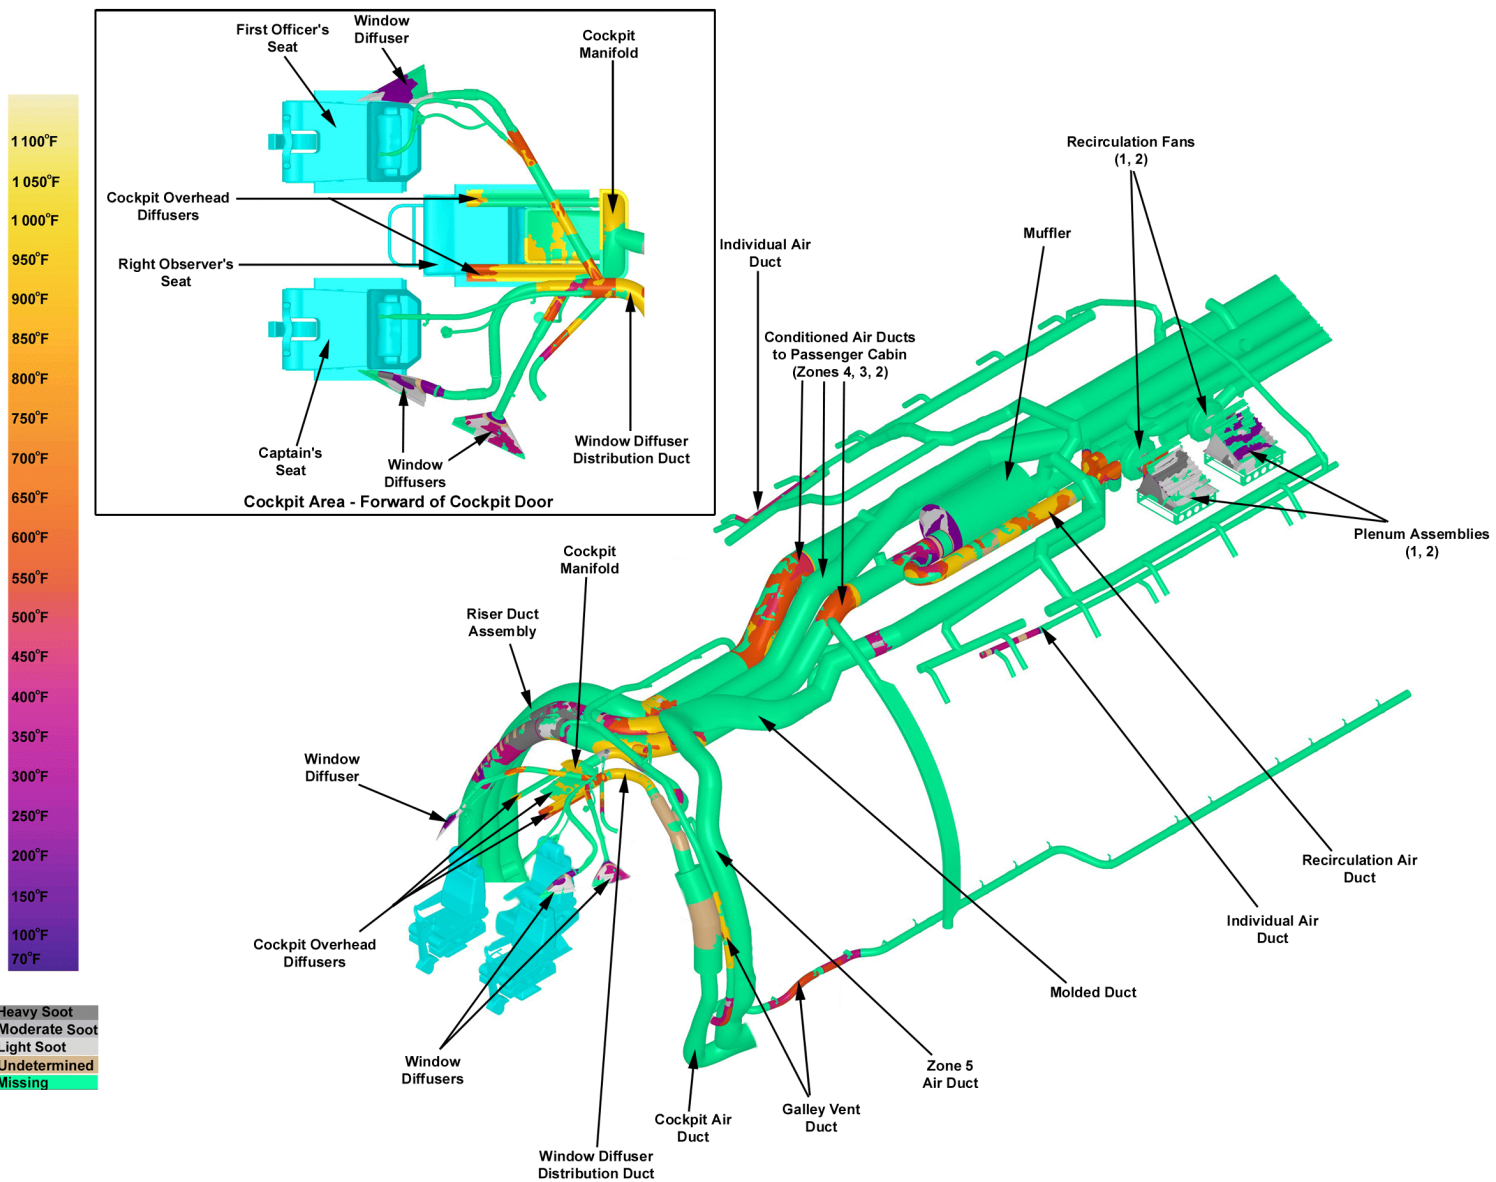
Figure 26: Heat damage – air distribution system

Forward passenger cabin individual air was supplied by a fan and plenum assembly identical to a recirculation air fan and plenum assembly. The fan was located at STA 990 at $X = -24$. The plenum assembly was between $X = -40$ and $X = -65$. The recovered portions of the plenum had no heat damage or soot accumulation. The individual air ducts were uninsulated and ran forward from STA 990 to a "Y" (split) at STA 750 at $Z = 91$, $X = -21$. One branch of the "Y" ran across the crown to the left side of the cabin at $X = 76$, and the other ran to the right side at $X = -76$. The recovered portions of these ducts had moderate to heavy soot accumulations on the exterior, with no heat damage. The aftermost section of individual air duct that was identified was from STA 934 to STA 955 at $X = -22$ and had light soot accumulation on the exterior.

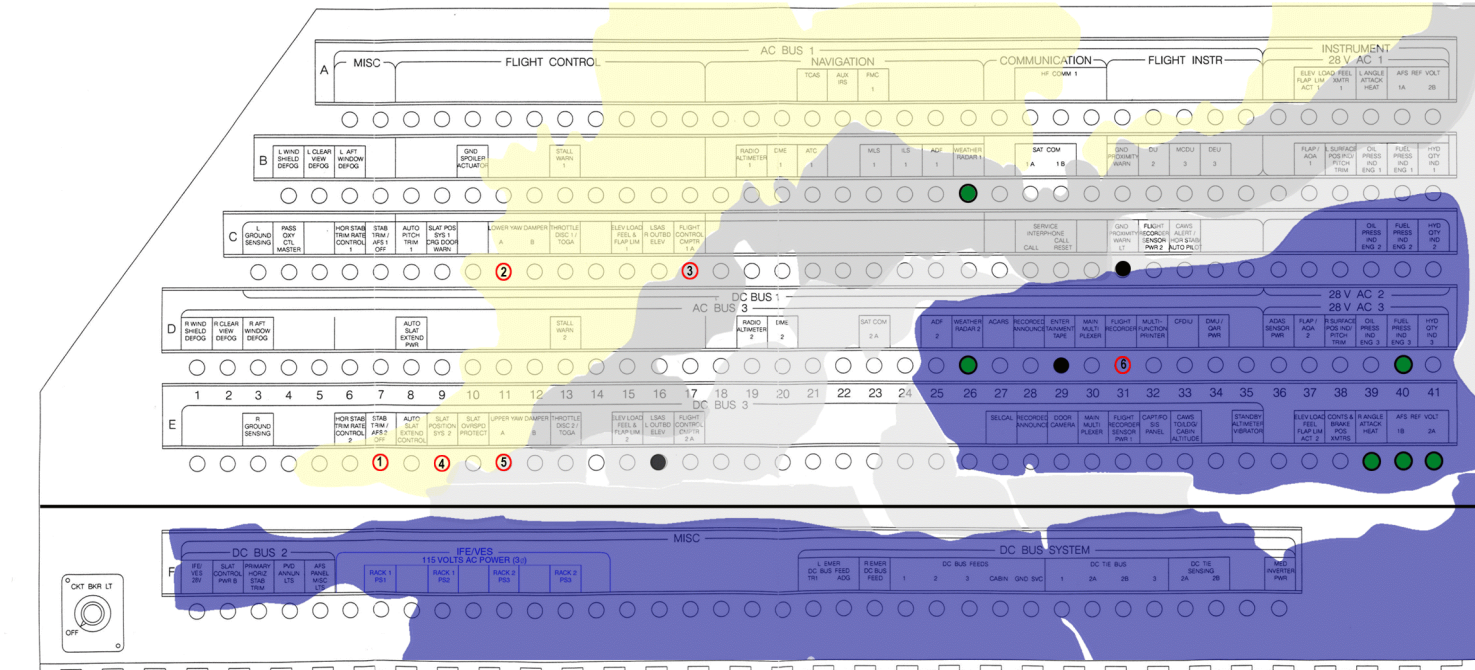
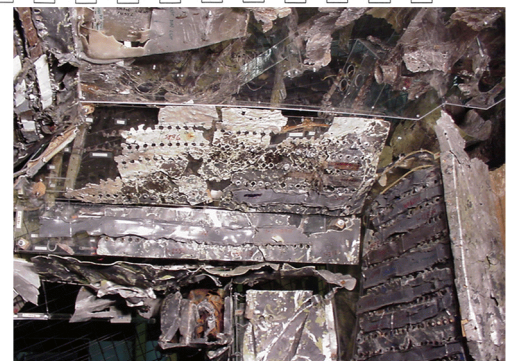
Figure 28: Heat damage – upper and lower avionics CB panels

- 427 to 621°C
800 to 1150°F
- 21 to 343°C
70 to 650°F
- Missing
- Soot - Light
- Soot - Moderate
- Recovered CBs with Significant Soot/Heat
- Recovered CBs without Significant Soot/Heat

Time	CB Location	FDR Parameter
① 0124:09	E-07	Autopilot 2 Disconnect
② 0124:54	C-11	Lower Yaw Damper A Failure
③ 0124:58	C-17	FCC-1 Channel A Lost
④ 0125:06 to 0125:14	E-09	Slat Position Sensor B Lost
⑤ 0125:34	E-11	Upper Yaw Damper A Failure
⑥ 0125:41.8	D-31	FDR Stopped Recording

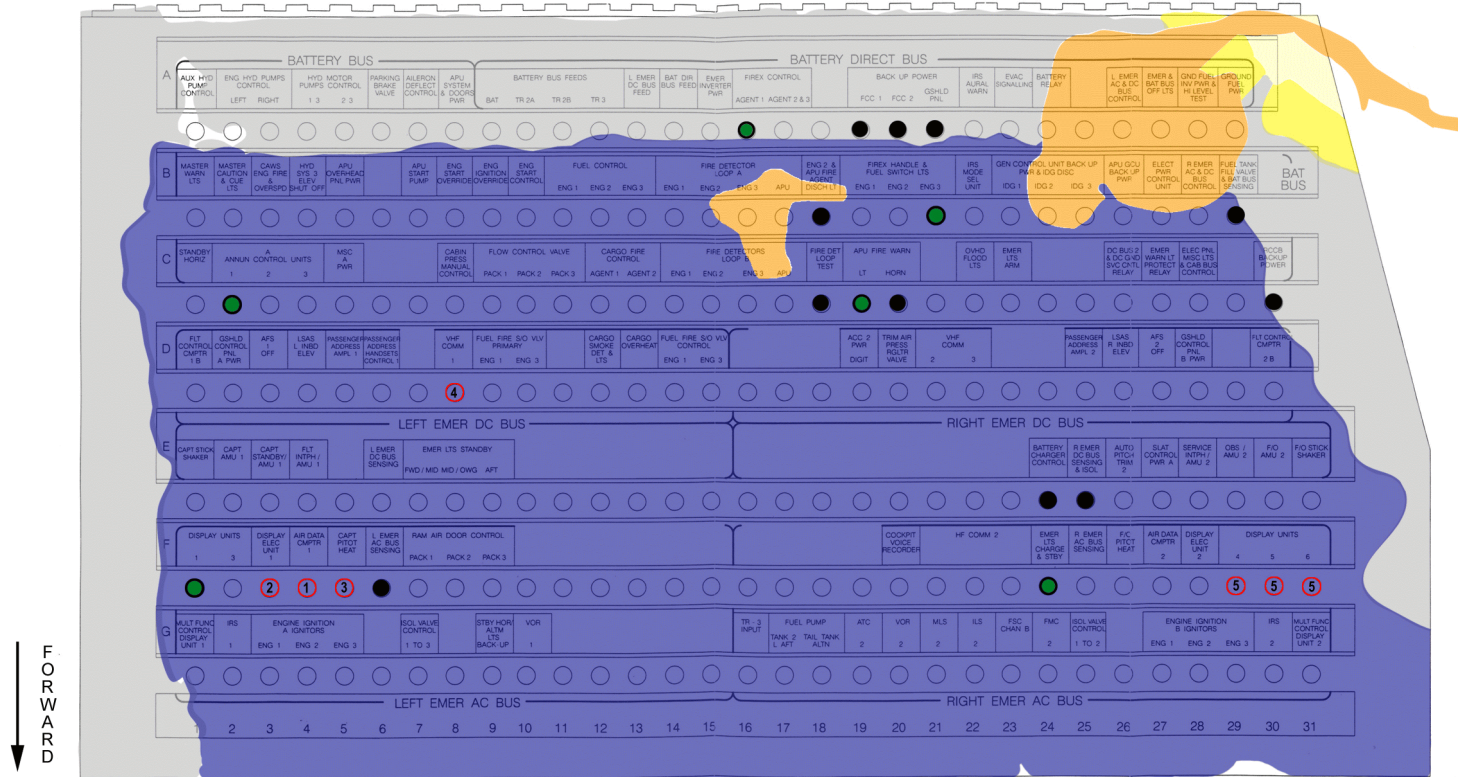
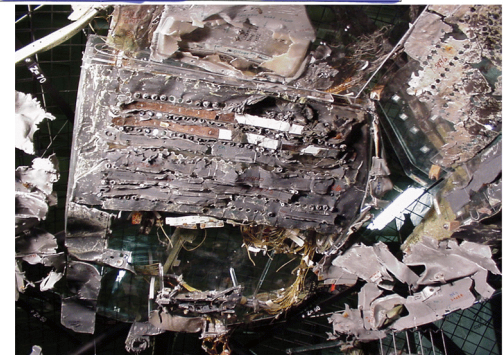
Figure 29: Heat damage – overhead CB panel

- 427 to 621°C
800 to 1150°F
- 343 to 398°C
650 to 750°F
- 21 to 343°C
70 to 650°F
- Missing
- Soot - Moderate
- Melt (Lightplate Base)
- Recovered CBs with Significant Soot/Heat
- Recovered CBs without Significant Soot/Heat

Time	CB Location	FDR Parameter
1	0125:06	F-04	ADC-1 Lost
2	0125:06	F-03	DEU-1 Lost
3	0125:06 to 0125:14	F-05	Captain's Pitot Heat Lost
4	0125:06	D-08	VHF-1 Transceiver Lost
5	0125:33	F-29, F-30 & F-31	DU 4, 5, and 6 Lost
