Runway Overrun Incident, Antonov Airlines, Antonov 124-100 UR-82029, Windsor Airport, Ontario, 18 December 2000

AVIATION INVESTIGATION REPORT

A00O0279

INCIDENT—RUNWAY OVERRUN

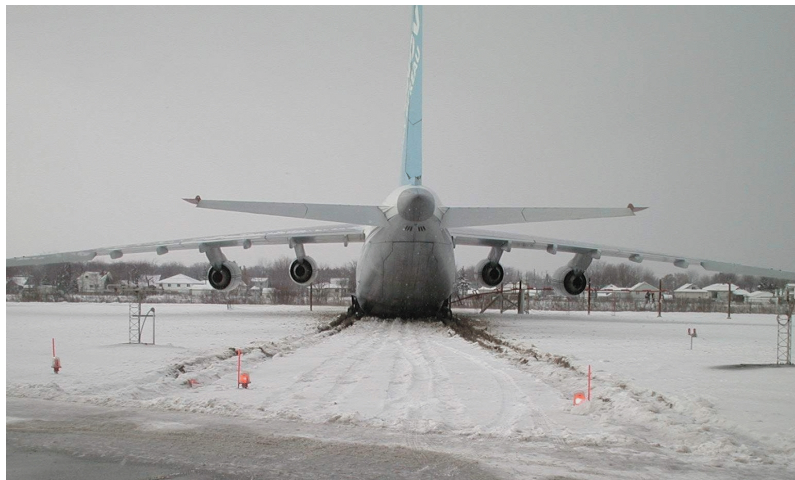
Figure 1 - Aircraft off the end of the runway

The aircraft sustained minor damage that required repair to the right nose-gear oleo bracket and replacement of the right fuselage landing light.

The aircraft overran the end of the runway by about 340 feet at approximately 30 knots. The ground past the end of Runway 25 was soft, causing the aircraft to decelerate quickly. Damage to the aircraft was minimal.

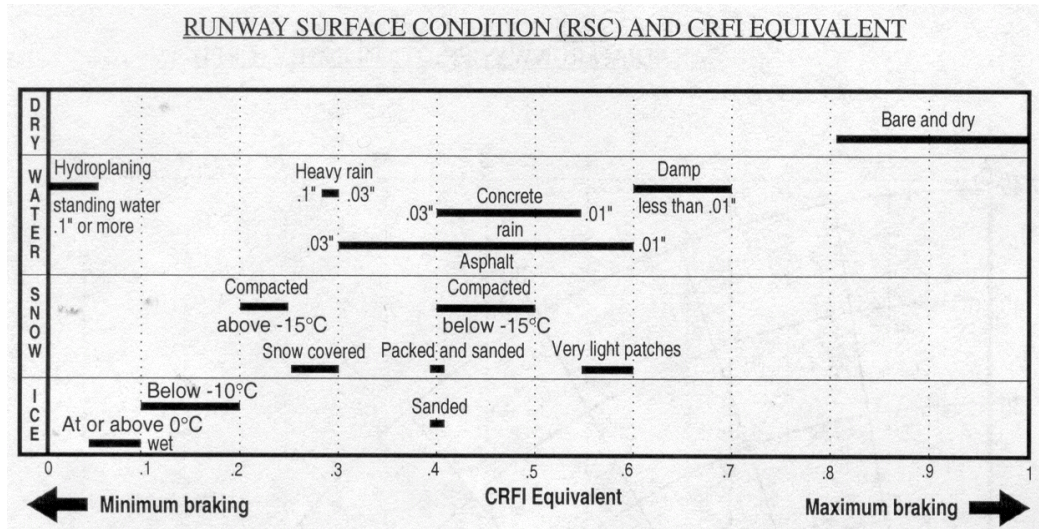
CRFI readings of 0.40 or less, which represent low braking coefficients of friction, are required to be reported as a special notice to airmen. The CRFI of 0.30, obtained 16 minutes before the overrun, was not reported on the notice to airmen system because the Windsor airport was

Figure 3 - RSC and CRFI equivalent

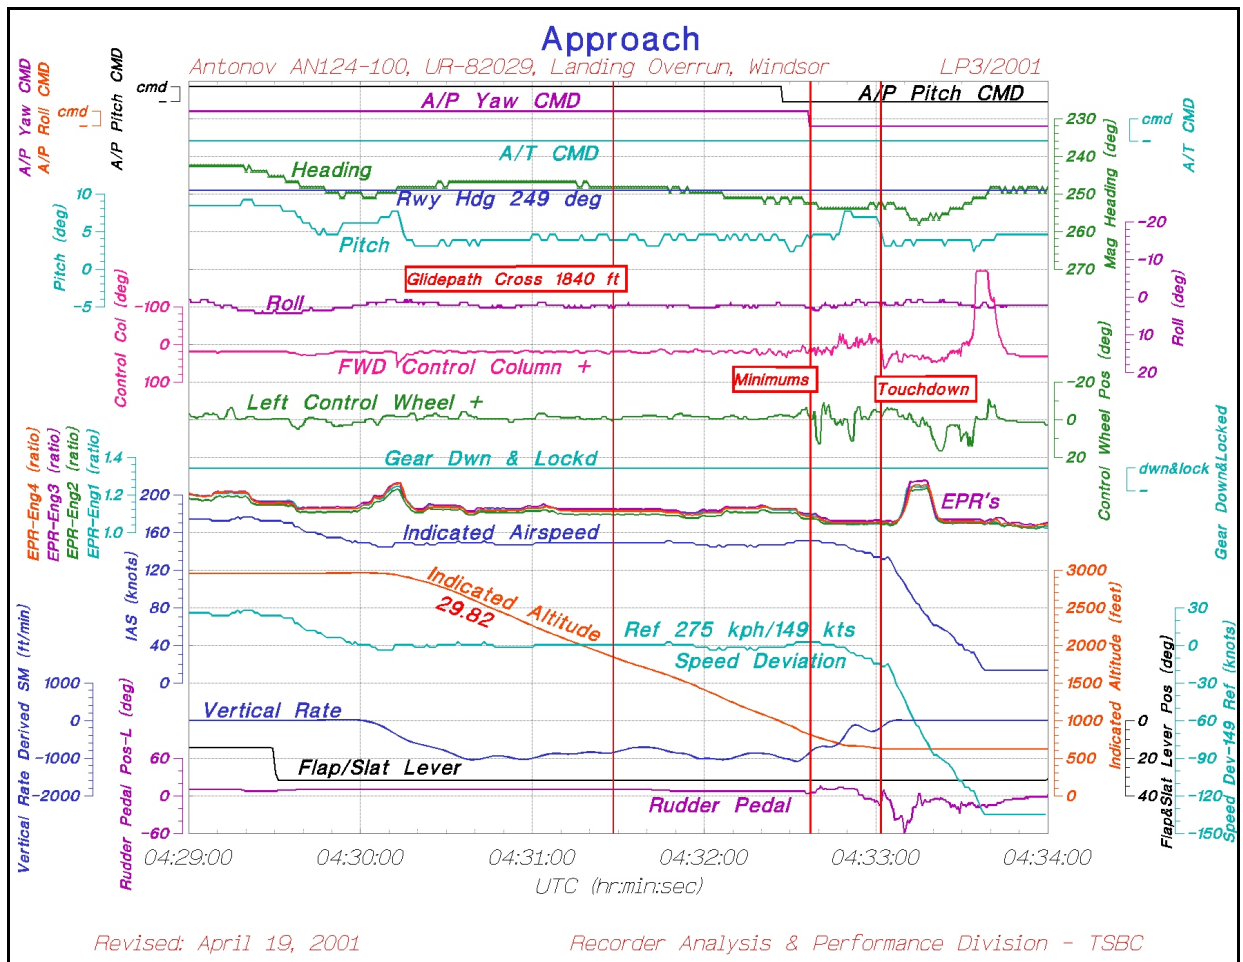
Based on the flight reconstruction, the aircraft floated during the flare and touched down firmly (1.7g vertical acceleration) at 133 knots, about 3400 feet past the threshold, with about 4450 feet of stopping distance remaining to the end of the runway. The estimated required landing distance, as calculated by the captain, was 6890 feet. This calculated distance is based on a TCH of 50 feet agl and a touchdown point of 984 feet past the threshold.

The wheel brakes were applied and reverse thrust selected 1.4 seconds after touchdown, and the thrust reversers deployed 4.3 seconds after touchdown. At that point, the aircraft was about 4400 feet from the threshold at 125 knots. Approximately 14 seconds after reverse thrust was selected and at 76 knots, in accordance with standard operating procedures, the thrust levers were moved to reverse idle.² The longitudinal g on landing indicated an average of -0.15g throughout the landing roll. The recorded longitudinal g deceleration data suggested that the aircraft braking system was functioning. Fifteen seconds after the deactivation of reverse thrust, the aircraft went off the end of the runway at about 30 knots.

Figure 4 - Flight data recorder plot

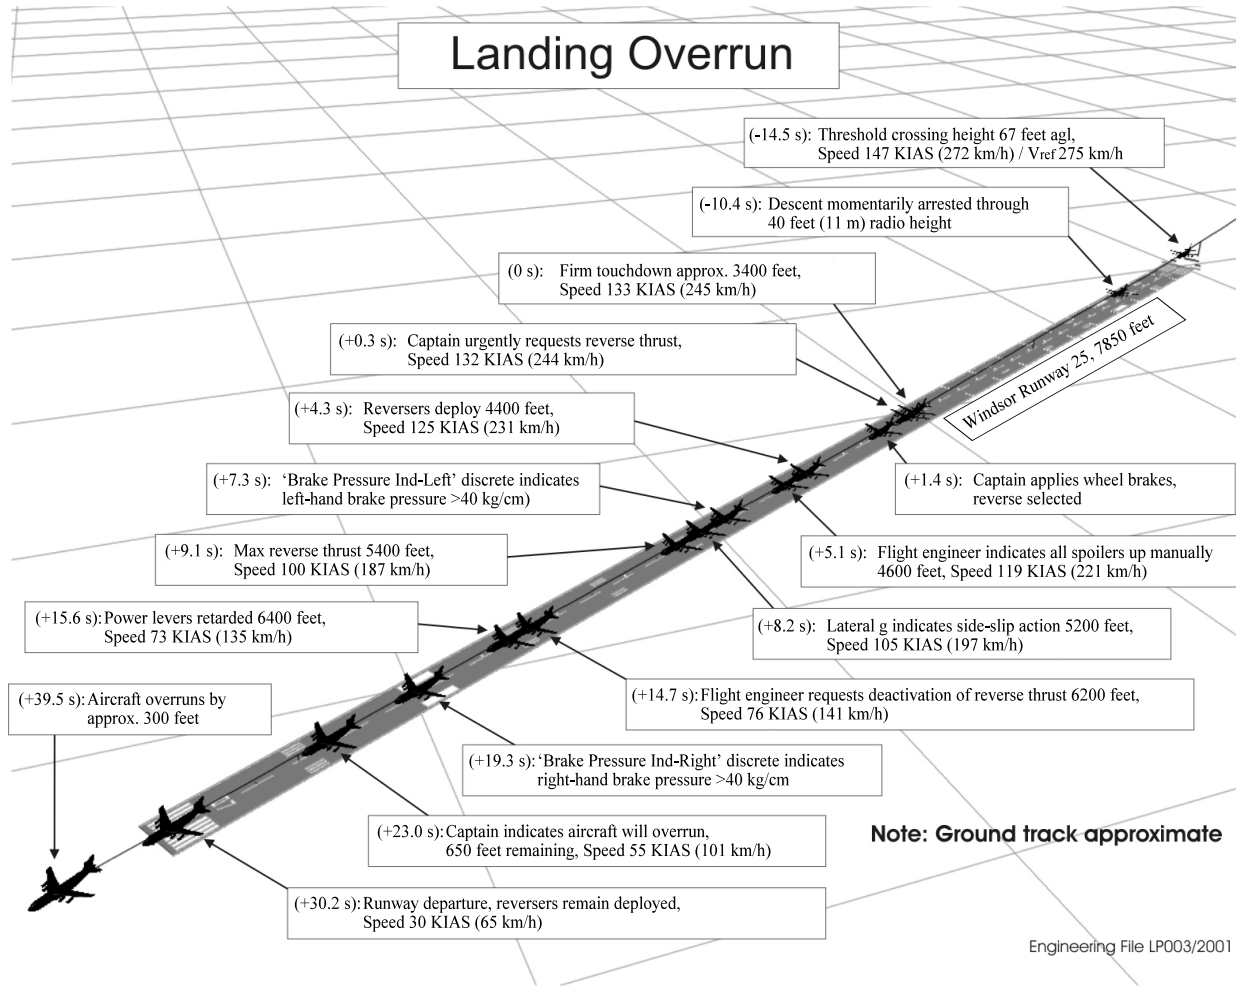
Appendix A—Landing Overrun and Windsor Airport

1. The aircraft touched down 3400 feet past the threshold of Runway 25 and could not be stopped in the remaining 4450 feet.
2. Because of the weather minima on Runway 07, the aircraft was landed with a 4-knot tailwind component on Runway 25. The aircraft was about 20 feet higher and about 6 knots faster than recommended when it crossed the threshold of Runway 25. Consequently, the aircraft touched down well beyond the normal touchdown point.
