AVIATION INVESTIGATION REPORT

A03P0332

MAINTENANCE ERROR – IN-FLIGHT FUEL LEAK

AIRBUS A330-300 C-GHKX

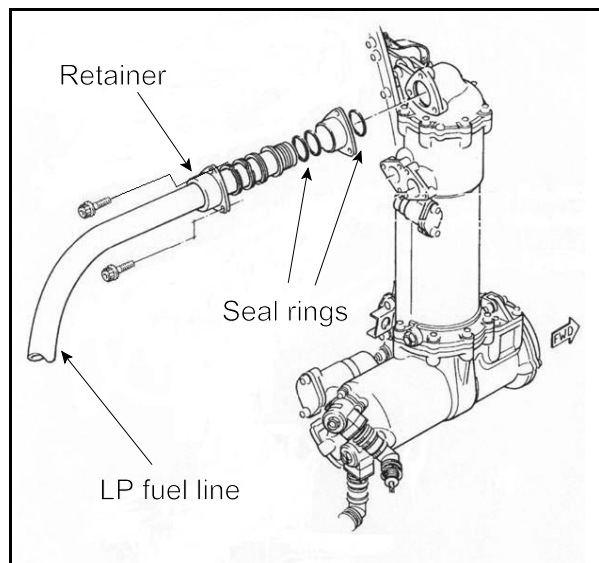
Figure 1. Fuel/oil heat exchanger

Transportation Safety Board of Canada (TSB) investigators and Air Canada maintenance personnel examined the engine and found that the LP inlet fuel line to the fuel/oil heat exchanger of the number 2 engine had detached. Although the fuel-line coupling appeared to be intact and the three bolts holding the coupling together were tight, the retainer was missing. The missing retainer was found further down the detached fuel line, obscured from view. The engine manufacturer, Rolls-Royce, indicated that it is possible, within the tolerance range of all the LP components, that the three bolts that hold the LP connection in place may not bottom out if the retainer is omitted. It is, therefore, possible to achieve torque of the proper value. In light of this scenario, the compression on the seal rings is possibly sufficient to prevent leakage at idle power. The flight data recorder (FDR) was removed from the aircraft and sent to Air Canada's maintenance facility in Dorval, Quebec, for downloading. The downloaded information was analysed by the TSB Engineering Laboratory.

Because of the conflict in written tasks between the job board and the aircraft logbook, combined with the technicians not using the TSM to resolve the problem, the LP fuel line to the fuel/oil heat exchanger was unnecessarily disconnected. Once the LP fuel line was disconnected, the technicians did not refer to or follow all of the reinstallation procedures in the available AMM. During the time it took for the replacement seal rings to arrive, the retainer, which cannot be removed from the fuel line, slid down the fuel line and became obscured from view. The LP fuel-line coupling was then reassembled without the retainer in place.

can appear secure without the retainer in place, along with the technicians unfamiliarity with this particular fitting, it would have been difficult to detect whether the retainer was missing, even from an elevated position. The seal rings on the LP fuel line had been compressed sufficiently to prevent any leaks, rendering the developer, if it had been used, ineffective in detecting the missing retainer.

As the engine power levers were advanced for take-off, an increase in fuel pressure, flow rate, and, perhaps, engine vibration caused the LP fuel line to detach from the fuel/oil heat exchanger because the retainer was missing. The fuel leak resulted in a large vapour trail, noticeable to other aircraft crew and observers on the ground (see Appendix A). A high-power ground run performed after the maintenance work had been completed would have greatly increased the probability of detecting the incorrect installation.

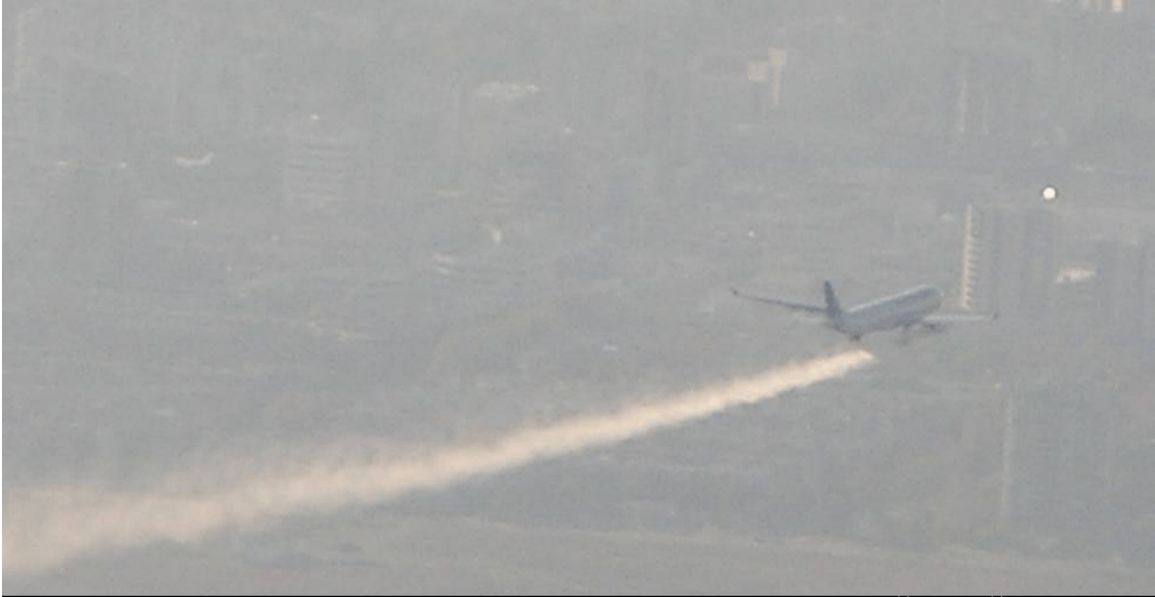
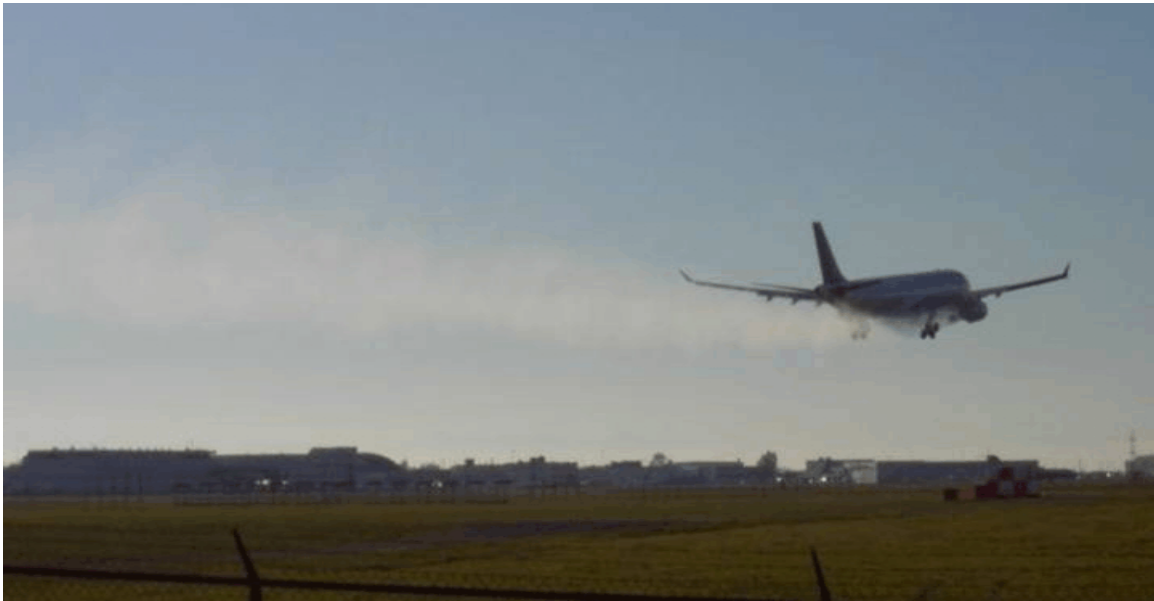
Appendix A – Visible Fuel Leak from Flight ACA216

The following day, the aircraft departed for Calgary, Alberta, as Flight ACA216. The taxi and the take-off roll were normal. The departure was during daylight hours and in clear weather conditions, and pilots of another aircraft waiting to depart observed a fuel leak from ACA216 as a significant vapour trail (see Appendix A). The pilots of that departing aircraft informed the Vancouver tower of the vapour trail coming from the number 2 engine of ACA216, and, in turn, the Vancouver tower relayed this information to ACA216.
