Engine fire, Final Report of the Aircraft Accident Investigation Bureau concerning the incident of the airplane Airbus A321-111, HB-IOC on 20 February 2001 at Geneva Airport

Investigative Body: Aircraft Accident Investigation Bureau (AAIB), Switzerland

Final Report of the Aircraft Accident Investigation Bureau

of the airplane Airbus A321-111, HB-IOC
on 20 February 2001
at Geneva Airport

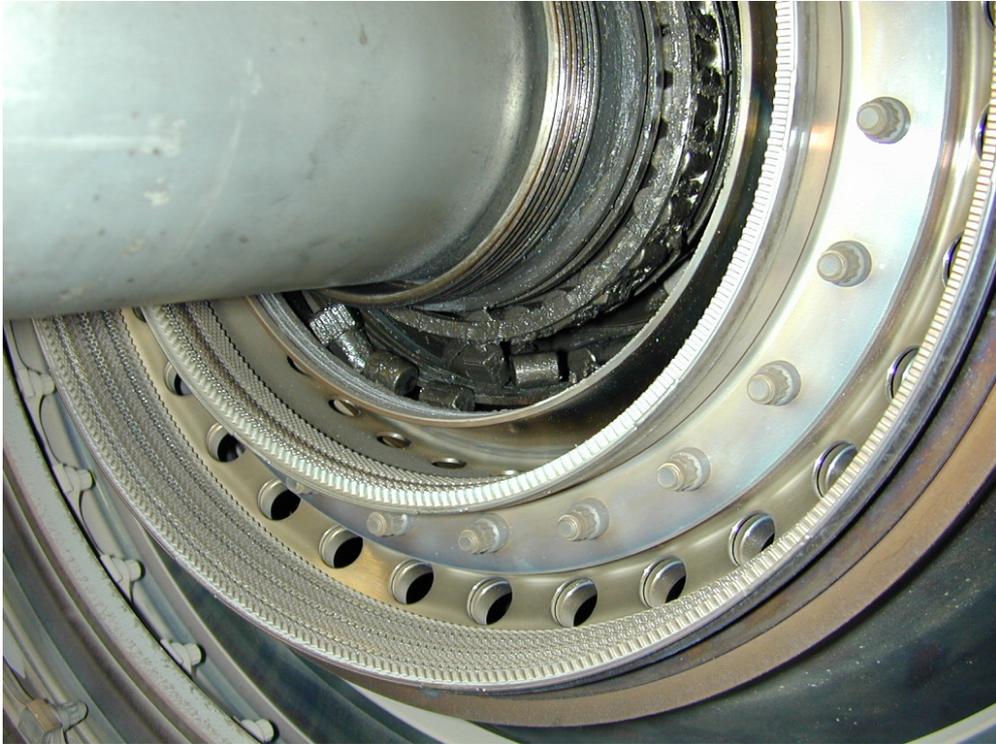
- The engine was removed for investigation. Disassembly started with presence of BFU representative and confirmed a defective bearing No. 4.

Fig. 1 Engine view Bearing 4

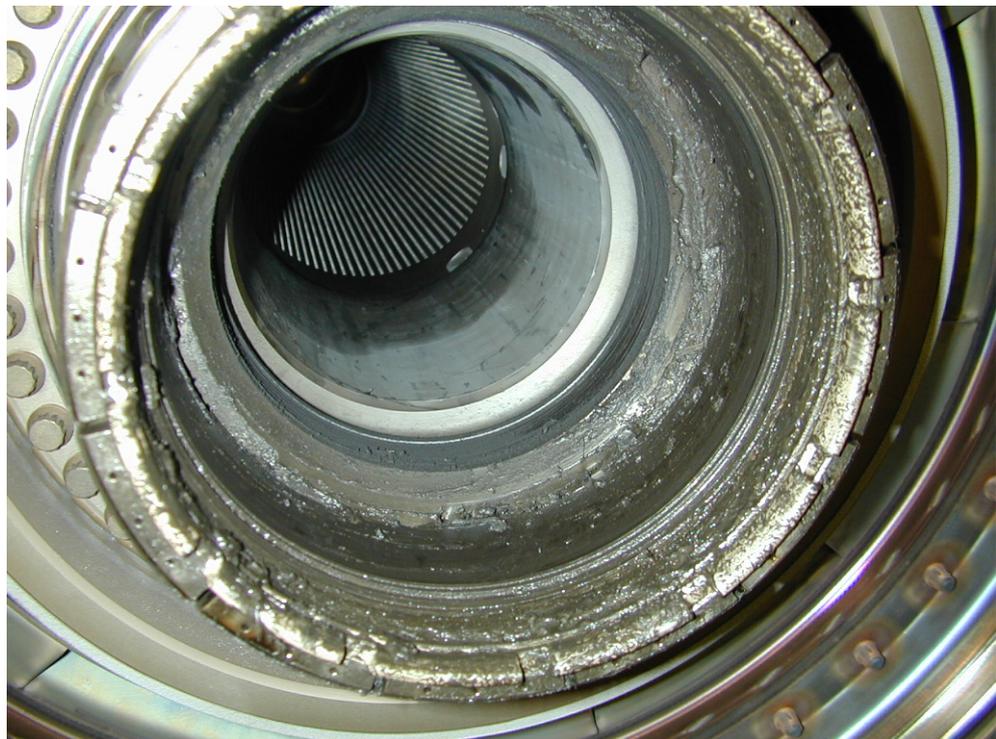
The incident was the result of the failure of Bearing No. 4 during the Flight from LHR to GVA. Despite the fact, that some days earlier, the engine #2 had showed a popped out chip detector indicator in BRU, there is no relation to the incident of 20 February 2001. The material removed after this incident has been analyzed and did not show Bearing material as used on Bearing No.4.

Fig. 2 Bearing No 4 Outer race

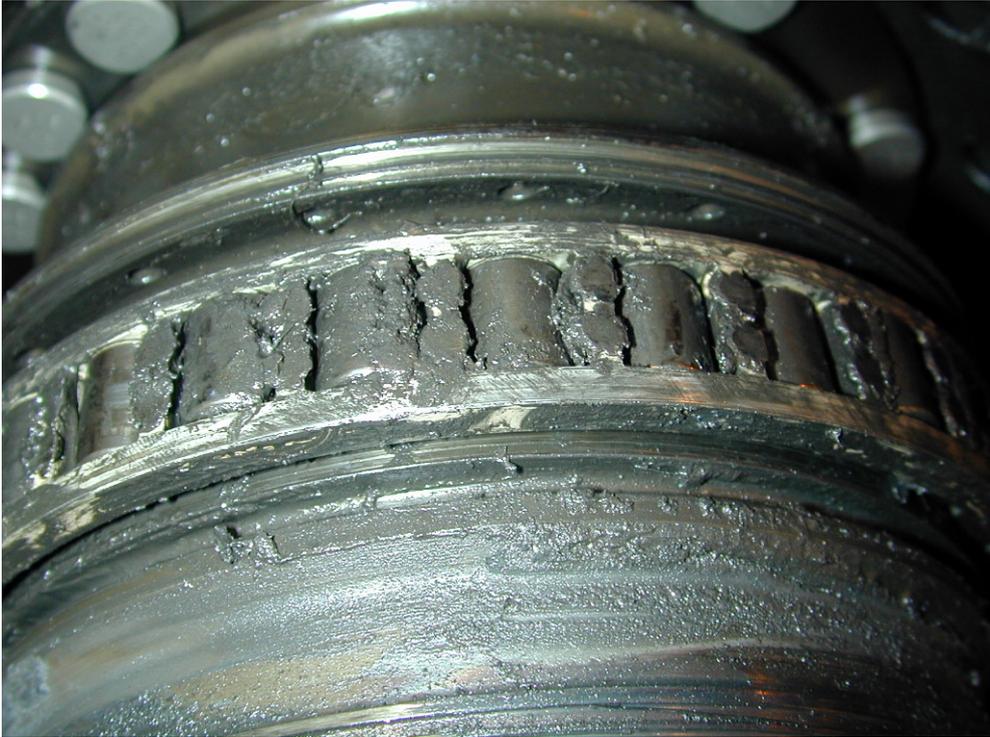
Fig. 3 Bearing No 4 Inner race

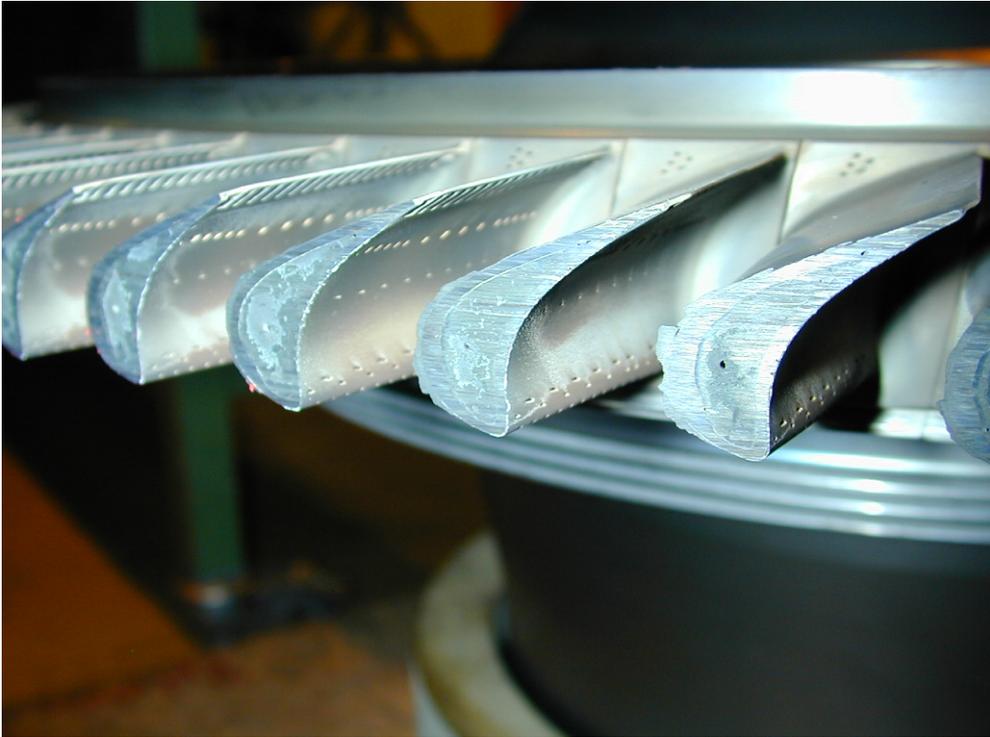
- The aircraft was landed by the CDR, which took over control as the vibrations got stronger.
- The disrupted gas flow due to the damaged blades and heavily fluctuating pressure P3 let the flame move back into the exhaust zone, where unburned fuel from the not properly working engine was ignited and was visible as fire.

The incident was caused by the failure of bearing No. 4 of the engine #2 with resulting damage to the HPT blade tips.

Fig. 4 Damaged blade tips

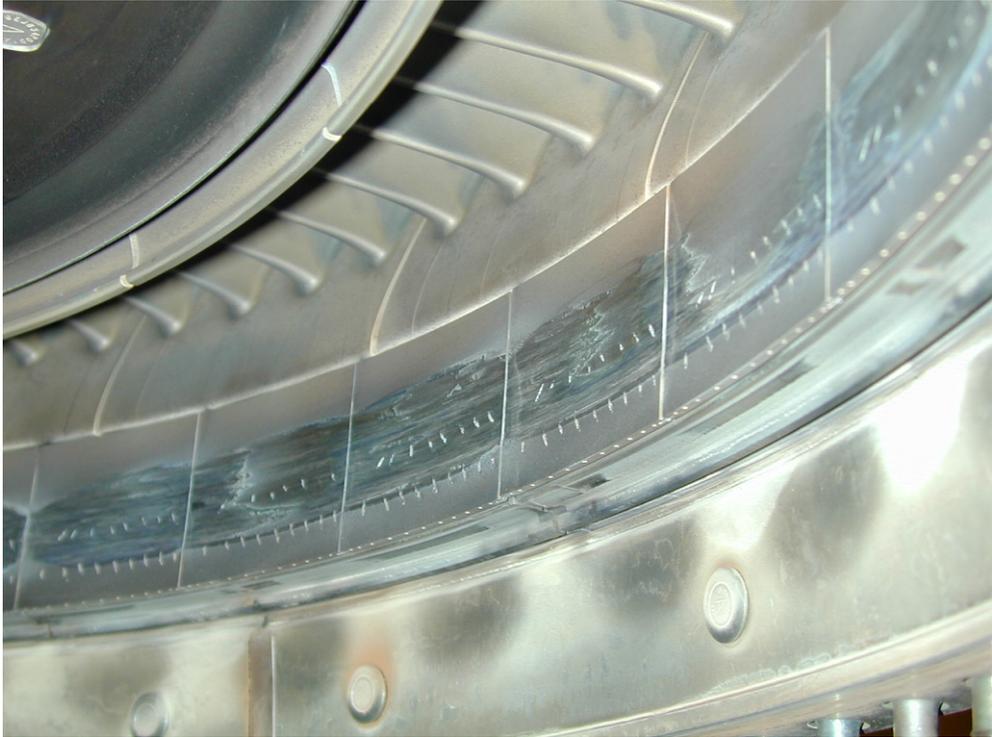
Fig. 5 Shroud

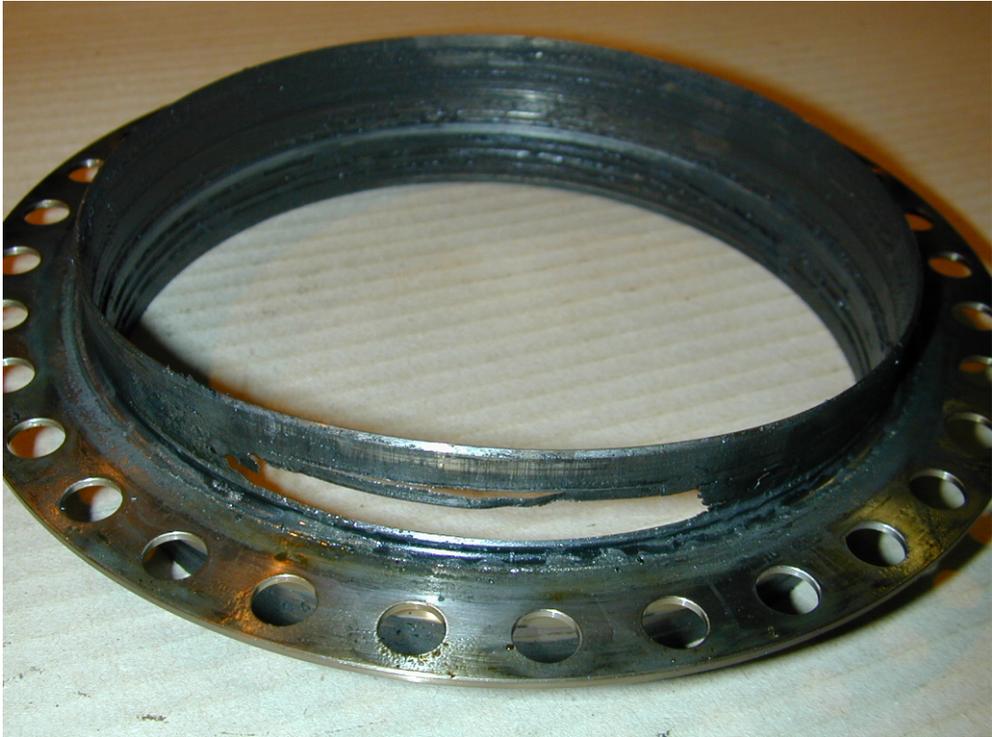
Fig. 6 Ring
