## Tailstrike on landing, Airbus A321-231, G-MIDA, 14 August 1998

# Airbus A321-231, G-MIDA, 14 August 1998

**AAIB Bulletin No: 4/2000      Ref: EW/C98/8/8    Category: 1.1**

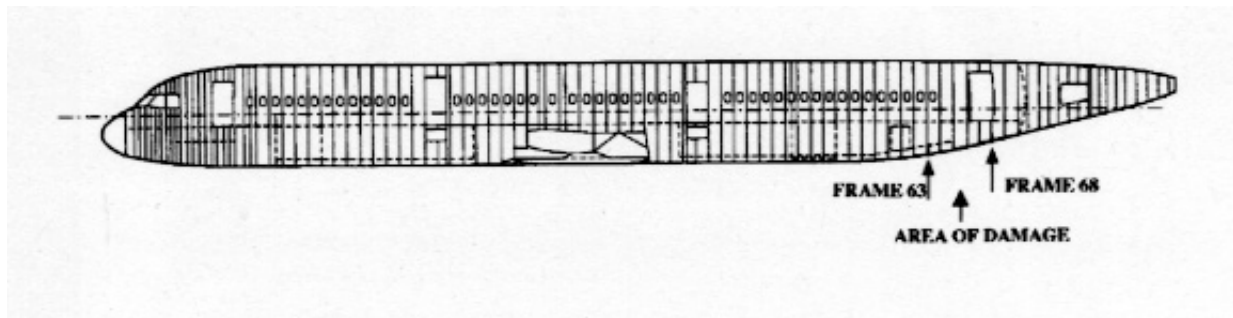
The fuselage underside had suffered abrasion damage consistent with a tailstrike, in the area indicated in the diagram below.

The fuselage centreline on the underside lies midway between stringer 41 left and stringer 41 right. Laterally the damage extended to stringer 40 on the right side and to halfway between stringers 40 and 39 on the left side, suggesting the aircraft had been banked slightly to the left at the time of the occurrence. This was confirmed by the FDR which showed the right landing gear oleo switch decompress again after the initial touchdown, with the oleo switch remaining compressed on the left hand side. The damage was most severe over frame nos. 64, 65 and 66, where the skin had been completely ground away such that the frames and stringers had also been abraded. A section of skin had become detached from the aft edge of frame 65 such that it was free to flap downwards, thus accounting for the pressurisation difficulties on the subsequent flight from Dublin.
