## Oily fumes on approach producing sickness, BAe 146-200, G-JEAK

# **BAe 146-200, G-JEAK**

| <b>Aircraft Accident Report No: 1/2004 (EW/C2000/11/4)</b> ..... | <b>2</b> |

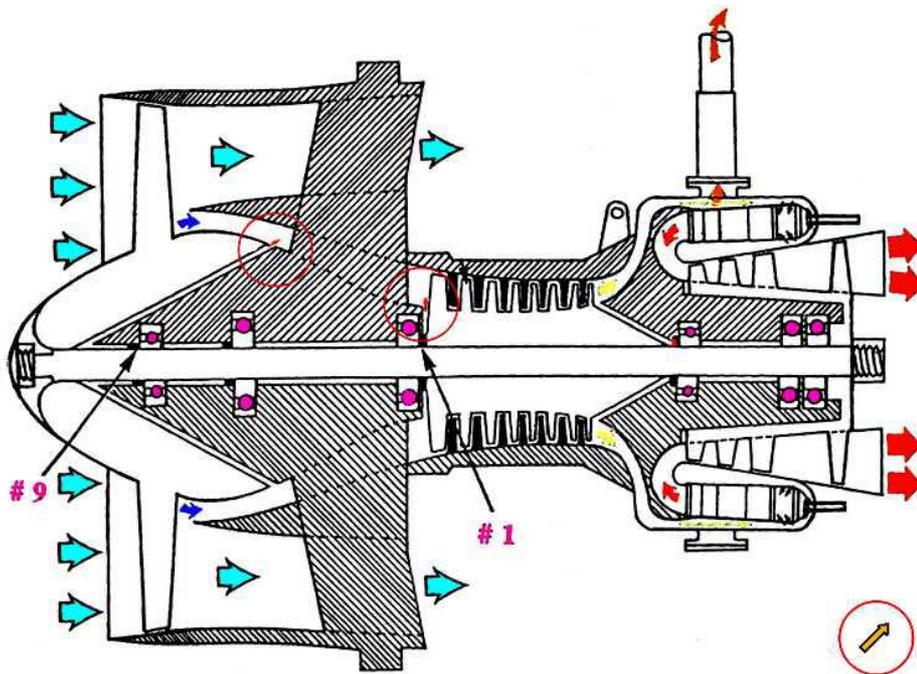
**Figure 2: Simplified Image of ALF 502 - Engine showing Bearing Location and Oil Leakage Paths**

Potential oil leakage paths from bearing Nos 1 and 9  
seals in to main gas stream

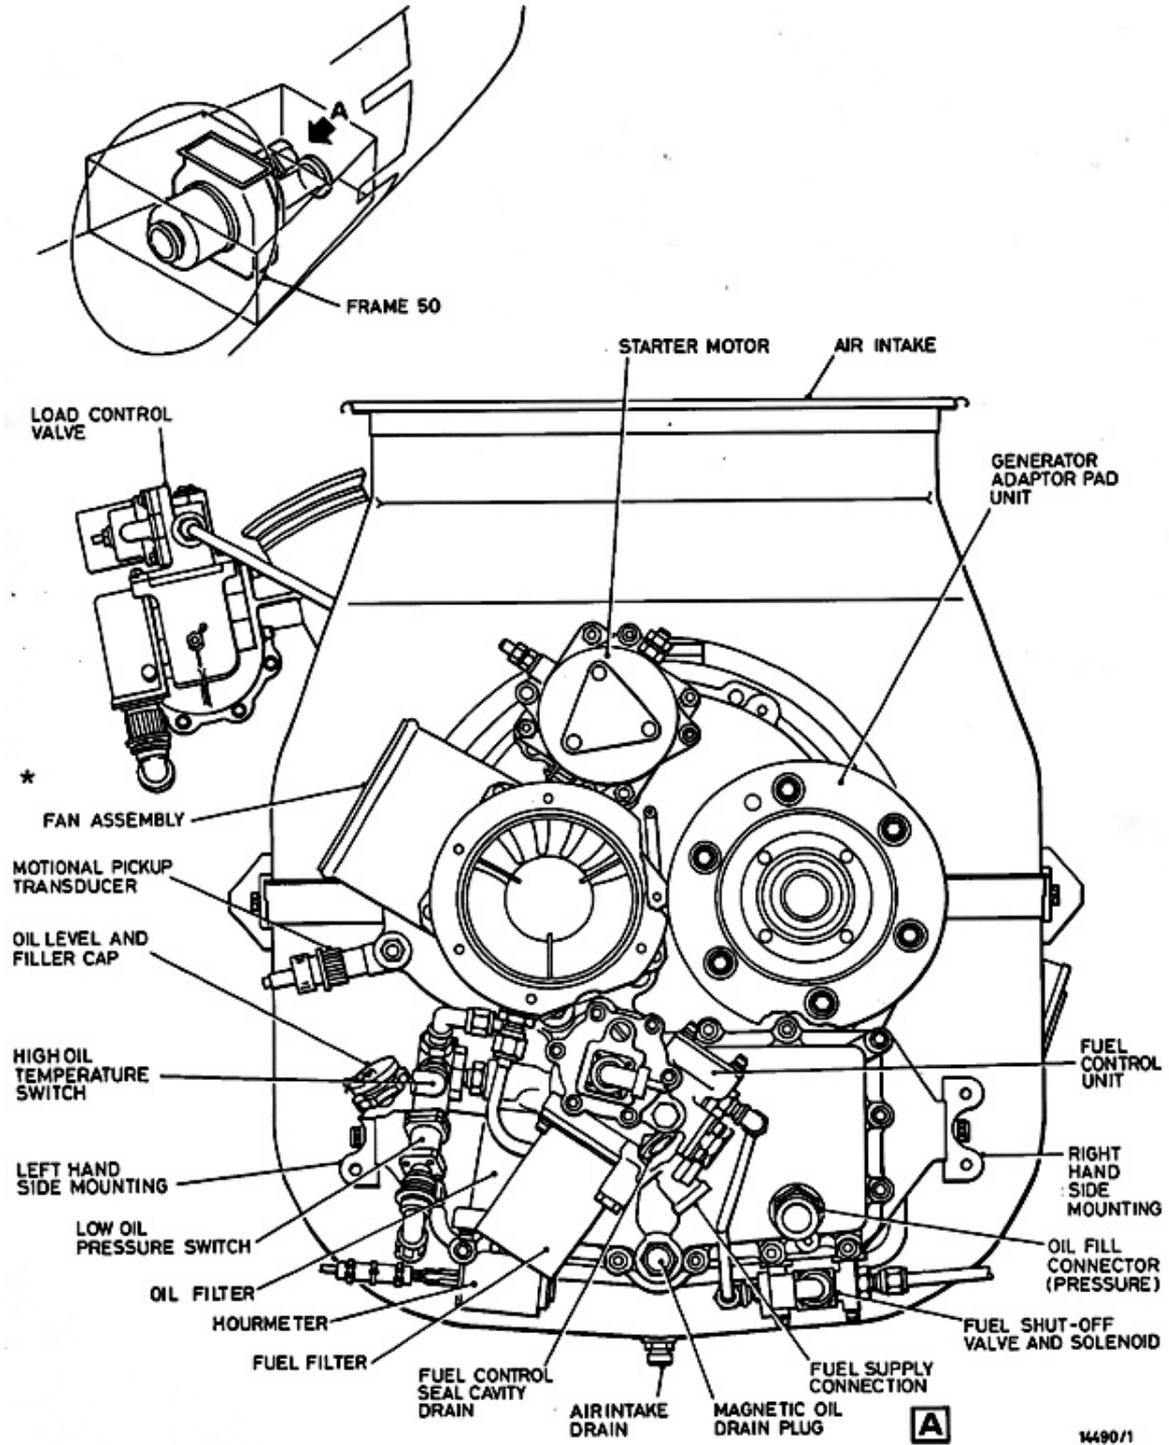
Figure 3: APU Details

An engineering investigation revealed the presence of an oil leak from the auxiliary power unit (APU) generator cooling fan seal, which allowed engine turbine oil to enter the APU air inlet plenum chamber and, subsequently, fumes to enter the cabin via the Environmental Control System (ECS).

APU Details  
Cooling fan \*
