Cowling separation, Boeing 747-240B, AP-BAT

Boeing 747-240B, AP-BAT

AAIB Bulletin No: 3/2004	Ref: EW/C2002/06/03	Category: 1.1
INCIDENT		
Aircraft Type and Registration:	Boeing 747-240B, AP-BAT	
No & Type of Engines:	4 General Electric CF6-50C2 turbofan engines	
Year of Manufacture:	1980	
Date & Time (UTC):	13 June 2002 at 0646 hrs	
Location:	Manchester International Airport, Manchester	
Type of Flight:	Public Transport	
Persons on Board:	Crew - 16	Passengers - 303
Injuries:	Crew - None	Passengers - None
Nature of Damage:	Outboard half of the No 3 engine thrust reverser translating sleeve separated from aircraft	
Commander's Licence:	Airline Transport Pilot's Licence	
Commander's Age:	56 years	
Commander's Flying Experience:	12,945 hours (of which 3,071 were on type)	
	Last 90 days - 132 hours	
	Last 28 days - 44 hours	
Information Source:	AAIB Field Investigation

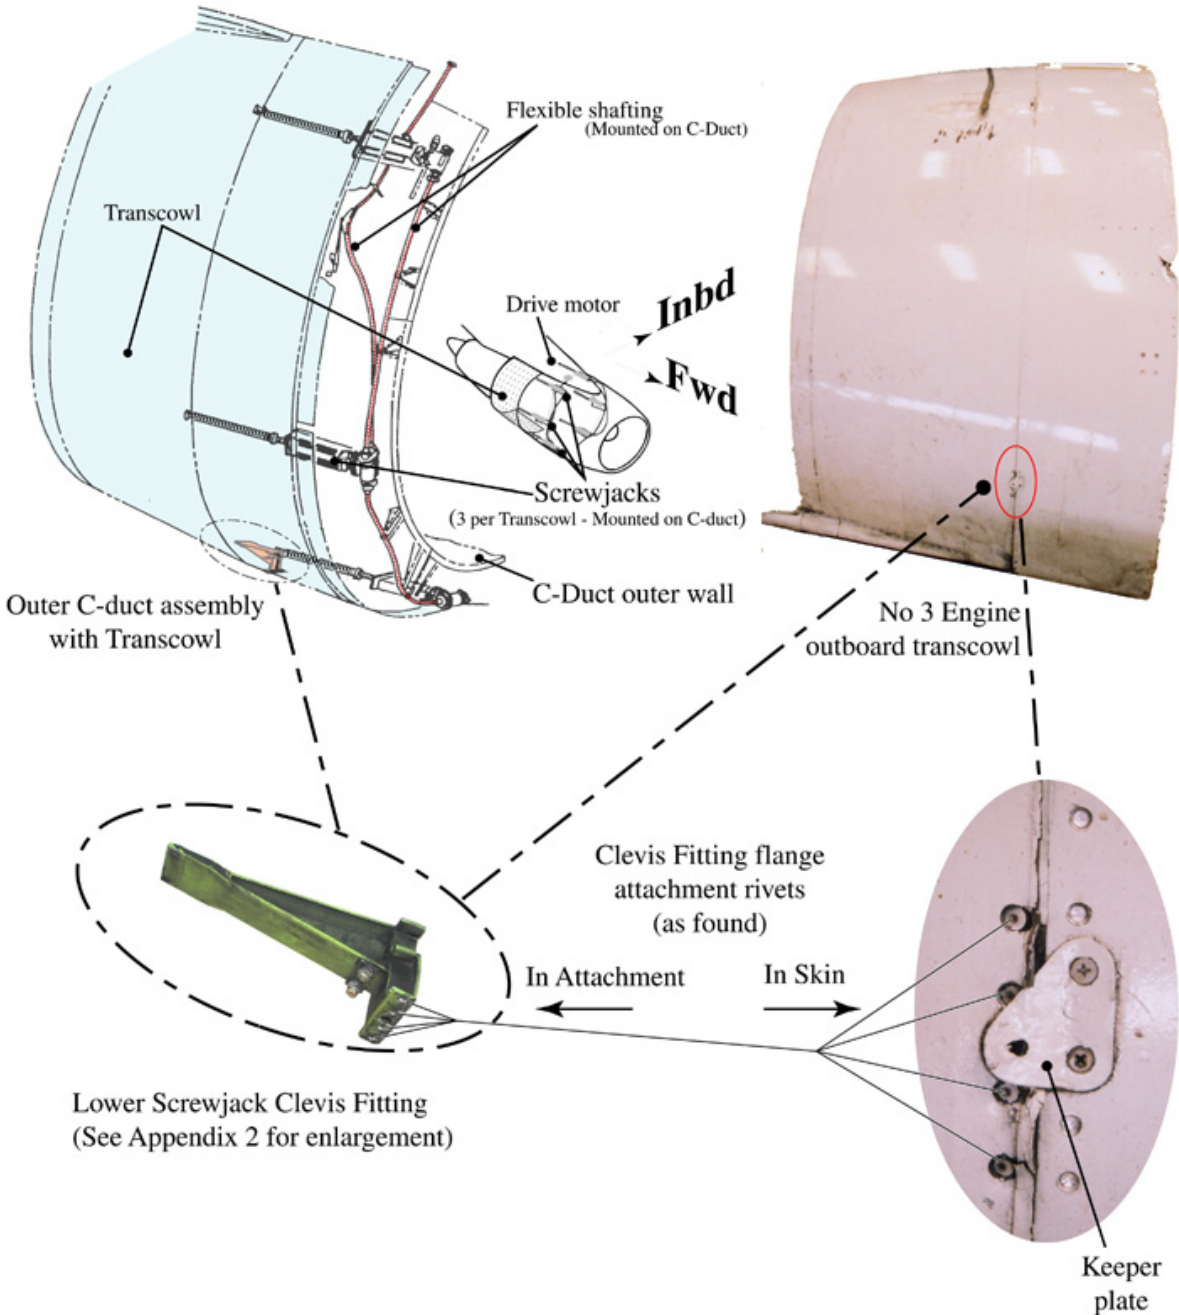
Location of Transcowl drive system components and lower clevis fitting on No.3 Engine outboard C-duct and transcowl

The separated part of the reverser was identified as the outboard half of the No 3 engine thrust reverser translating sleeve (normally called the transcowl). This, together with several small pieces of debris, amongst which was the lower screwjack clevis fitting, were removed from the runway and stored for investigation.

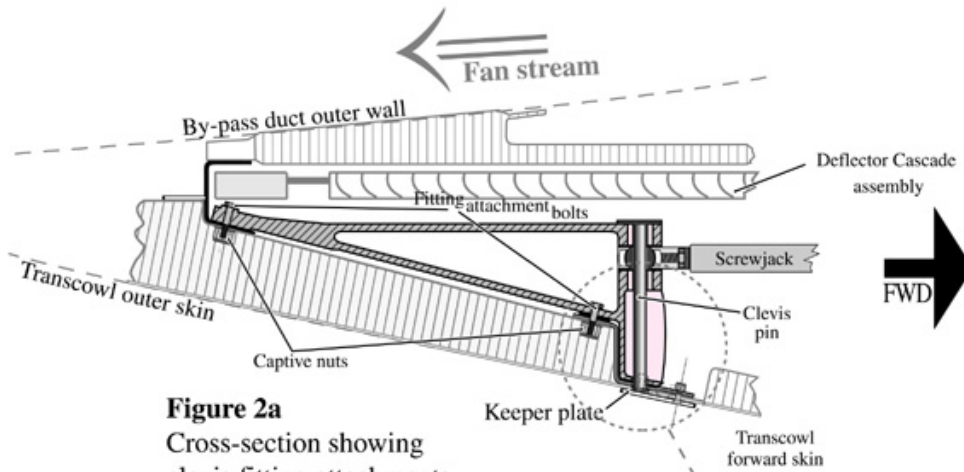
Figure 2a
Cross-section showing
clevis fitting attachments

Owing to the cross-sectional shape of the nacelle, the lower clevis fitting is larger and has a different attachment to the transcowl structure than the simpler upper and centre clevis fittings. The upper and centre fittings are relatively narrow and their inner and outer flanges are attached directly to the transcowl skin structure using solid rivets. By contrast, the lower clevis is stood off from the transcowl outer skin (see Appendix 2, Figures 2a & 2b) and has a more complex rivetted and bolted attachment.

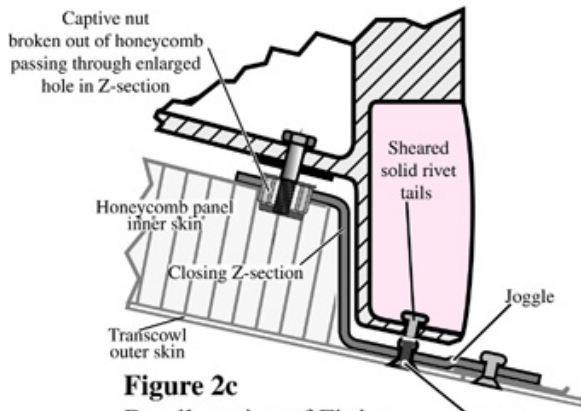
Figure 2c
Detail section of Fitting
flange and forward bolt
attachments before separation.

Examination of the lower clevis fitting showed that the tails of the four solid flange to skin attachment rivets were still retained in their holes in the flange. (See Appendix 2, Figures 2c & 2d.) All four had failed in shear in a direction consistent with the fitting being pulled forwards relative to the transcowl. The two bolts immediately aft of the riveted flange were still attached to the clevis fitting and their captive nuts, which had been bonded into the transcowl honeycomb skin structure, were still attached to the bolts. Of the two bolts which should have attached the tail of the fitting to the skin structure, one was completely missing and only the threaded portion of the other remained in the captive nut.

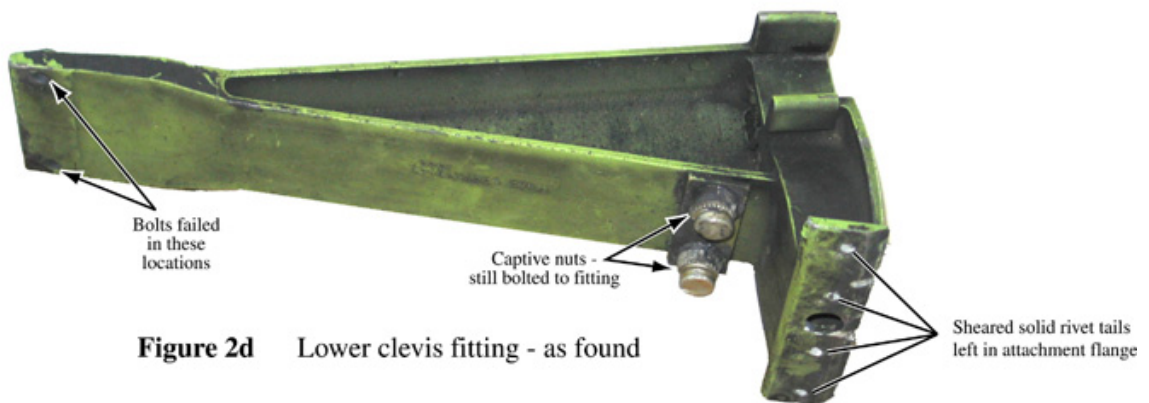
Figure 2d Lower clevis fitting - as found

Examination of the lower clevis fitting attachment zone revealed evidence that the original solid rivets attaching the fitting to the transcowl had failed in shear overload. (Appendix 2, Figure 2d.) One of the two aft attachment bolts had failed in shear but there was no trace of the second. The bond between the closing section and the honeycomb panel inner skin had failed, allowing the honeycomb panel closing Z-section to flex forwards, tearing out the bolt holes in the inner skin to its forward free edge and destroying the bond between the honeycomb and the Z-section web. The captive nuts at this location had also separated from the inner skin, allowing the bolts to enlarge the holes in the Z-section. (Appendix 3, Figure 3c.)

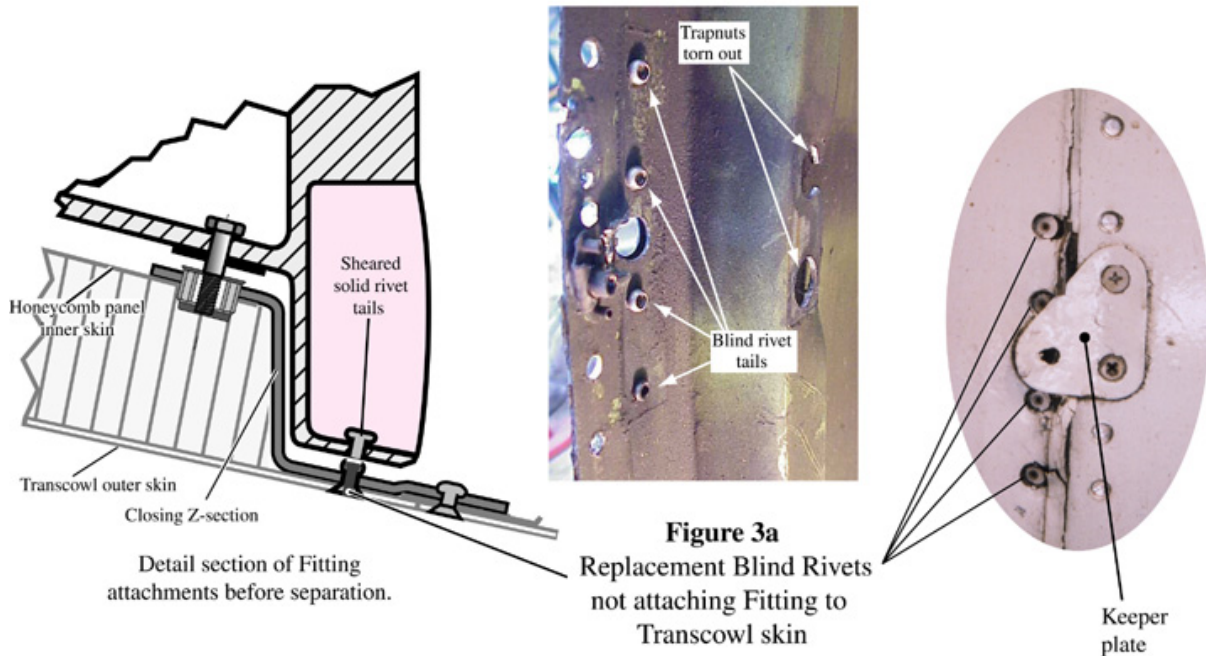
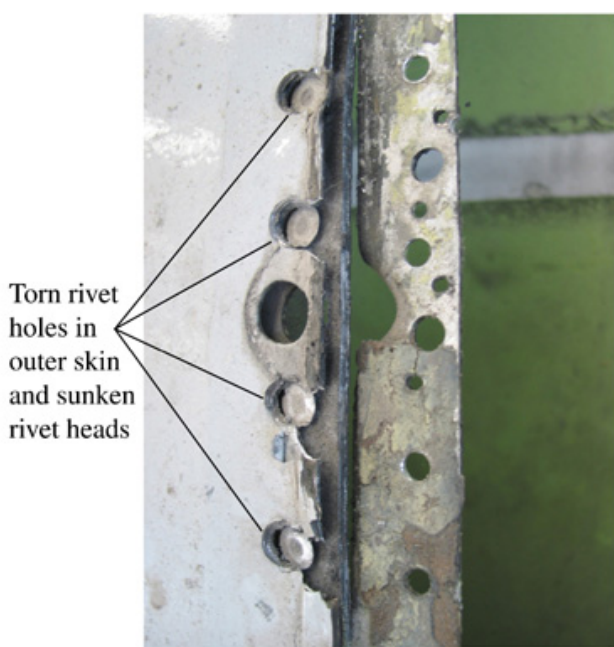
Figure 3b
View on outer skin and Z section forward flange (forward skin removed)

The lower clevis fitting had separated, complete and undistorted, from the transcowl and there was little evidence of overload distortion on the outside of the transcowl, in the area of its attachment. The heads of the four rivets which should have attached the forward flange of the fitting to the transcowl outer skin were all apparently in place and appeared to be 'blind' type, (see Appendix 1) unlike all the other rivets in the area which were countersunk alloy 'solids'. The replacement rivets were all deeply set into the countersinks and the metal between the holes and the forward edge of the transcowl skin section had been torn out (Appendix 3, Figure 3b). The clevis pin keeper plate was still in position.

When the keeper plate had been removed it could be clearly seen that the skin forward of all four of the rivet holes had been broken out but there was no shear distortion of any of the rivets. This indicated that the rivets had been installed with the holes already in this condition. The forward skin of the transcowl was removed for better access to examine the failed clevis fitting attachment points. This confirmed that, on the lower fitting, the flange attachment had not been effective since the installation of the existing rivets.

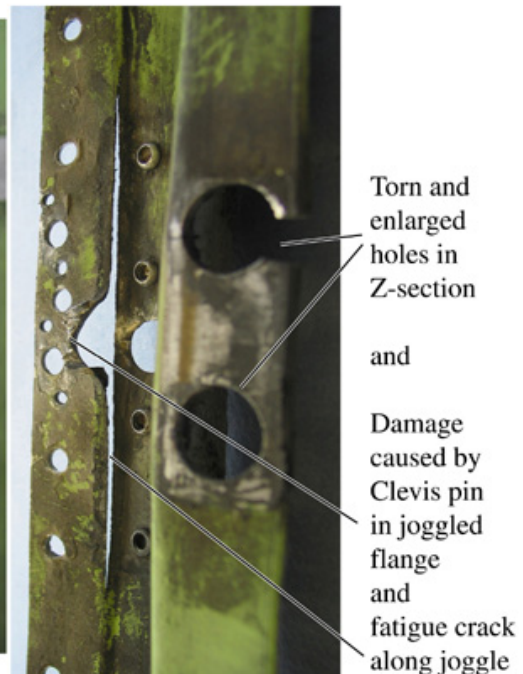
Figure 3c
View on inside of Z-section

There were marks on the attachment flange of the clevis fitting made by the tails of the blind rivets which appear to have been installed to fill the holes left in the outer skin and Z-section flange. These marks indicated that the fitting was generally held against the rivet tails, at a slight angle to its proper orientation and slightly forward of its proper position. (Appendix 2, Figure 2c.) There were other marks on the fitting flange which, together with a set distortion of the Z-section web and damage to its forward flange, indicated that the fitting had been drawn forward, repeatedly and progressively further, relative to the transcowl structure. This movement had resulted in the clevis pin end riding up out of its insertion hole through the Z-section and striking the joggle in the forward flange of the section. (Appendix 3, Figure 3c.)

This action had resulted in a fatigue failure initiating and running circumferentially round the joggle line in both directions from the point at which the clevis pin had contacted the joggled edge. This contact had torn an indentation into the raised element of the joggled flange and progressively rolled its lip forward. The presence of this fatigue indicated that the damage had resulted from repeated operation of the thrust reverser with the lower clevis fitting inadequately attached to the transcowl. The fatigue had characteristics consistent with relatively rapid progression, indicating that the shear failure of the clevis fitting attachment rivets had been relatively recent.
