Ground collision between Boeing 767 and Boeing 737-800, 5B-DBX

Boeing 737-800, 5B-DBX

AAIB Bulletin No: 6/2004	Ref: EW/G2003/11/11	Category: 1.1
INCIDENT		
Aircraft Type and Registration:	Boeing 737-800, 5B-DBX	
No & Type of Engines:	2 CFM 56-7 turbofan engines	
Year of Manufacture:	2003	
Date & Time (UTC):	14 November 2003 at 2326 hrs	
Location:	Manchester Airport, Manchester	
Type of Flight:	Public Transport (Passenger)	
Persons on Board:	Crew - 7	Passengers - 188
Injuries:	Crew - None	Passengers - None
Nature of Damage:	Damage to left upper winglet of the Boeing 737 and the right wing tip of a Boeing 767 (G-OBYC)	
Commander's Licence:	Airline Transport Pilot's Licence	
Commander's Age:	36 years	
Commander's Flying Experience:	8,200 hours (of which 515 were on type)	
	Last 90 days - 211 hours	
	Last 28 days - 67 hours	
Information Source:	Aircraft Accident Report Form submitted by the pilot plus a report from Manchester Airport

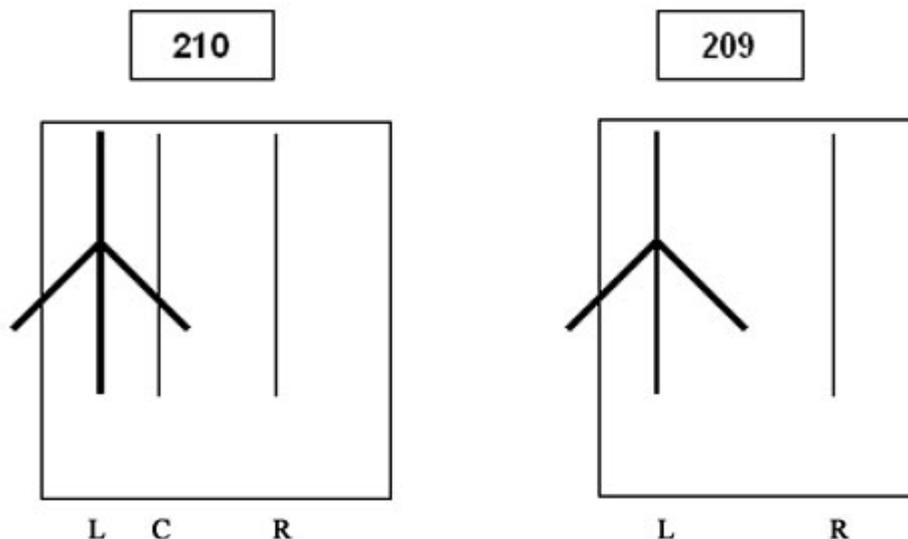
Figure 1

When the Left Centreline of each stand is occupied, this effectively blocks the use of all other centrelines. It should be noted that only this combination is allowed, ie 210C could not operate if 209L is used. Typically, maximum aircraft size for both 209L and 210L is the Boeing 757 (B757). It is also relevant that a Boeing 737-800H variant, that is a B737 with winglets has a greater wingspan than other B737 variants, and as such is treated as a B757 for the process of stand allocation.

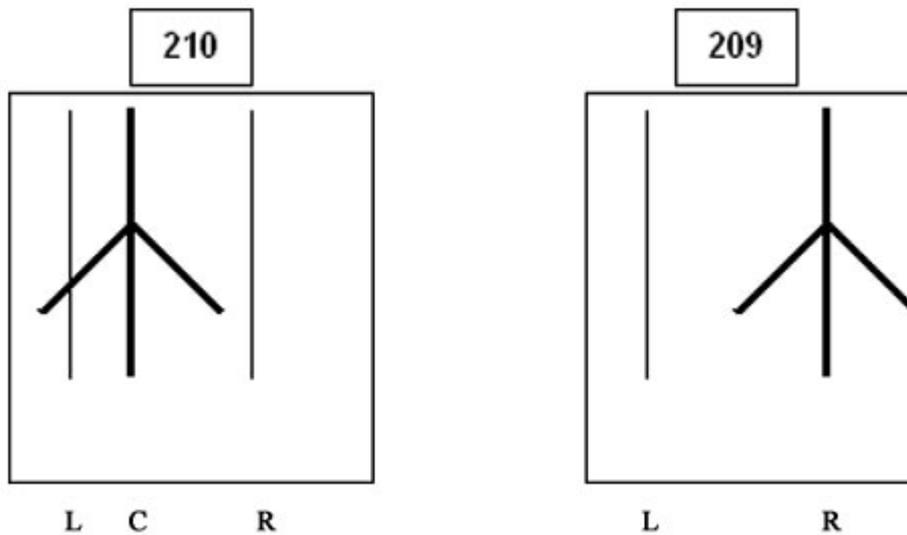
Figure 2

When the even-numbered stand centreline is occupied, eg 210C, then the adjacent odd-numbered stand's right centreline should be used, eg 209R. Should 209L be used, then there is a compromise of wingtip clearance with Stand 210. Typically, the maximum aircraft size for 209R is a B737 (without winglets) and for 210C it is a Boeing 767 (B767).

Using the principles, above and applying them to the allocation of stands on the night of the incident, it is clear that to allocate an aircraft to 209L whilst 210C is occupied was not permitted. Consequently the wingtip clearance was compromised with the result that a collision occurred when the B737 taxied onto stand. The investigation has therefore concentrated on the events that led up to the incident.

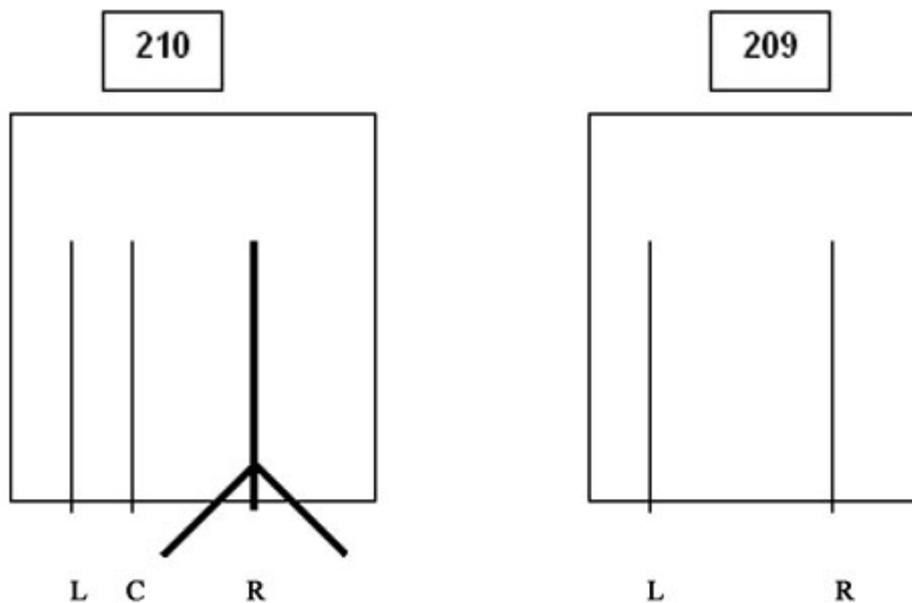
Figure 3

The final example shows the use of the even-numbered stand right centreline, which could be utilised by a wide body aircraft, such as a Boeing 747 (B747). This would effectively close both stands and only Stand 210R could be occupied.
