Collision with taxiway while parking, Boeing 747-436, G-BNLG

Micro-summary: This Boeing 747-436 struck a jetway while attempting to park.

Event Date: 2004-04-21 at 1002 UTC

Investigative Body: Aircraft Accident Investigation Board (AAIB), United Kingdom

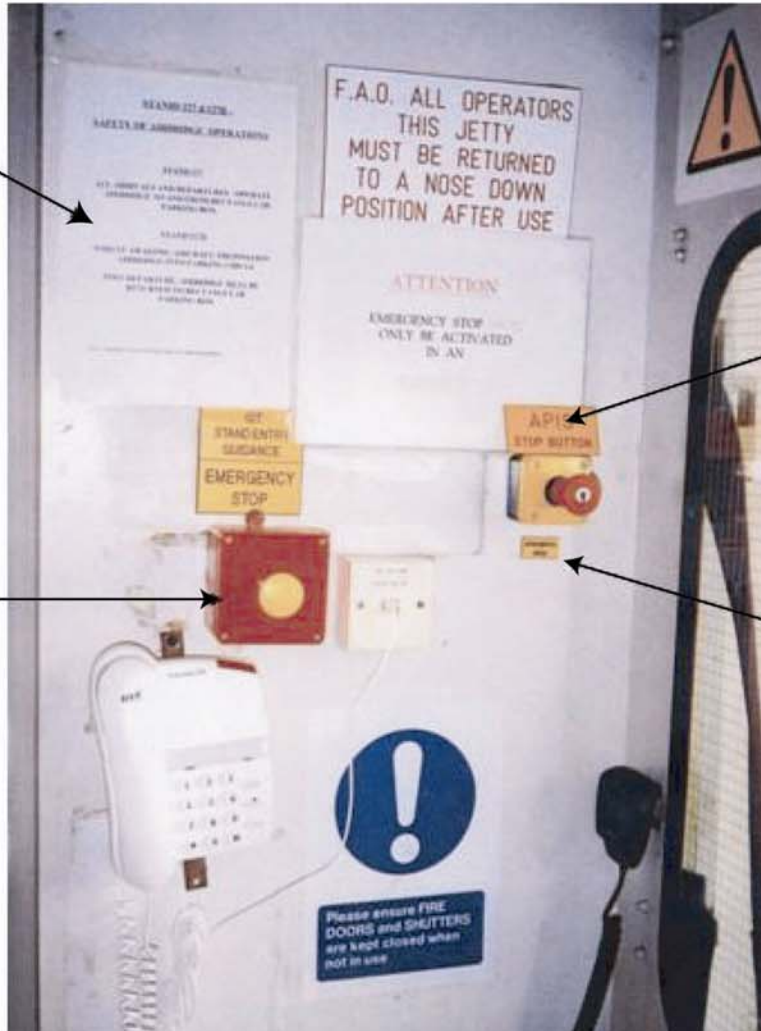
In a subsequent visit by the AAIB to Stand 127, on 23 August 2004, a STOP button had been fitted to the airbridge as part of the on-going program. This had however been placed in close proximity to another stop button intended to stop the airbridge moving in case of emergency and markings did not make it clear which of the stop buttons was for which purpose. Indeed, one label was found simply propped up on one of the switches, Figure 2.

Sign added after accident to G-BNLG

Sign found propped up on box. Unclear where this was meant to be properly attached.

Button labelled 'Emergency Stop', with '127 stand entry guidance' marked above. This is the new STOP light activation button.

Note other signs partially obscuring the top of this label, with the potential to obscure the entry guidance legend. Operator would then be faced with two buttons marked 'Emergency Stop'.

Labelled 'Emergency Stop'. Unclear if this is for the Airbridge only.

View illustrating confusing nature of displayed information/emergency stop buttons on Stand 127

It is recommended that Heathrow Airport Limited should expedite the program to install duplicate emergency stop buttons at all of its airbridge control stations and ensure that all such buttons are clearly and unambiguously marked.
