## Uncertain landing gear on approach, Fokker F28 Mark 0100, G-BXWE

**Investigative Body:** Aircraft Accident Investigation Board (AAIB), United Kingdom

**INCIDENT**

<b>Aircraft Type and Registration:</b>	Fokker F28 Mark 0100, G-BXWE	
<b>No &amp; Type of Engines:</b>	2 Rolls-Royce Tay 650-15	
<b>Year of Manufacture:</b>	1991	
<b>Date &amp; Time (UTC):</b>	14 August 2004 at 1940 hrs	
<b>Location:</b>	London Heathrow Airport, London	
<b>Type of Flight:</b>	Public Transport (Passenger)	
<b>Persons on Board:</b>	Crew - None	Passengers - None
<b>Injuries:</b>	Crew - None	Passengers - N/A
<b>Nature of Damage:</b>	None	
<b>Commander's Licence:</b>	Airline Transport Pilot's Licence	
<b>Commander's Age:</b>	Not known	
<b>Commander's Flying Experience:</b>	Not known	
<b>Information Source:</b>	AAIB Field Investigation

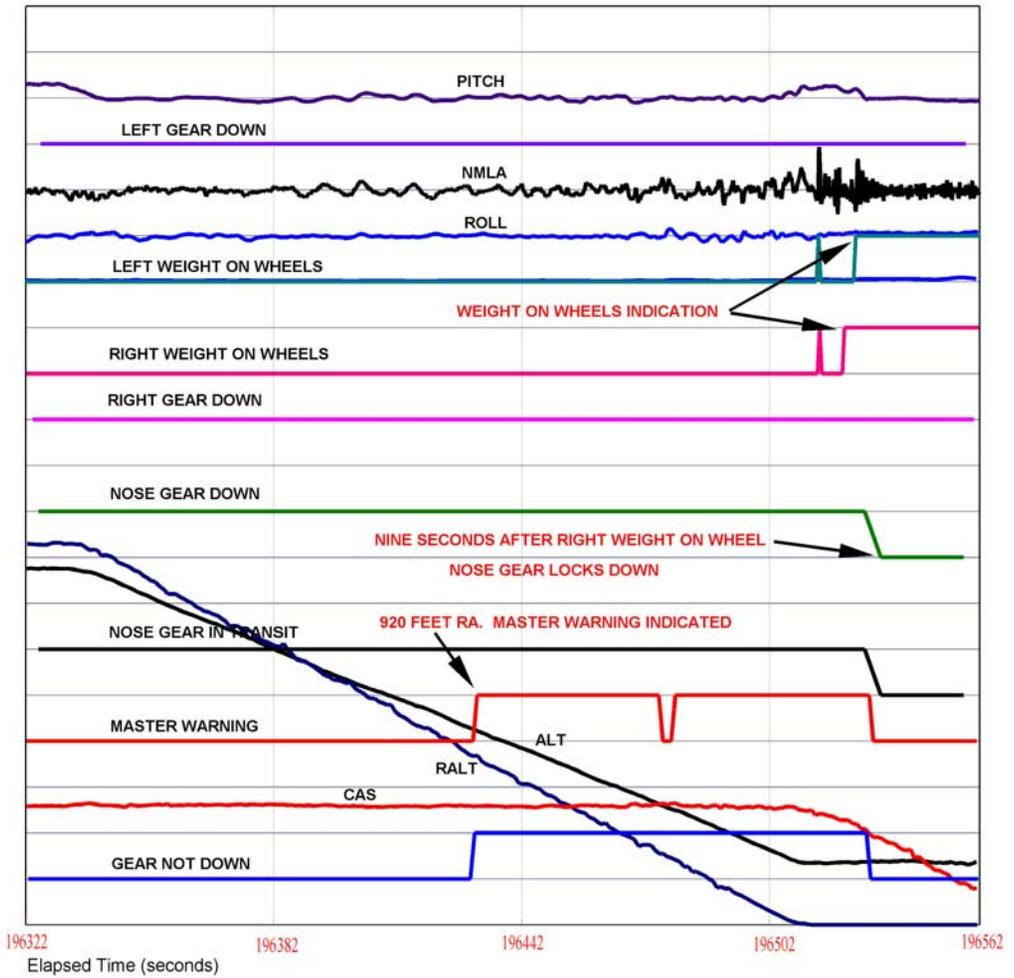
Figure 1

The data for the final approach to land showed the following sequence of events (see Figure 1). At 1837 hrs, at about 2,000 feet amsl with the autopilot and autothrust engaged, at an airspeed of 130 kt, and flap 42 selected, the aircraft turned onto a heading of 270° and established the localiser and glideslope. The aircraft then started to descend. The left and right main gear indicated down and locked. The nose gear indication was in the up position.

During the next three seconds the pitch attitude increased slightly to 2.02° nose-up and the airspeed had reduced to 110 kt, the left weight on wheel parameter was then recorded. Over the next 3.5 seconds the pitch attitude decreased to a nose-down attitude of 0.08° and about one second later the nose gear was recorded in the down position, the master warning at this time was also no longer recorded. The aircraft continued to decelerate at an average of 1.5 metres per second until it came to a stop.
