Multiple system failures, Airbus A340-642, G-VATL

INTERIM REPORT AND SAFETY RECOMMENDATIONS

AAIB Bulletin S1/2005

Ref: EW/C2005/02/03

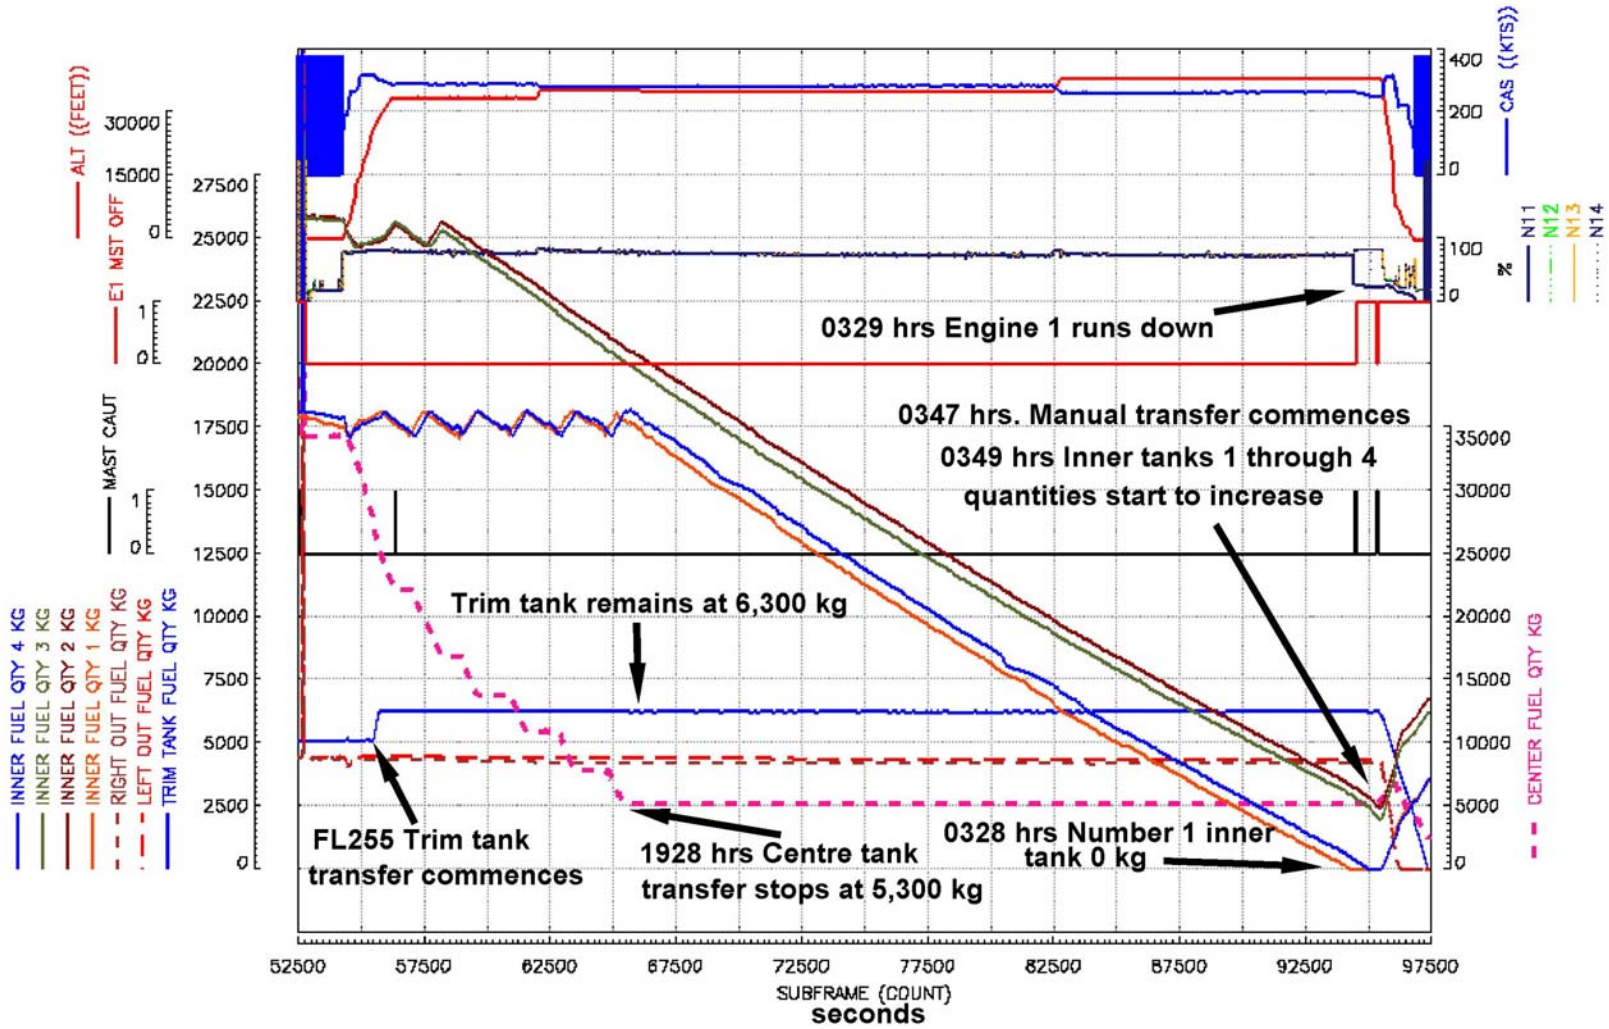
Figure 1 – An Extract of Relevant Flight Data

An extract of the relevant recorded flight data is shown at Figure 1. Takeoff occurred at 1621 hrs with a total recorded fuel of 135,450 kg. As the aircraft climbed, normal fuel transfer occurred. At 1928 hrs, at FL 354, transfer from the centre fuel tank stopped; the tank quantity at that time was 5,300 kg. The aircraft continued en route until at 0328 hrs the inner 1 fuel tank quantity indication reached zero; 40 seconds later the No 1 engine started to run down and the engine was subsequently shutdown. At 0340 hrs the inner 4 fuel tank quantity reduced to zero and the No 4 engine started to run down. At 0345 hrs the flight crew attempted to restart the No 1 engine, but they were unsuccessful. Shortly afterwards at 0347 hrs, the flight crew manually started fuel transfer from the trim, centre and outer tanks to the four inner fuel tanks. At 0349 hrs there was an increase in all four inner fuel tank quantities. The inner fuel tank quantities continued to increase as fuel was transferred from the trim, centre and outer tanks. Touchdown was at 0410 hrs, with a total of 22,960 kg of fuel remaining, with the inner 1 through 4 fuel tank quantities of 2,641 kg, 5,922 kg, 5,370 kg and 2,583 kg respectively. Fuel continued to transfer to the inner tanks until the engines were shut down.
