Engine failure on takeoff, Boeing 747-436, G-BNLG

Investigative Body: Aircraft Accident Investigation Board (AAIB), United Kingdom

INCIDENT

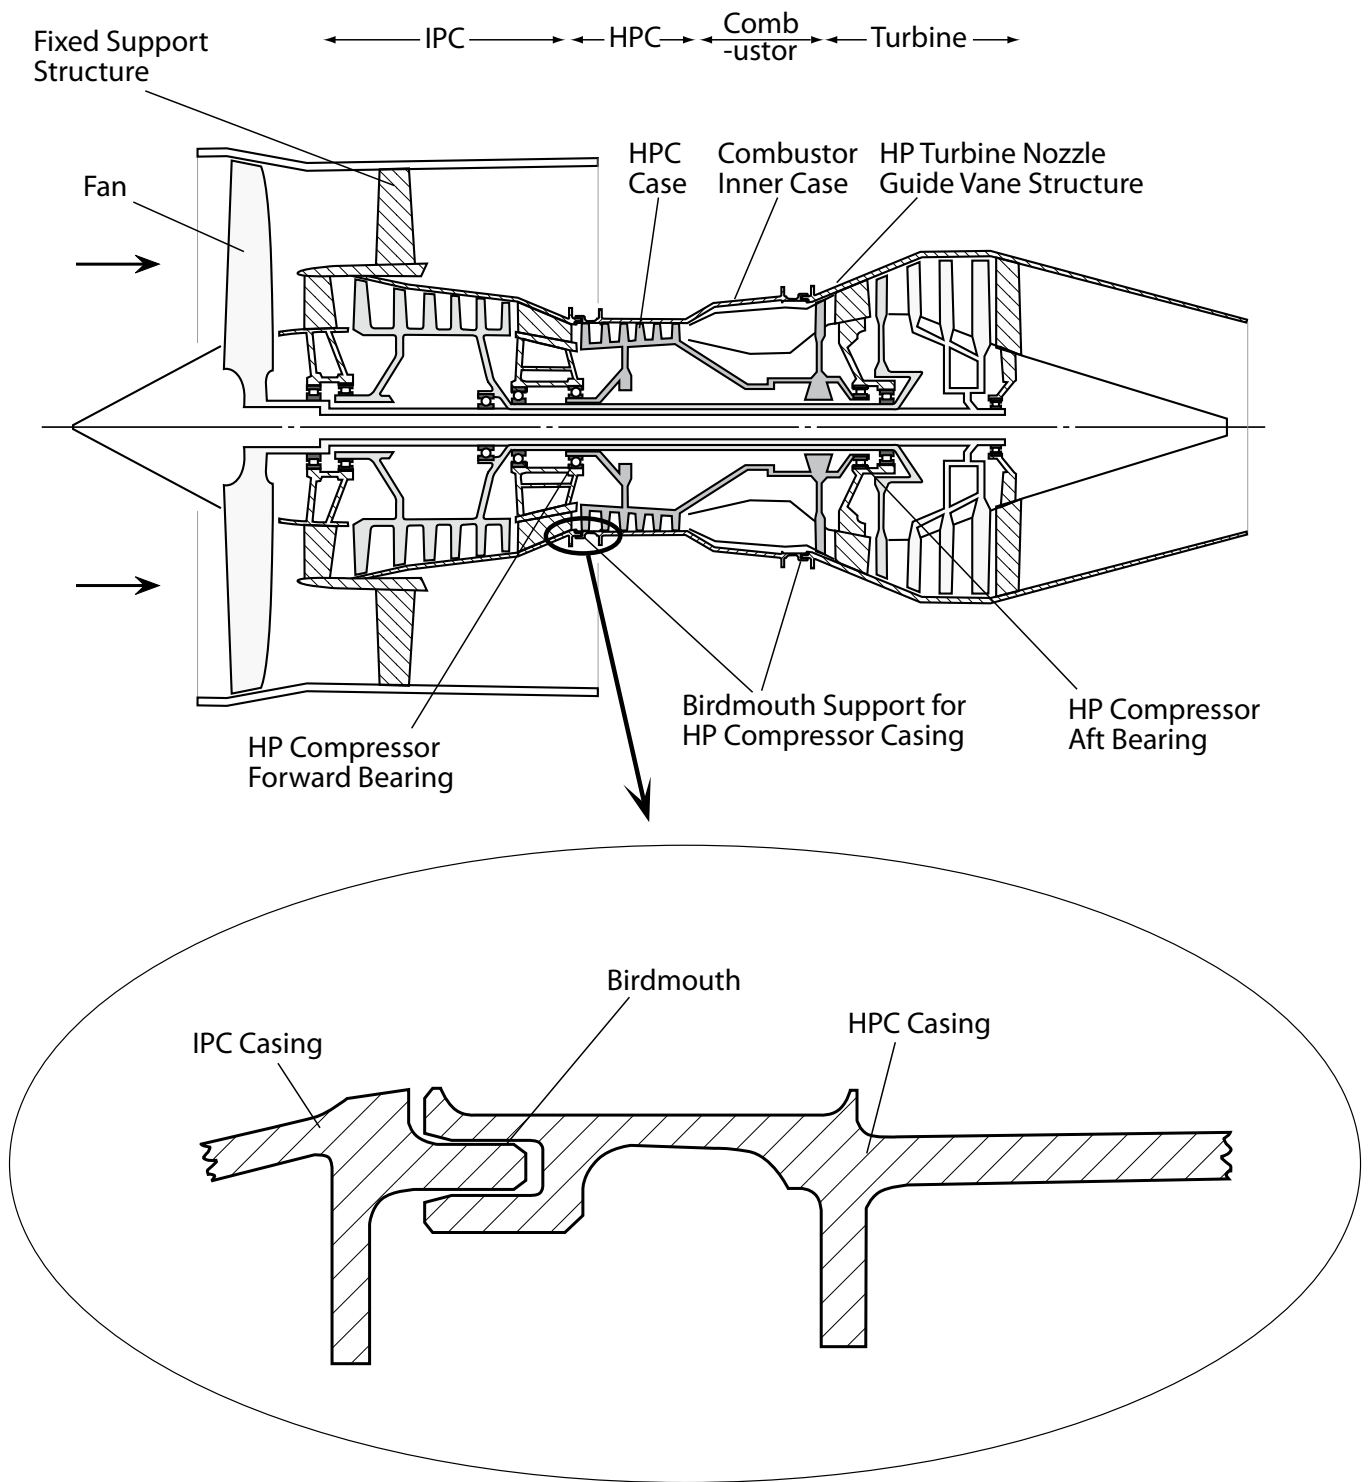
Figure 1
Engine HP Compressor Support Arrangement

Rotor blade tip clearance can be affected by wear of the HPC casing birdmouth feature. Excessive wear allows the forward end of the HPC casing to displace radially downwards, thereby increasing blade tip clearances over the lower half of the compressor and causing the rotor blades to contact the liner over the upper part and erode, further increasing the lower clearances. Experience has shown that where this has led to a compressor stall and engine surge the HPC tip clearance has increased to around 0.020-0.040 inch, with the engine typically having accumulated in the order of 3,500 cycles. Commonly, where the clearances have become excessive, a stall will occur when power is increased in reverse thrust. Information suggested that this may have been used as an indicator that repair was required. Two previous cases of RB211 in flight shut downs (IFSDs) due to surge resulting from HPC birdmouth wear had been reported, on RB211-524G-T and 524H-T type engines.

It was clear from the evidence found during the investigation that the initial No 2 engine problem had been a surge. The degree of wear found to the front of the HPC casing birdmouth locating ring allowed radial displacement of the front of the HPC casing that would have increased the HPC rotor blade tip clearance and thus eroded the normal compressor stall margin. The further increase in clearance, that was a consequence of the loading and thermal effects when engine power was advanced, was predicted to peak around 50 seconds after setting take-off power. The surge that occurred just after G-BNLG took off was consistent with the effects of a compressor stall induced by the increase in HPC tip clearance from these combined effects.

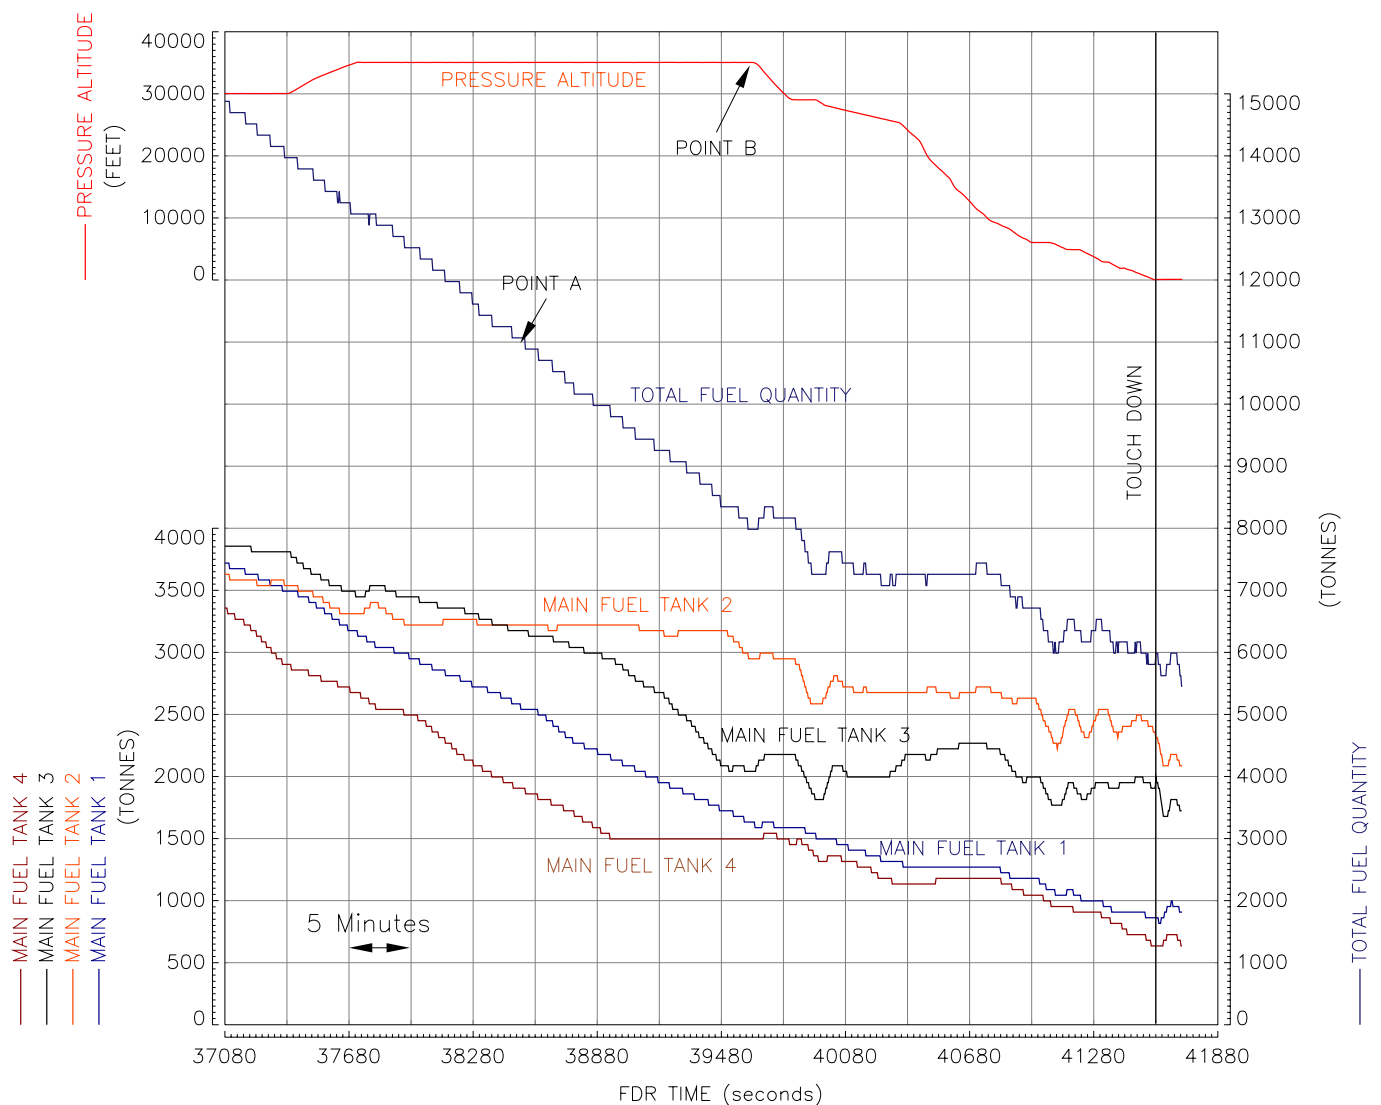
Figure 4
 Salient FDR Parameters
 (Incident to G-BLNG on 20 February 2005)

The main tank fuel quantities prior to the top of descent until the landing are depicted in Figure 4. At 1513 hrs (Figure 4, point A) whilst at FL350, the total fuel quantity was 11 tonnes. The stabiliser, and both reserve fuel tank quantities were at zero with the centre tank at 0.2 tonnes and the main fuel tank quantities for No 1 to No 4 tanks were: 2.6 tonnes, 3.2 tonnes, 3.1 tonnes and 1.9 tonnes respectively. At 1532 hrs (Figure 4, point B), with a total fuel quantity of 8.1 tonnes, a descent to FL290 was initiated; this altitude was maintained until 1537 hrs when the final descent was commenced.

Touchdown occurred at 1604 hrs when the total fuel quantity was 5.8 tonnes. The fuel distribution across the No 1 to No 4 main fuel tanks was: 0.9 tonnes, 2.4 tonnes, 1.9 tonnes and 0.6 tonnes respectively. The FDR stopped recording at 1617 hrs when the aircraft was shutdown.

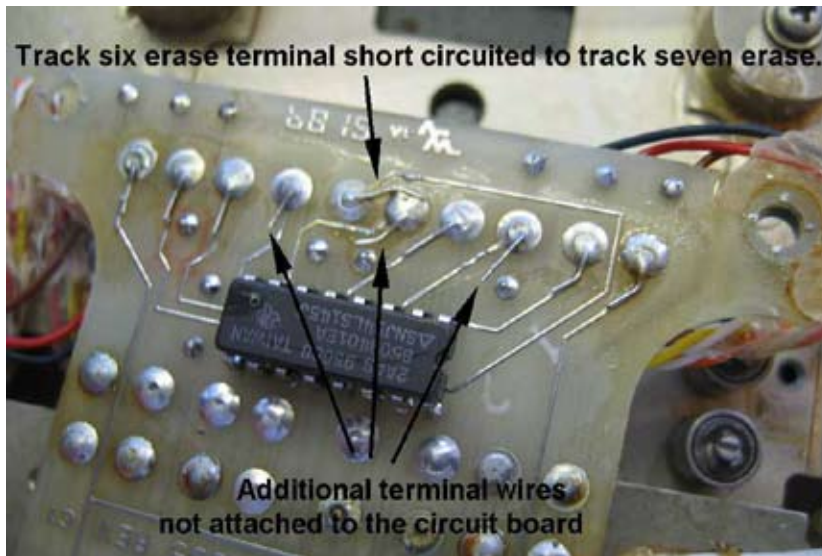
Figure 5 (left)
Faulty distribution board

The fault was traced to the distribution board. The distribution board forms part of the crash protected tape transport assembly. Part of its function is to provide an interconnecting point between the four heads and the FDR's circuitry that was external to the crash protected assembly. A short circuit, between terminals E48 and E49, was found on the underside of the distribution board (see Figure 5). The short circuit was made by a terminal attachment wire, from terminal number E48, becoming

detached from its correct position and becoming soldered to the adjacent terminal, E49. It was also noted that other attachment wires were in close proximity to adjacent circuitry. Figure 6 shows the attachment wires in the correct positions.

September 2002. The operator's annual FDR replay records were inspected and it was found that the erasure fault had not been present prior to the replacement of the heads. Therefore it is considered most likely to have been introduced as a result of this maintenance work. The short circuit was not detectable until the board had been physically removed from the transport assembly. The operator advised that the board would not typically be removed when the heads were replaced as access to the solder terminals was adequate. The history also indicated that after the heads had been changed the unit had been to the workshop on three further occasions and released to service prior to the incident.

Following the discovery of the short circuit fault, the operator's avionics repair facility introduced a change to its testing procedures for the series 980-4100 model of FDR. The change required that a recording test be performed, using the functional tester, that would identify a failure in the erase function.
