Tailstrike on takeoff, Boeing 757-204, G-BYAO

Micro-summary: Following a high rate of rotation, this Boeing 757-204 experienced a tailstrike and diversion.

Investigative Body: Aircraft Accident Investigation Board (AAIB), United Kingdom

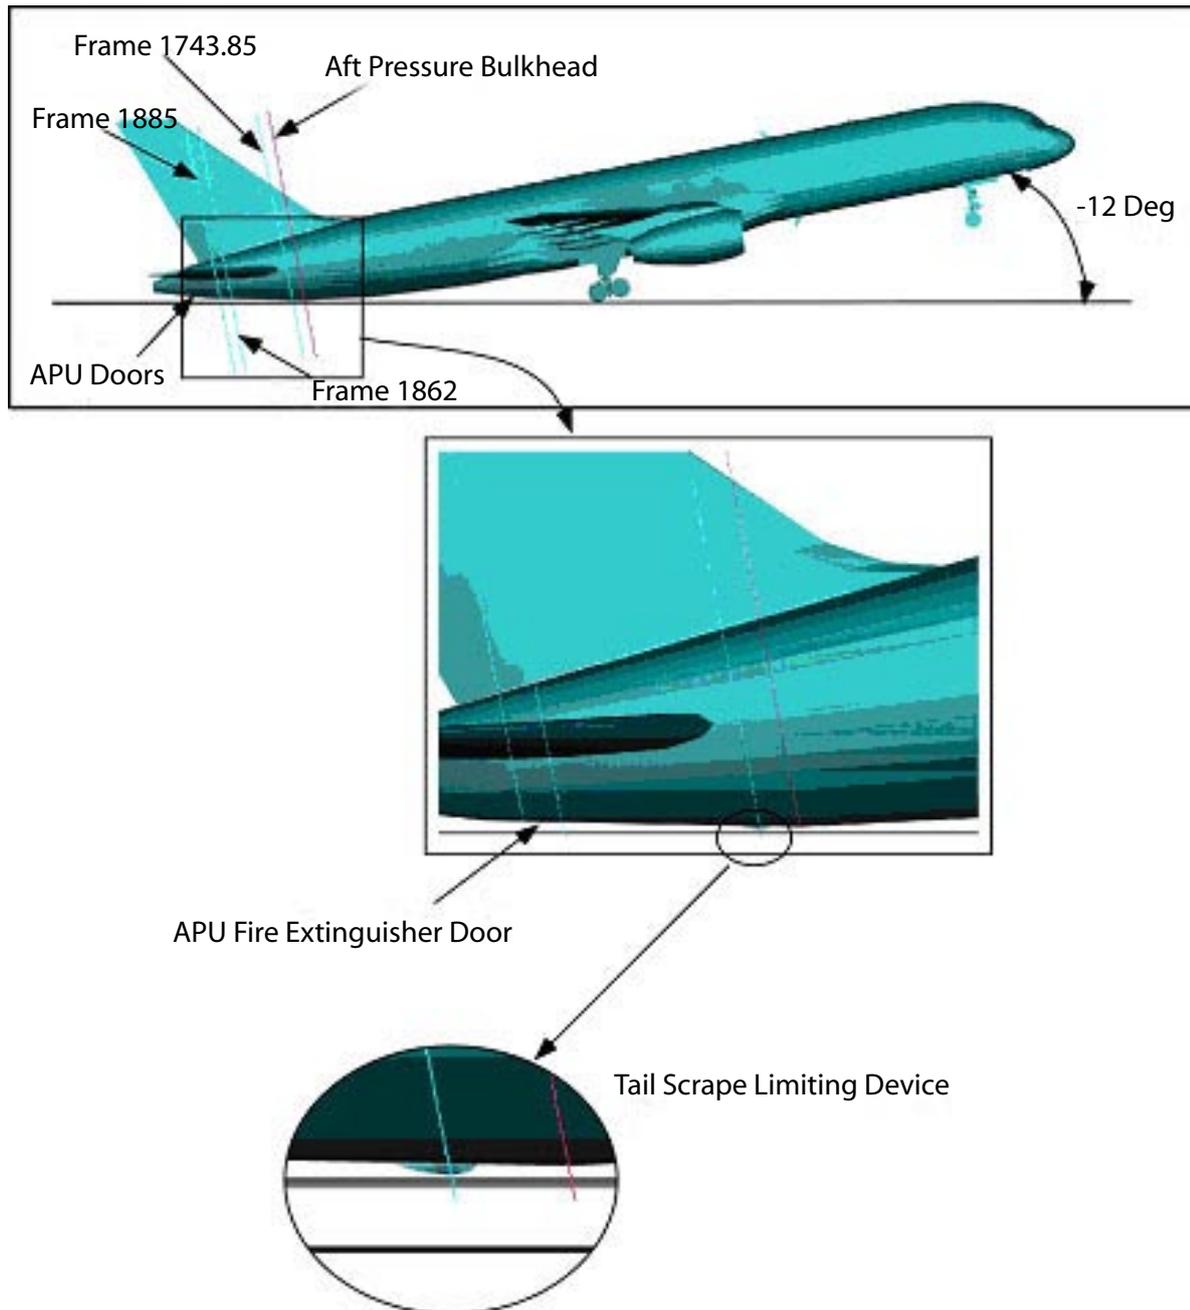
Figure 1

The TSLD had extensive contact damage, with the inverted section worn down so that it was flush with its fairing. Around the device, the airframe skin had buckled and rivets, attached to the frame, had pulled away from the external skin. Internally, frame 1743.85 had been

buckled in two diametrically opposite areas where stringer 29L and stringer 29R were attached to the frame. This buckling was consistent with an extensive upward force on the TSLD with the load being transferred into the frame, pushing this upward and causing the plastic deformation of the frame and aircraft skin.

Moving aft from the TSLD, the next contact point was at the APU fire extinguisher access door located between frames 1862 and 1885. Light scrapes were evident 150 mm aft of frame 1862, with these worsening toward the rear of the aircraft. 420 mm aft of the frame, the paint on the access door was worn away in line with the centreline of the aircraft and over an area measuring 160 mm wide and 90 mm in length. The APU access doors were mounted just aft of frame 1885, with a deflector strip mounted on the frame. The centre of the deflector strip was totally worn away, with scuffing of the airframe skin underneath over a width of about 100 mm either side of the aircraft centre line. The scrape damage continued onto the two APU access doors up to a point 470 mm aft of frame 1885. The APU doors contained several proud roundhead rivets and those along either side of the centre line had been completely worn down; coupled with additional wear of the door down to its metal skin. This damage was worse on the right hand door, with the damage at its widest point some 65 mm to the right of the centre line. The left door also suffered similar damage but this only extended 20 mm to the left of the centreline.

The airframe damage was limited to the un-pressurised area of the aircraft. The aft pressure bulkhead remained undamaged, which was mainly as a result of the TSLD. The aircraft was later flown to its home base for repair. The frame and the skin damage repairs at frame 1885 were carried out in accordance with prescribed manufacturer structural repair manual instructions and a bespoke doubler repair was carried out to the skin surrounding the TSLD. The APU fire extinguisher doors, the two APU access doors and the deflector strip were all replaced with new parts. (See Figure 1)

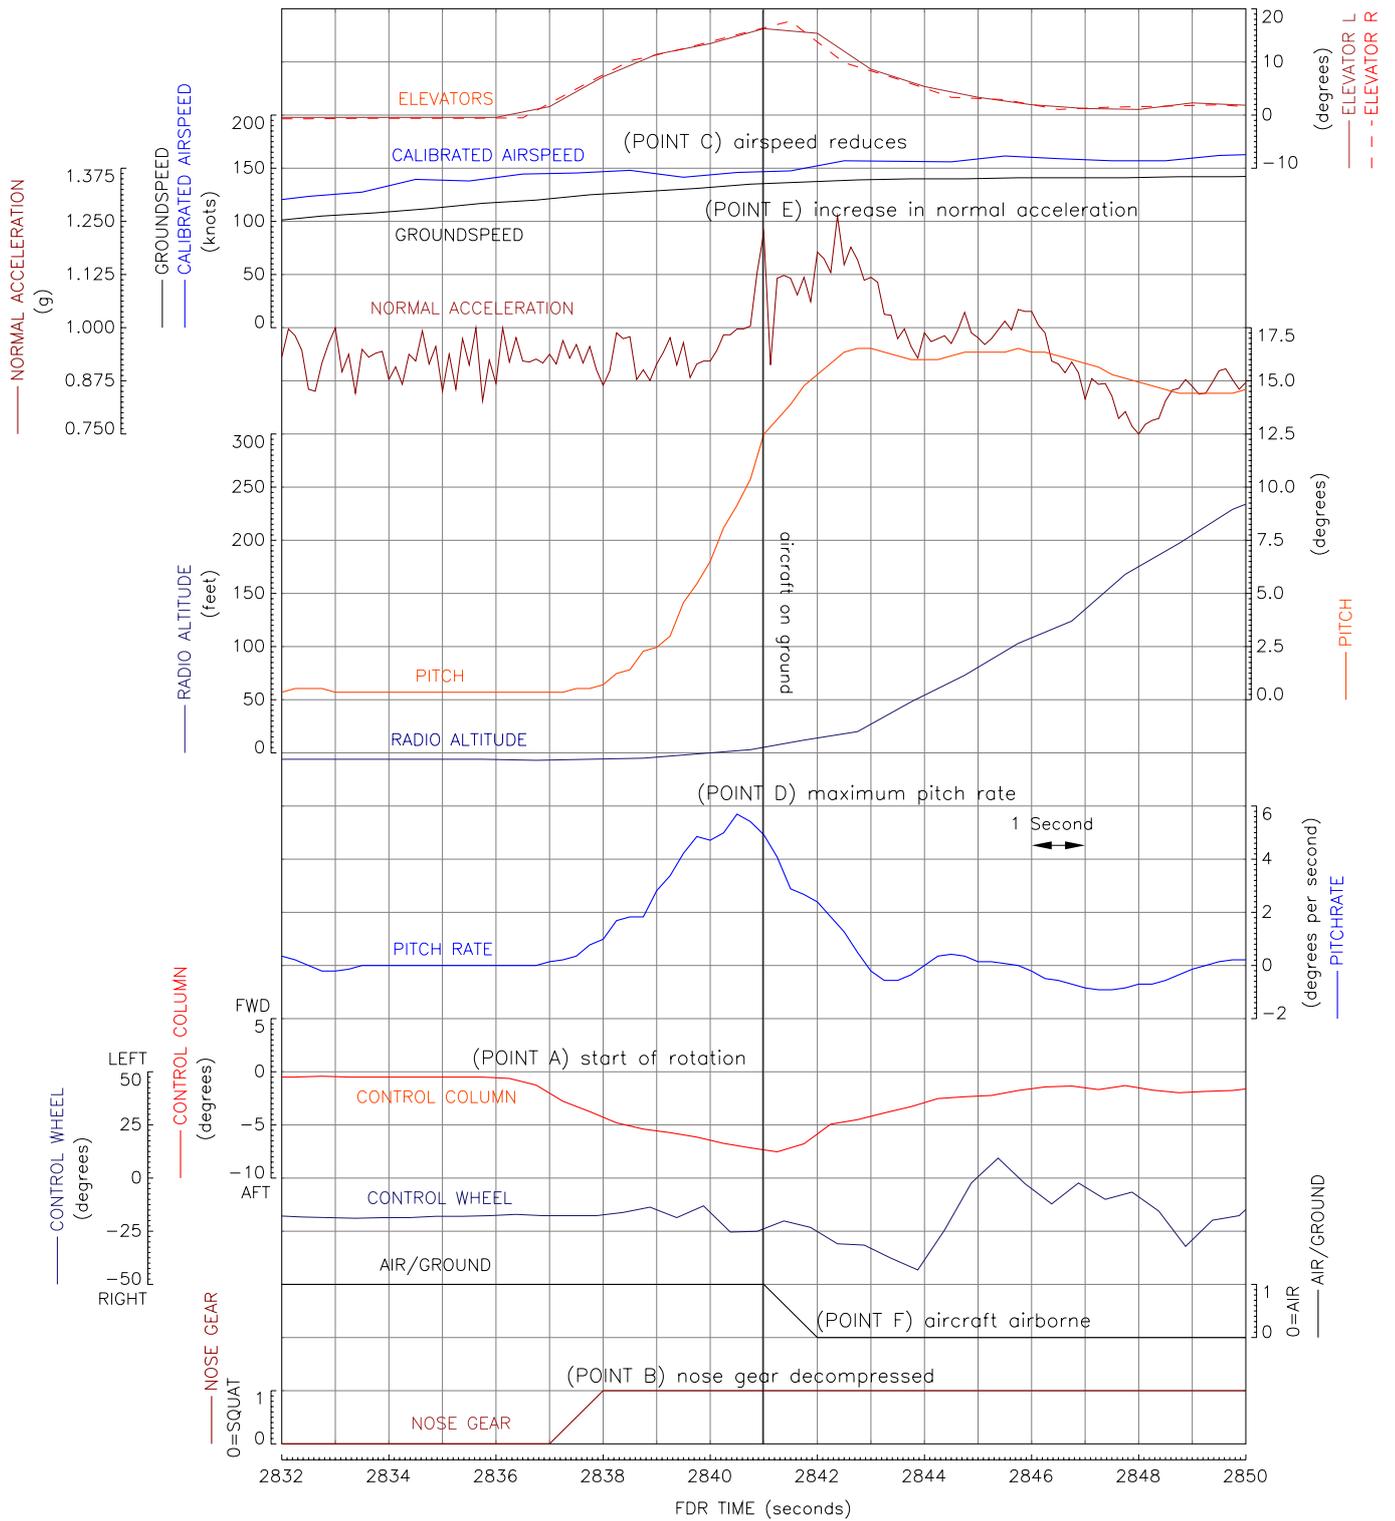
Figure 2
Salient FDR Parameters

Figure 2 details the salient parameters during the takeoff phase. At 1647:18 hrs, at an airspeed of about 144 kt and a groundspeed of about 120 kt, the control column started to move aft (Figure 2, Point A) and about two seconds later the nose squat switch indicated that the nose gear was no longer compressed (Figure 2, Point B).

About one second later the airspeed reduced to about 142 kt (Figure 2, Point C), however the groundspeed continued to increase.

About four seconds after the control column had started to move aft the pitch attitude was at about 10° nose up and the airspeed was about 146 kt; at that time the pitch rate was about 5.7° per second (Figure 2, Point D). The control column continued to move aft and the pitch attitude continued to increase. When the pitch attitude was at about 12.5° nose up, a normal acceleration of 1.22 g was recorded (Figure 2, Point E). At that time the main undercarriage truck tilt parameters indicated that the aircraft was on the ground and the elevators were at about 16° trailing edge up. For a short duration the control column continued to move aft and the elevators moved to about 17.6° trailing edge up, before the control column was then moved forward. About half a second later the air ground parameter indicated that the aircraft was airborne¹ (Figure 2, Point F), airspeed was about 148 kt and the groundspeed was about 137 kt. During the take-off roll and rotation phase the aircraft had remained predominantly wings level.

About four seconds after rotation had been initiated the pitch attitude had reached 10°, this was in accordance with the manufacturer's recommended average rotation rate of 2.5° per second over a four second period, however the pitch rate at the commencement of the rotation had initially been low and had then rapidly increased. During the rotation the elevator had moved to about 17.6°, about 5.6° beyond the maximum position that the manufacturer advised would have been necessary to have maintained an average pitch rate of about 2.5° per second. The control column position and coincident elevator movement indicated that the rapidly increasing pitch rate had been due to an increase in the aft column position.

between the airspeed and groundspeed). As the aircraft had started to rotate the headwind component started to reduce which, as the aircraft had approached 10° of pitch attitude, resulted in an airspeed that was about 10 kt below V_{LOF} . The pitch attitude continued to increase while the aircraft's landing gear was still in contact with the runway and it was most likely that at about 12.5° pitch attitude the aft body made initial contact with the runway as indicated by the coincident recording of 1.22 g.
