Turbulence injuries, Boeing 747-443, G-VROM

Event Date: 2005-07-26 at 2107

Investigative Body: Aircraft Accident Investigation Board (AAIB), United Kingdom

Synopsis

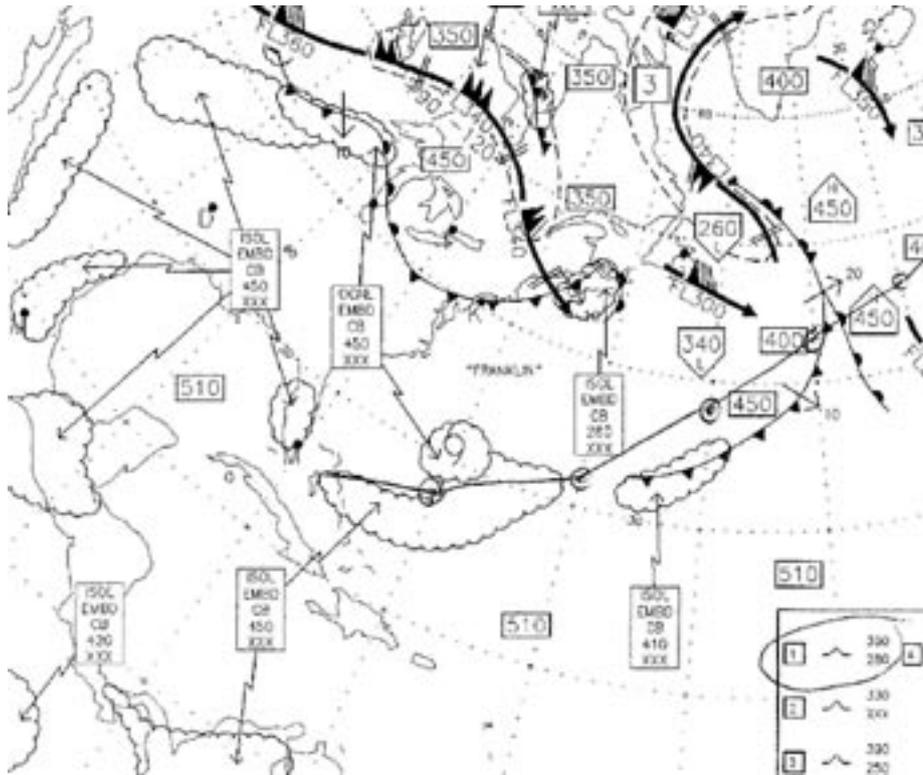
Figure 1

The aircraft had departed Nassau, Bahamas in daylight on a scheduled flight to London Gatwick Airport. Push-back was at 2030 hrs and takeoff at 2047 hrs. The aircraft's planned route is shown at Figure 1, as plotted by the flight crew on the Significant Weather Chart. Tropical Storm Franklin was located approximately 600 nm northeast of the Bahamas. Associated with Franklin and to the south of it was a band of weather lying approximately north-east to south-west. This weather was forecast to contain isolated embedded cumulonimbus (CB) clouds. The intended track passed south of Tropical Storm

The aircraft's planned route marked on the Significant Weather Chart

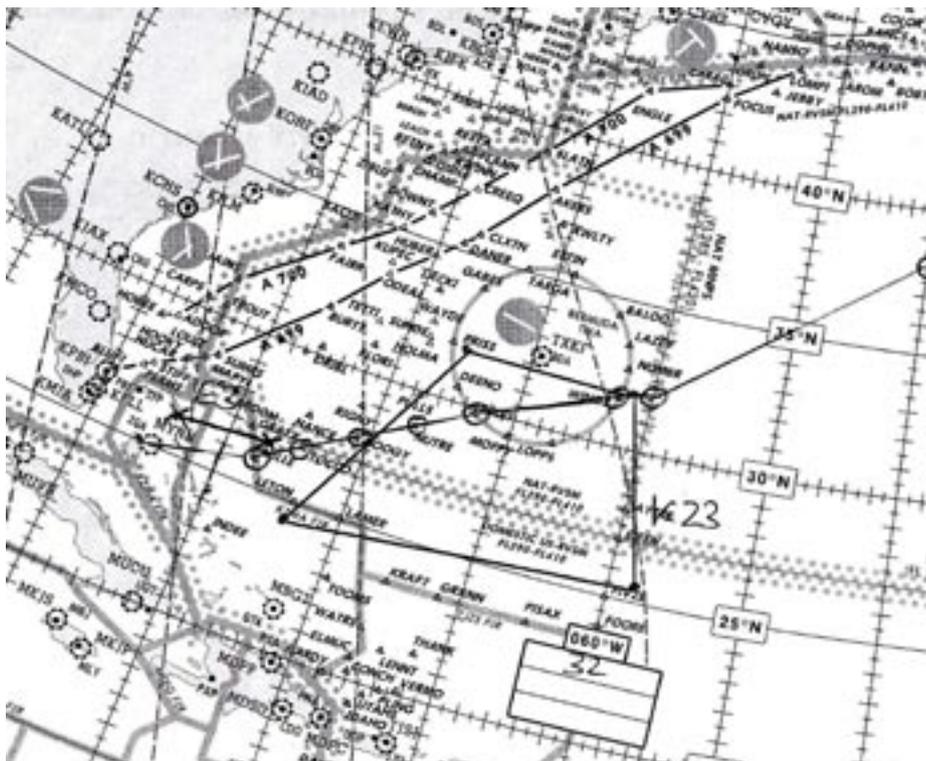
The flight crew had discussed the possible effects of the weather, particularly Tropical Storm Franklin, and they had marked on the Mid-Atlantic Plotting Chart, two SIGMET¹ areas received from New York. A copy of the chart is shown at Figure 2 with the SIGMET areas annotated by the crew as E3 and K23. These were areas of moderate turbulence associated with Tropical Storm Franklin. Area E3 was advised before departure whereas the flight crew were not informed of area K23 until after the turbulence encounter.

Chart with SIGMET CAT areas annotated by the crew as E3 and K23
