Ground collision, Airbus A319-111, G-EZEU, November 24, 2005

Micro-summary: This Airbus A319 struck an A320 while taxiing

Investigative Body: Aircraft Accident Investigation Board (AAIB), United Kingdom

ACCIDENT

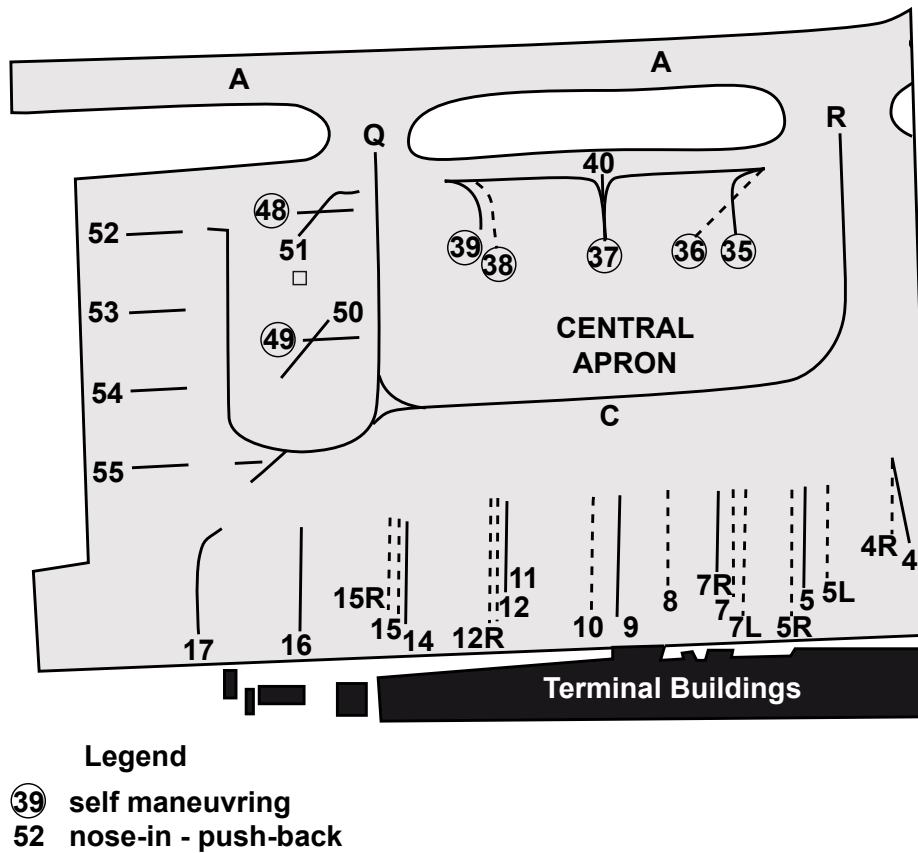
Figure 1

The aircraft was departing on a scheduled passenger flight to Alicante. For the commander, who was normally based in Berlin, this was his first experience of a departure from Stand 50, Figure 1. When boarding the aircraft in preparation for the flight, he had noticed the proximity of a light pylon near the left wing tip and an unmanned Airbus A320 belonging to another operator, beyond the pylon on Stand 51, facing the opposite direction to his own aircraft. He checked the aerodrome charts for the Central Apron and confirmed that Stand 50 was designated a push-back stand.

Diagram of stands layout of the central apron at East Midlands Airport at the time of the wingtips collision

After this incident ATC ensured that all aircraft departing from Stand 50 were pushed back before being cleared to taxi, thereby following the published procedure for that Stand and maintaining the approved obstacle clearance criteria. The operator issued a notice to crews (NTC) reminding them of the correct published procedure for the Stand. Subsequently, that part of the airport's manoeuvring area was redesigned, as part of an unrelated plan, and Stand 50 no longer exists.

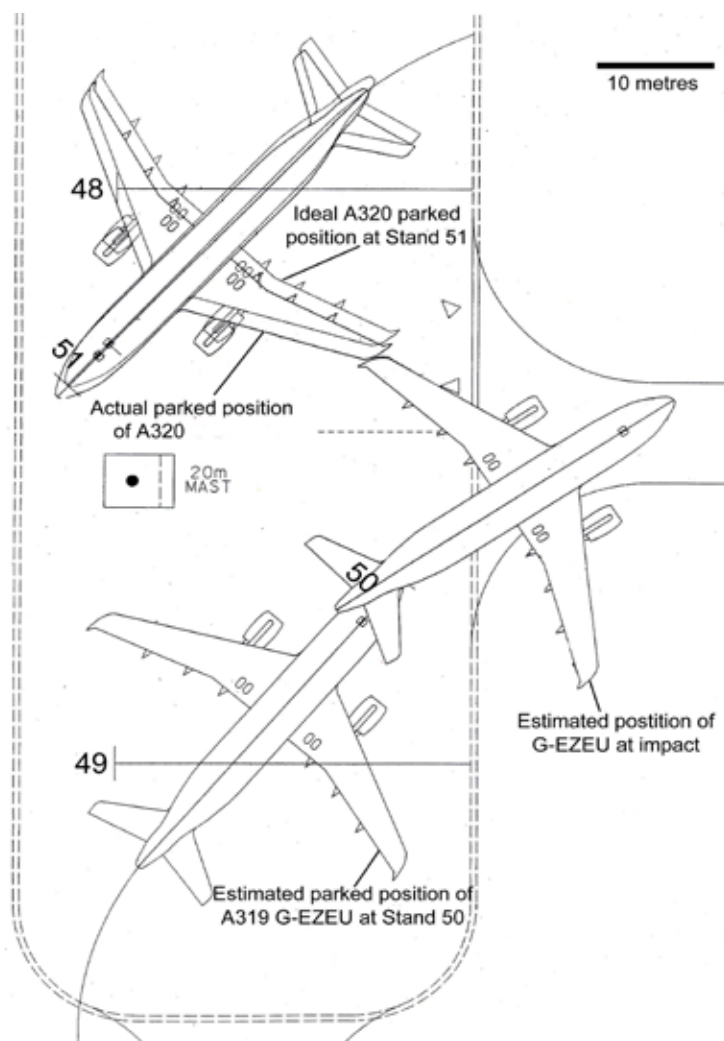
Figure 2

The estimated relative positions of both aircraft at impact is shown in Figure 2. G-EZEU suffered damage to its left wing tip assembly and winglet. The upper section of the winglet had bent aft and a small section of the top of the winglet (approximately 20 cm by 15 cm) had separated and become embedded in the left wing tip leading edge of the A320. The navigation lights in the A320's left wingtip were damaged and the wing lower surface in this area exhibited scrape marks. Neither aircraft sustained any internal structural damage as a result of the impact.

Estimated relative positions of the aircraft at impact

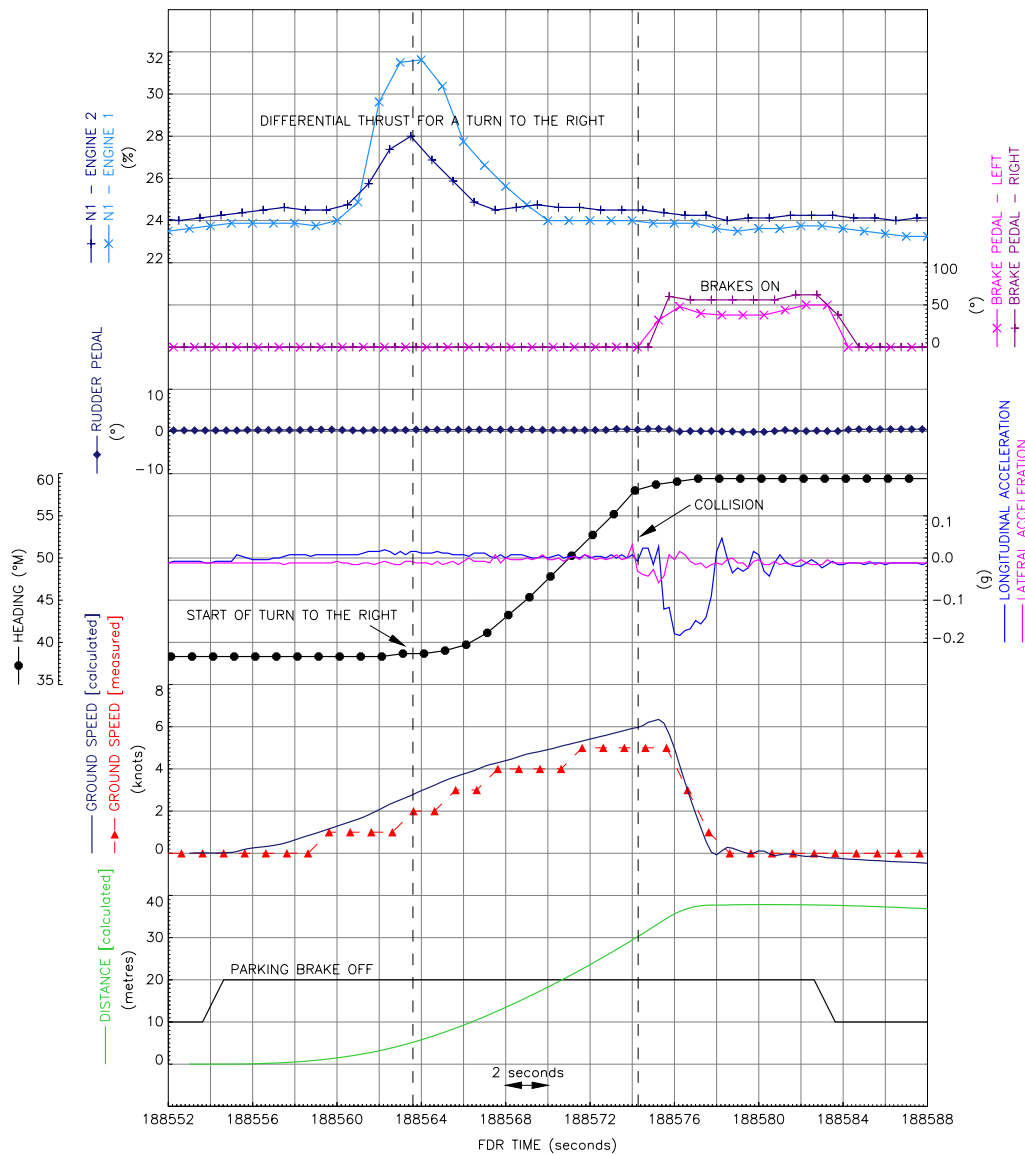
Figure 3
 Salient FDR Parameters
 (Accident to G-EZEU on 24 November 2005)

A time-history of the relevant parameters during the ground collision is shown at Figure 3. The data presented at Figure 3 starts one second before the parking brake is released and shows an initial recorded heading of just over 038°M and about 24% N_1 on both engines.

Five seconds after the aircraft started to roll forward, the N_1 started to increase on both engines, reaching a maximum of 31% on engine No 1 (left side) and 28% on engine No 2 (right side), three seconds later. As the thrust was increasing, and after approximately five metres of forward movement², the aircraft started a turn to the right; this was consistent with the use of differential thrust. There was no evidence of rudder pedal or brake pedal movement during the turn and nose wheel steering angle and tiller angle were not recorded.

The aircraft continued turning to the right for approximately 12 seconds to a heading of 058°M before colliding with the A320. The rate of change of heading at the point of collision was about 2.8° per second and the ground speed, at most, six knots. The turn to the right immediately slowed, consistent with the left wing being temporarily constrained, and the brakes were applied, bringing the aircraft to a stop eight metres further on. The final heading was recorded at just over 059°M and the aircraft had travelled a total distance of 38 metres.
