# Uncontained Engine Failure, Aircraft Incident Report, Japan Airlines Flight JL726, B747-300 JA8178, Tangerang, West Java, Indonesia, 5 September 2000

**AIRCRAFT INCIDENT REPORT**

Japan Airlines Flight JL726

B747-300 JA8178

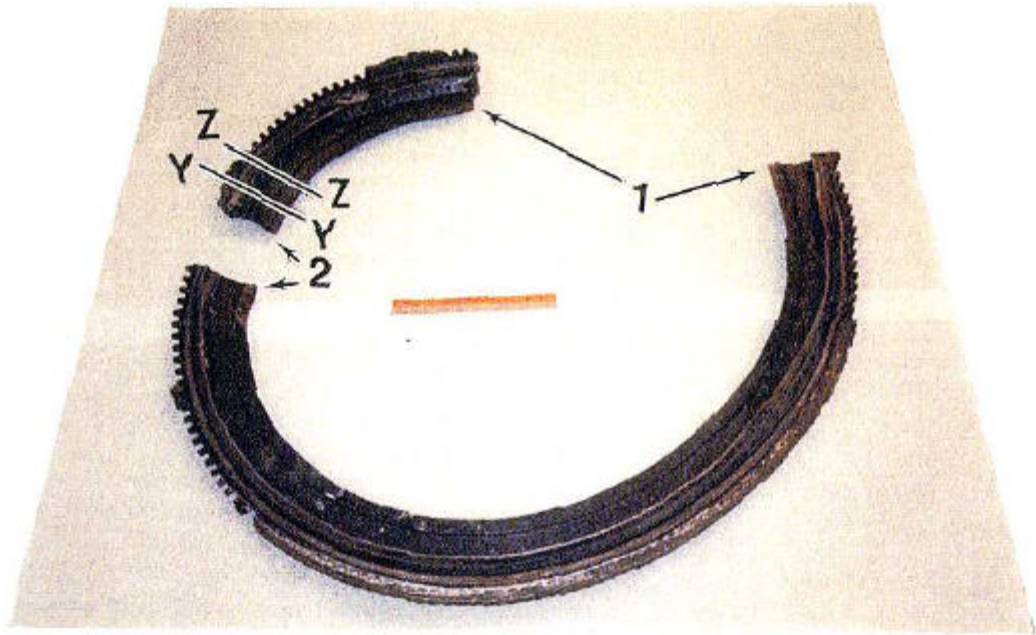
The 5<sup>th</sup> stage LPT disk of No. 1 engine failed, broke into two parts, both parts were ejected out from the inboard side of LPT case with heavy damage sustained by the inboard LPT casing.

Figure 1. The 5<sup>th</sup> stage disk (source: NTSB Report)

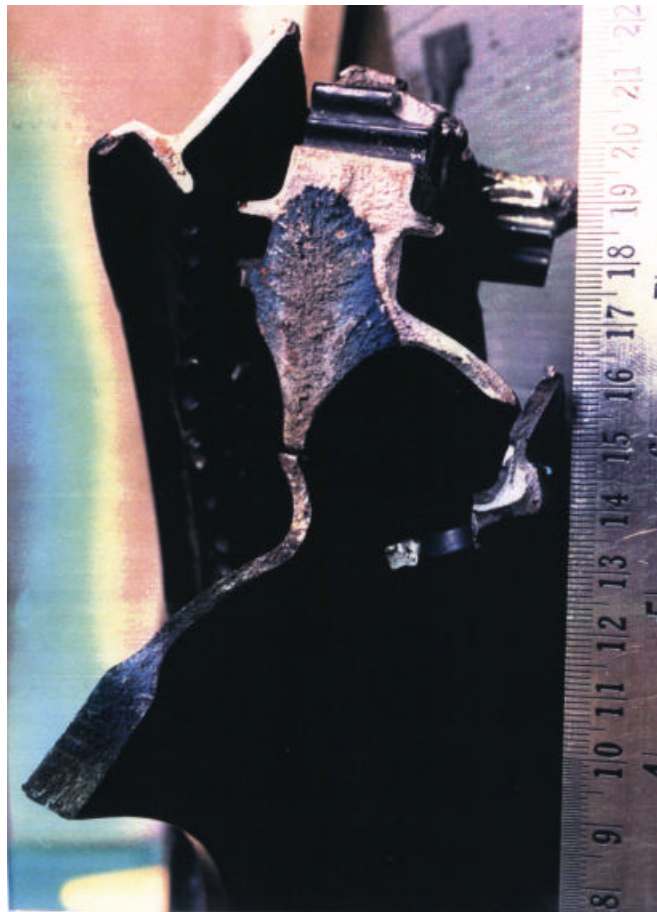
One pair of the fracture surfaces revealed a typical fatigue pattern-fatigue which had a flat surfaces and different color (blue & gold tint) as compared to the adjacent area (see Fig. 2).

Figure 2. Fracture surface of the fatigue area (source: ITB Report)

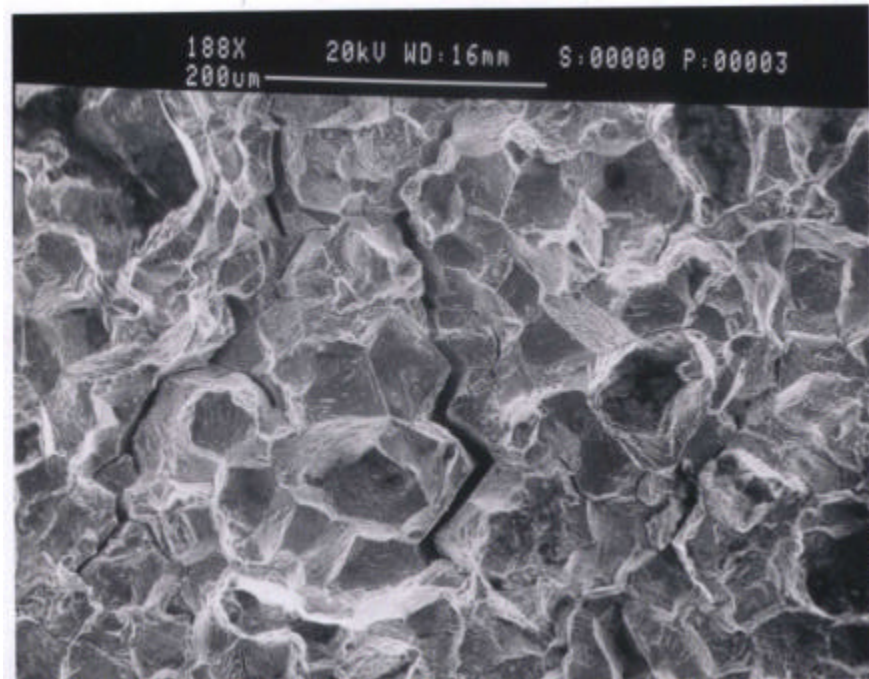
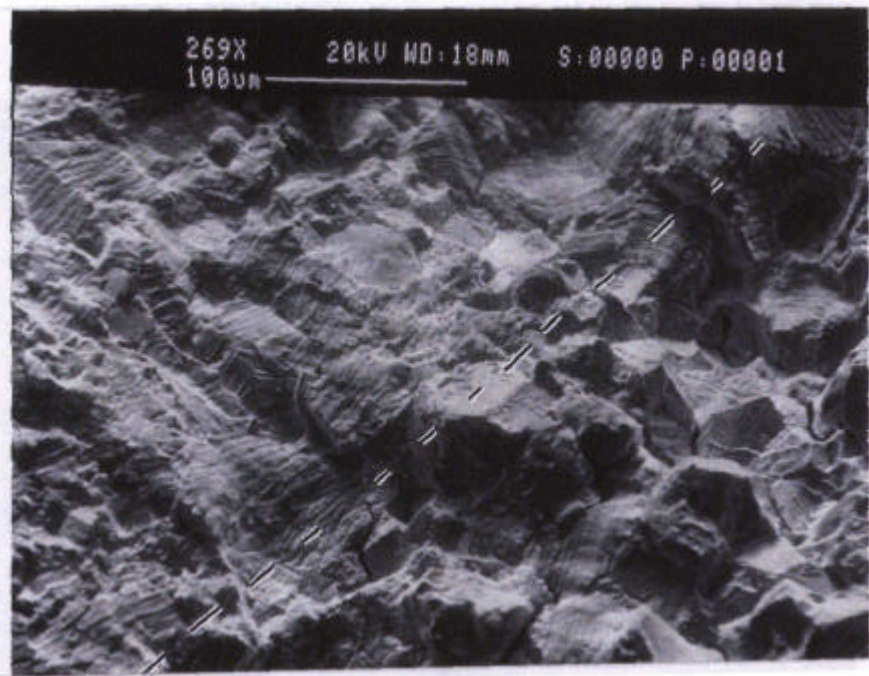
The findings of the examinations revealed that the failure of the disk was attributed to intergranular, elevated temperature fatigue, which had progressed from the surface of the web. The fracture originated in a blended repaired area on the front surface of the disk.

Figure 3. Fracture surface of SEM, the intergranular surface (top) and transition surface (bottom) (source: NTSB Report)

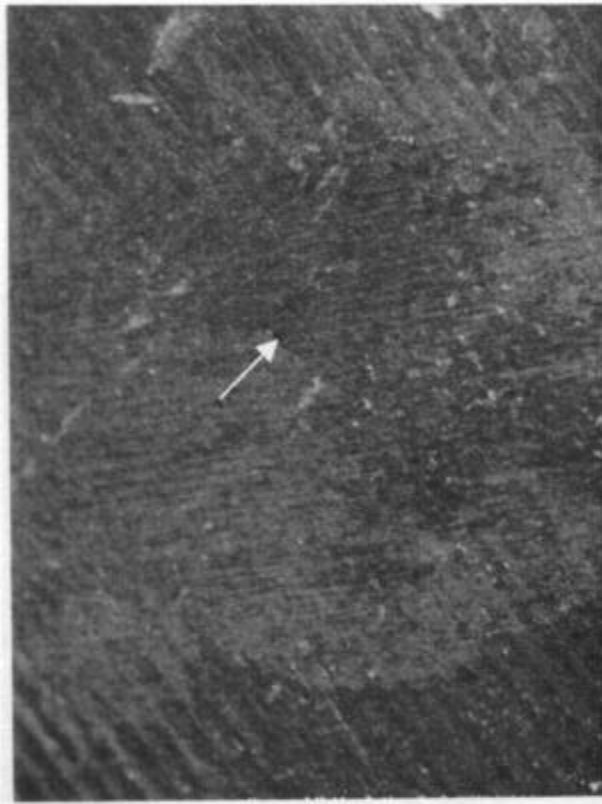
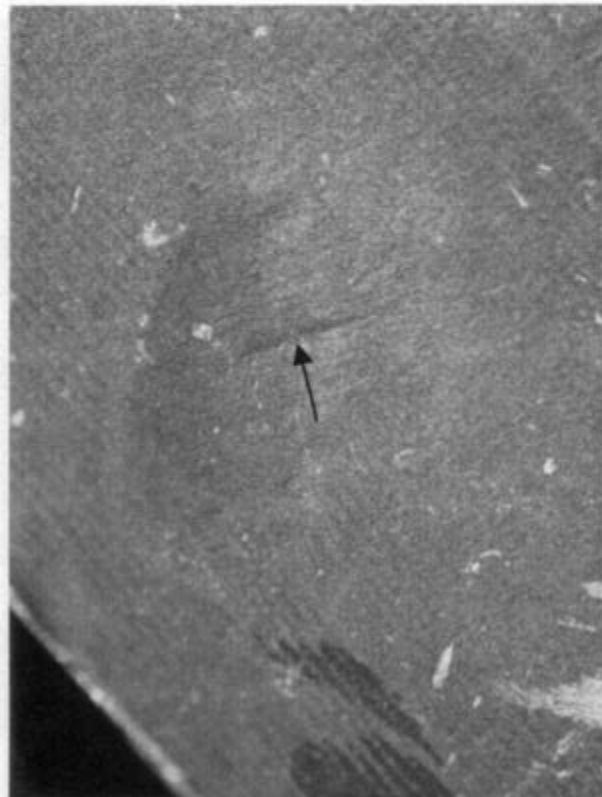
The investigation concluded that blending operation, in particular on a disk or on a highly stressed part carries a high risk of residual damage (worked material or shallow cracks) remaining and these sites are potential sites for fatigue crack initiation. Therefore, the NTSC recommended that;

Figure 4. Blending area of the disk (source: P&W Report)

1. Residual damage seems to be the origin of fatigue crack on this disk. Such a residual damage could not be detected by available NDI method. To prevent similar occurrence, blending operation as described by engine manufacturer on such a particular disk should be reviewed.
2. It found necessary the disk design should be reviewed by the manufacturer.

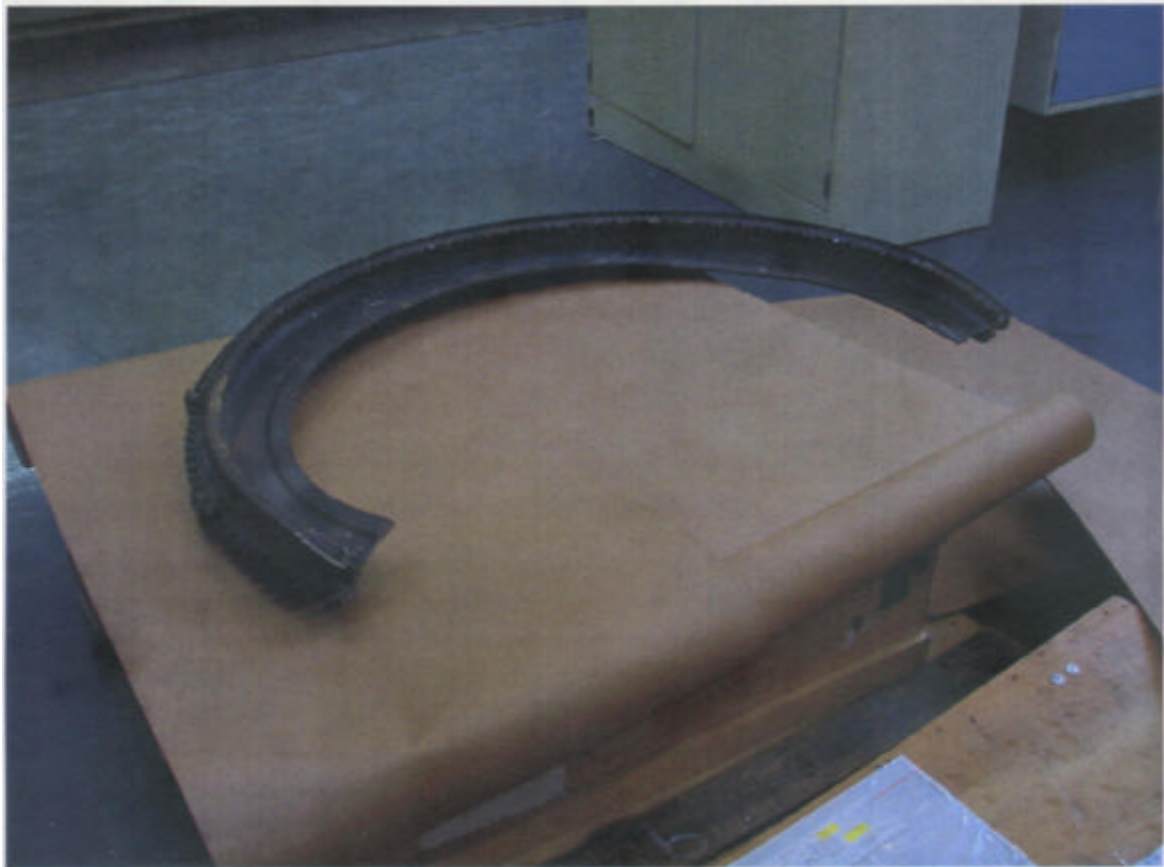
FIGURE 1

PHOTOGRAPH SHOWING APPEARANCE OF LARGE PORTION OF FRACTURED JT9D FIFTH STAGE TURBINE DISK WHICH WAS RECEIVED FOR EXAMINATION IN MATERIALS AND PROCESSES ENGINEERING

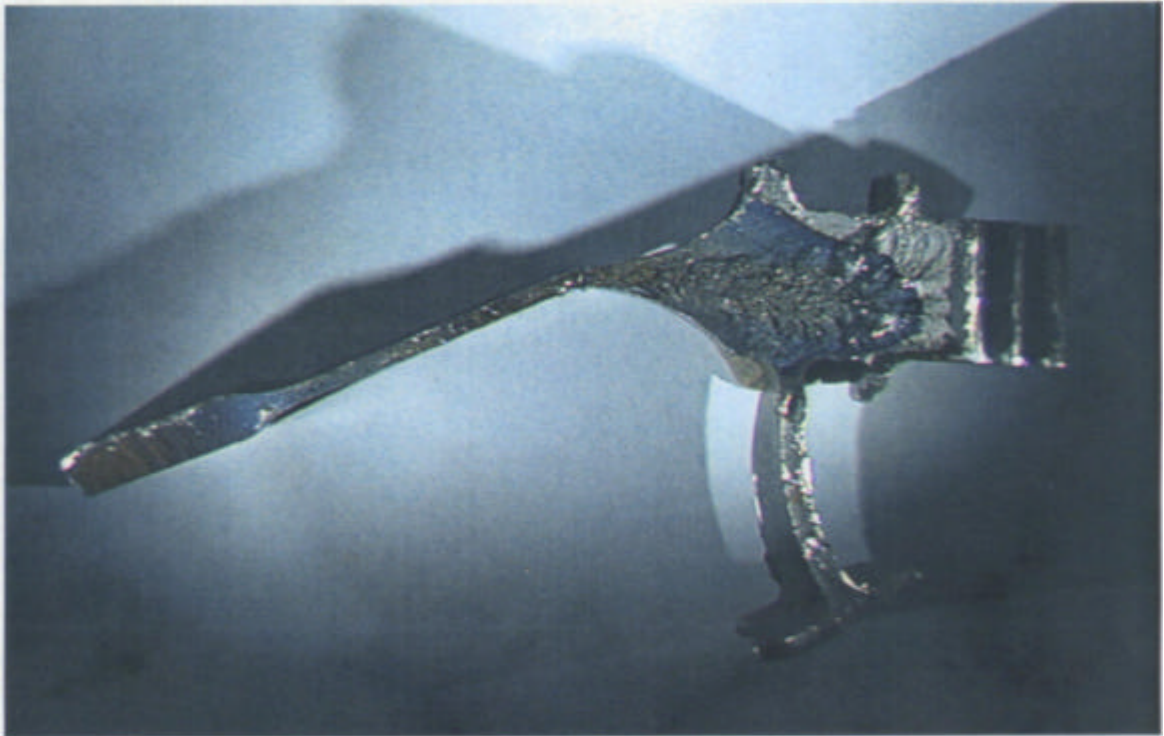
FIGURE 2

OVERVIEW OF PRIMARY RADIAL FRACTURE SHOWING LOCATION OF FLAT, GRANULAR APPEARING, OXIDIZED AREA IN THE WEB.

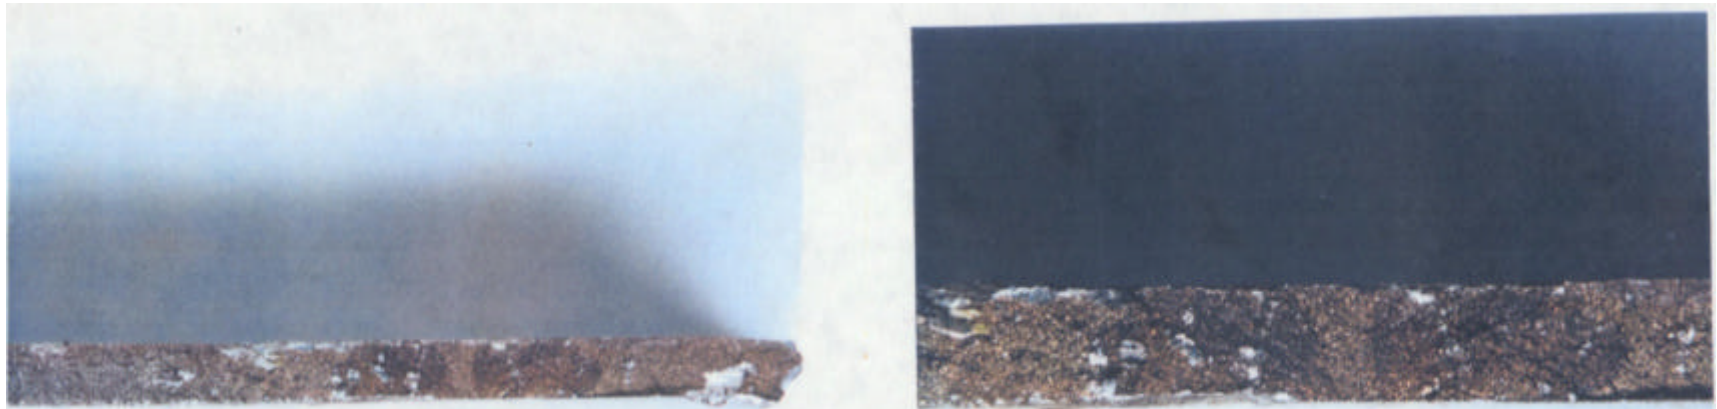
FIGURE 3

CLOSE-UPS OF FRACTURE SURFACE IN ORIGIN AREA, SHOWING FLAT, GRANULAR, OXIDIZED APPEARANCE.

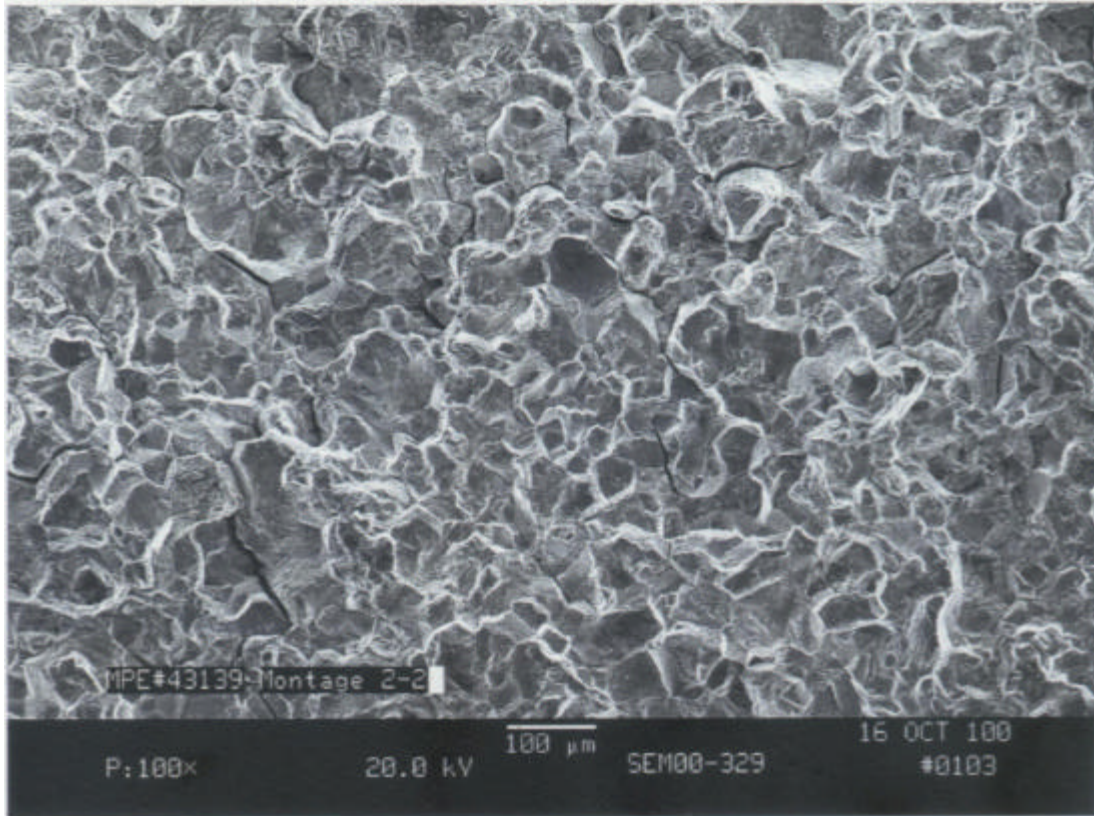
FIGURE 4

SCANNING ELECTRON MICROSCOPE PHOTOGRAPH OF FRACTURE SURFACE IN OUTER PORTION OF WEB, SHOWING INTERGRANULAR FRACTURE APPEARANCE WHICH WAS PRESENT THROUGH THE WEB THICKNESS FOR APPROXIMATELY 0.4 INCHES OF RADIAL DISTANCE.

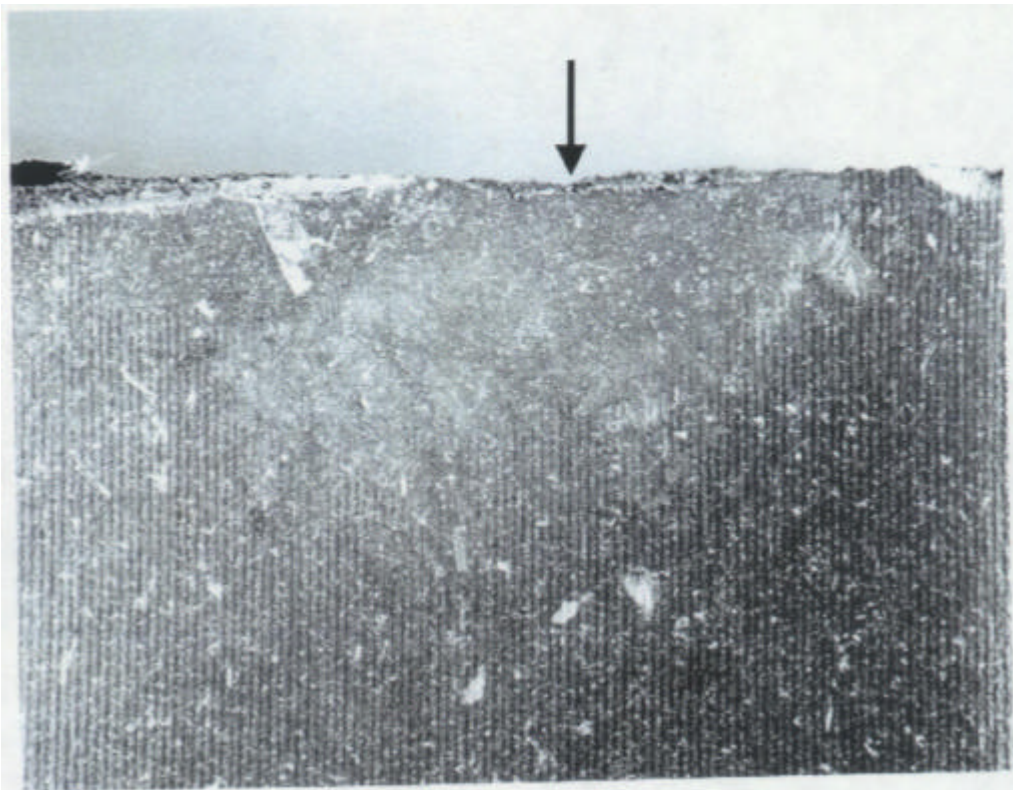
FIGURE 5

CLOSE UP OF FRONT SURFACE OF WEB IN THE AREA OF THE FRACTURE INITIATION, SHOWING SMOOTH, POLISHED APPEARING AREA WHERE ORIGINAL MACHINING LINES HAD BEEN REMOVED, INDICATIVE OF LOCAL BLENDING. ARROW SHOWS APPROXIMATE LOCATION OF FRACTURE ORIGIN.

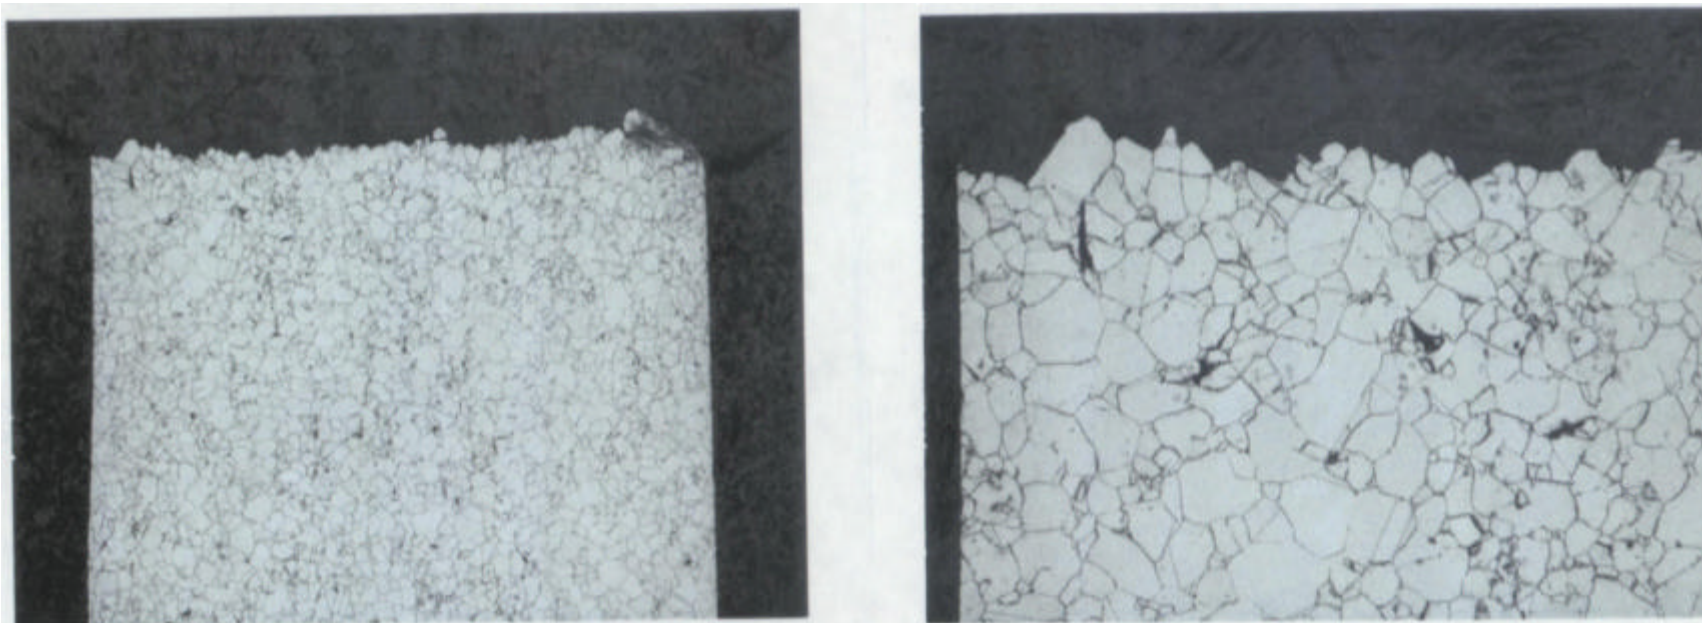
FIGURE 6

PHOTOMICROGRAPHS OF SECTIONS THROUGH VICINITY OF FRACTURE ORIGIN  
SHOWING INTERGRANULAR FRACTURE PATH, AND APPEARANCE OF  
MICROSTRUCTURE

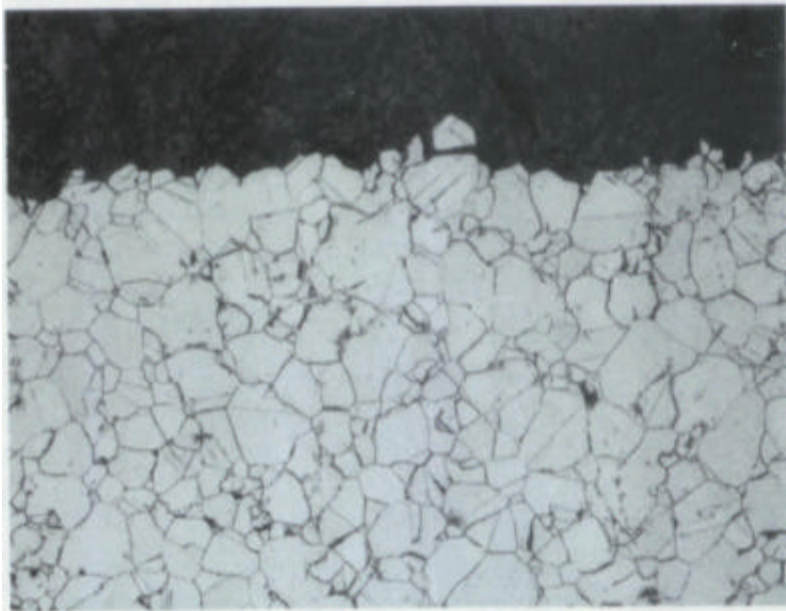
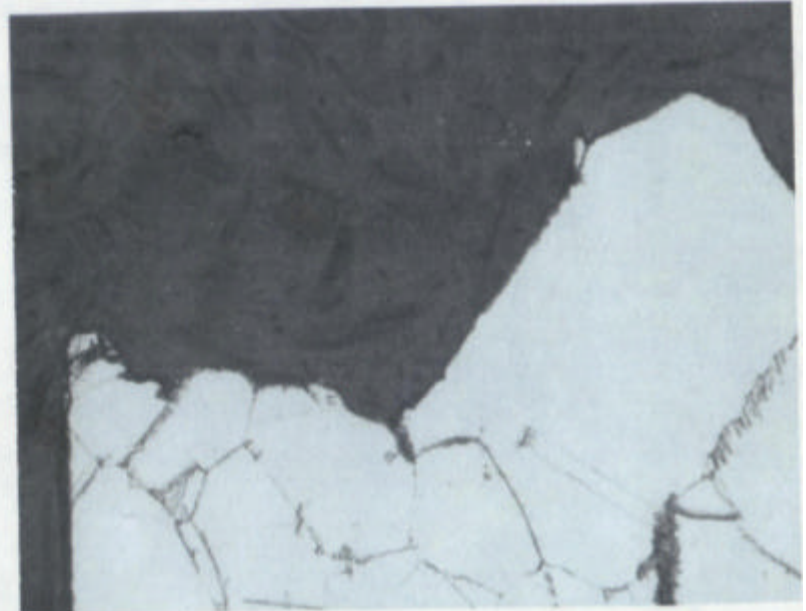
FIGURE 7

PHOTOMICROGRAPHS OF SECTIONS THROUGH VICINITY OF FRACTURE ORIGIN  
SHOWING INTERGRANULAR FRACTURE PATH, AND APPEARANCE OF  
MICROSTRUCTURE

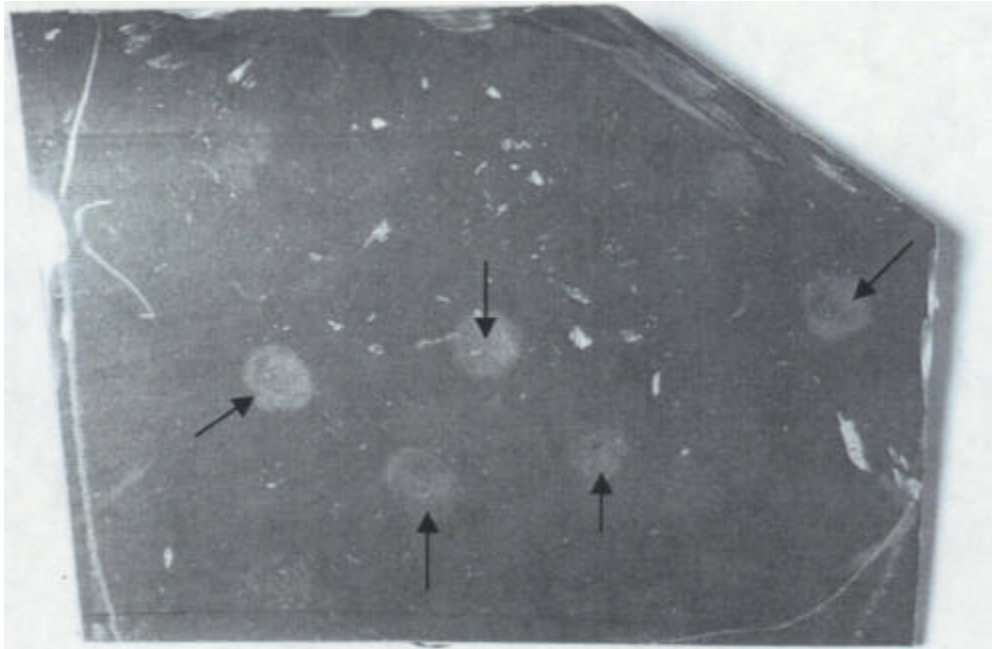
FIGURE 8

VIEW SHOWING APPEARANCE OF SECTION OF DISK WEB  
WHICH WAS SECTIONED OUT FOR EXAMINATION OF  
BLENDS (ARROWS)

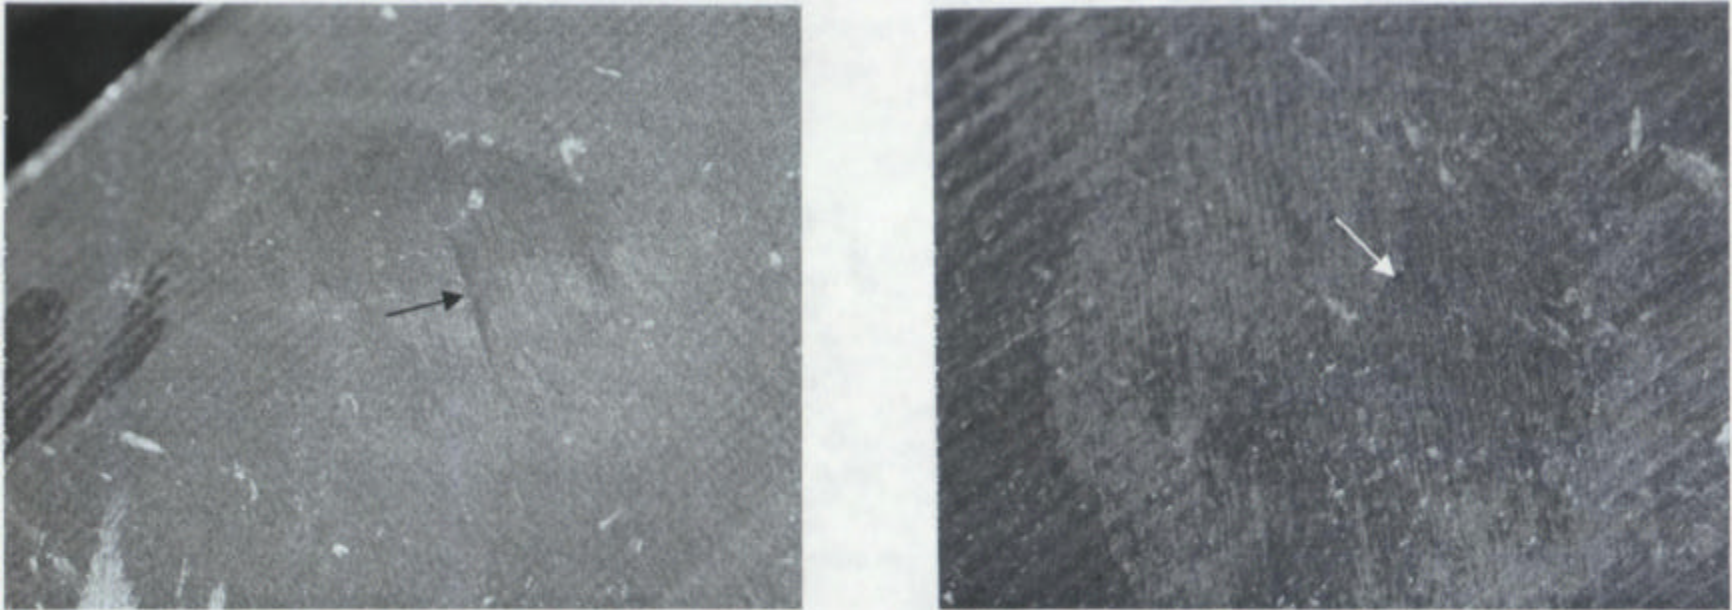
FIGURE 9

CLOSE-UPS OF TWO BLENDS WHICH SHOWED EVIDENCE OF RESIDUAL MECHANICAL DAMAGE (ARROWS)

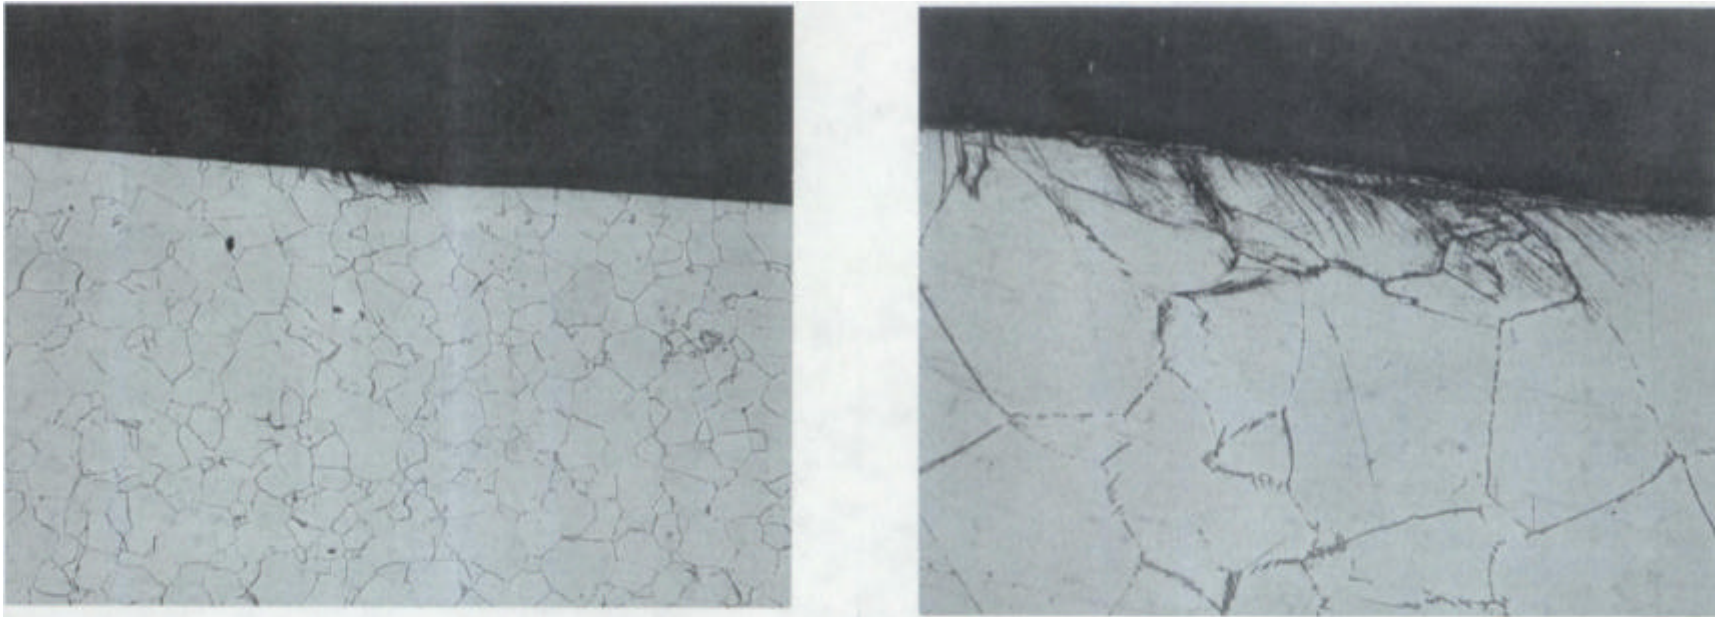
FIGURE 10

PHOTOMICROGRAPHS OF SECTIONS THROUGH BLEND AT LEFT IN FIGURE 9,  
SHOWING APPEARANCE OF WORKED MATERIAL AT THE BASE OF THE AREA  
OF MECHANICAL DAMAGE

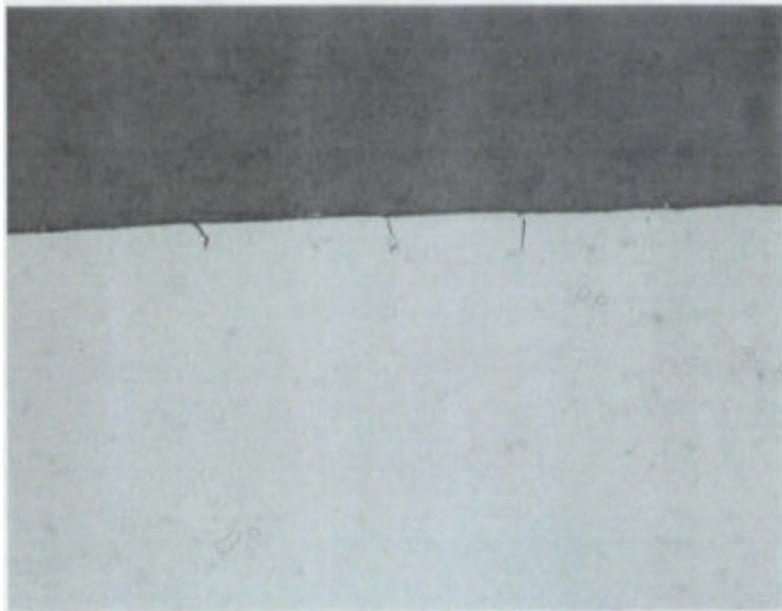
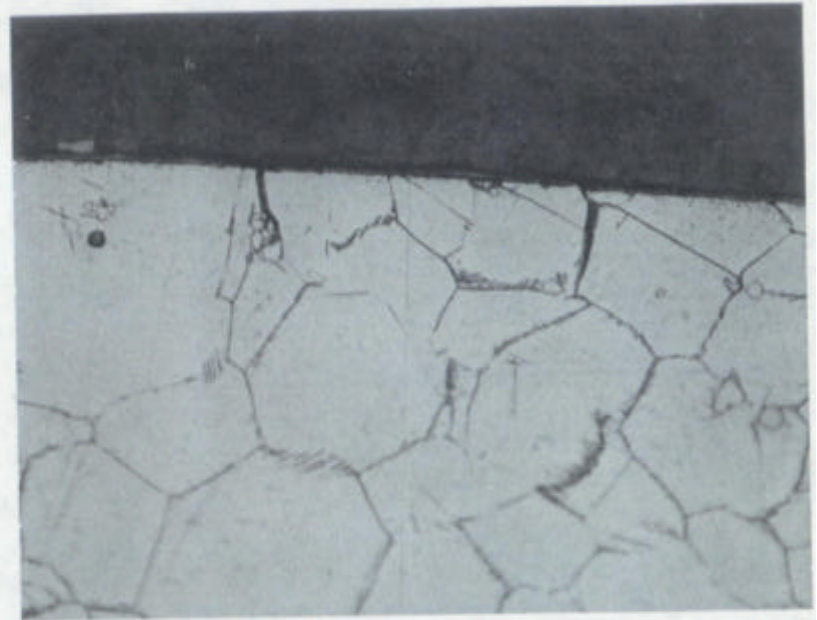
FIGURE 11

PHOTOMICROGRAPHS OF SECTION THROUGH BLEND AT RIGHT IN FIGURE 9  
SHOWING SHALLOW INTERGRANULAR CRACKS NEAR CENTER OF THE BLENDED  
REGION

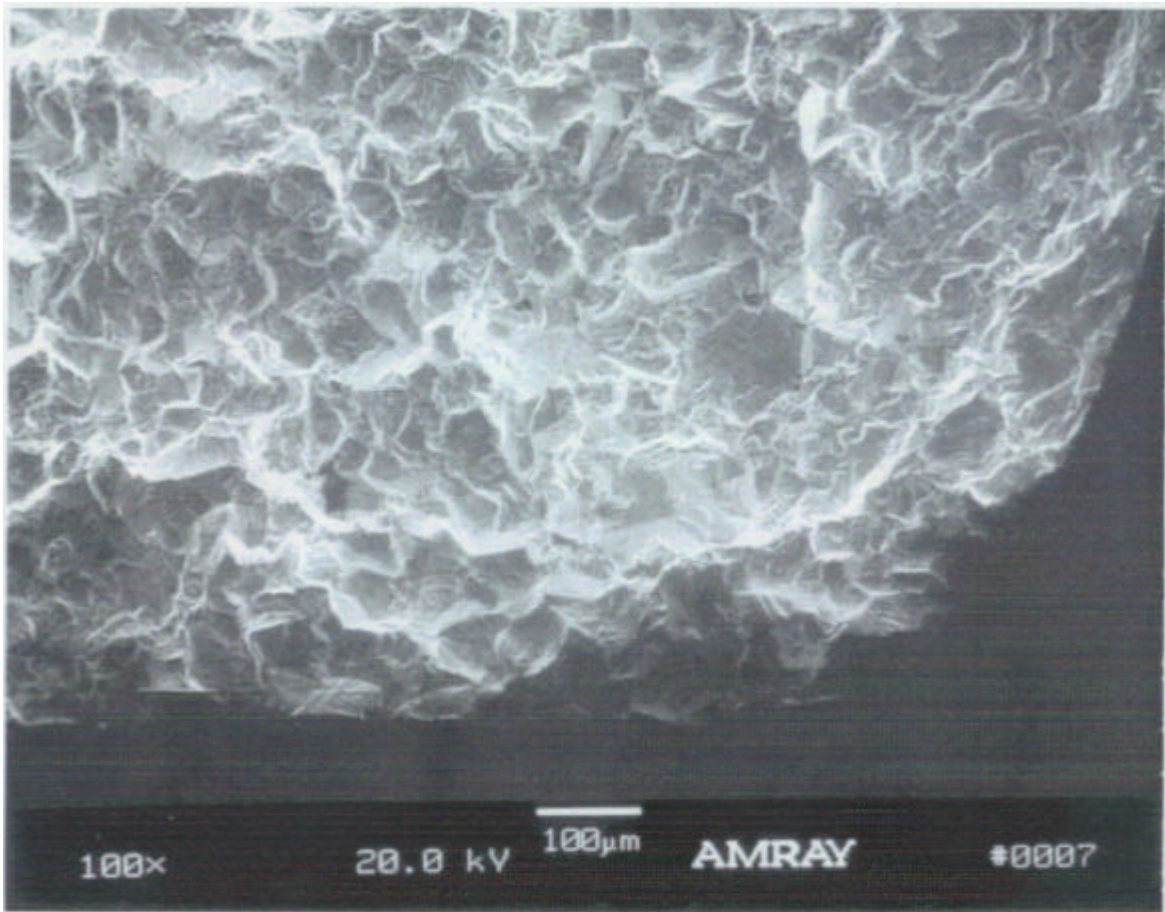
**FIGURE 12**

SCANNING ELECTRON MICROSCOPE PHOTOGRAPH OF FATIGUE SPECIMEN TESTED AT 1000°F, WITH FIVE MINUTES DWELL AT MAXIMUM STRESS. NOTE INTERGRANULAR FRACTURE APPEARANCE.

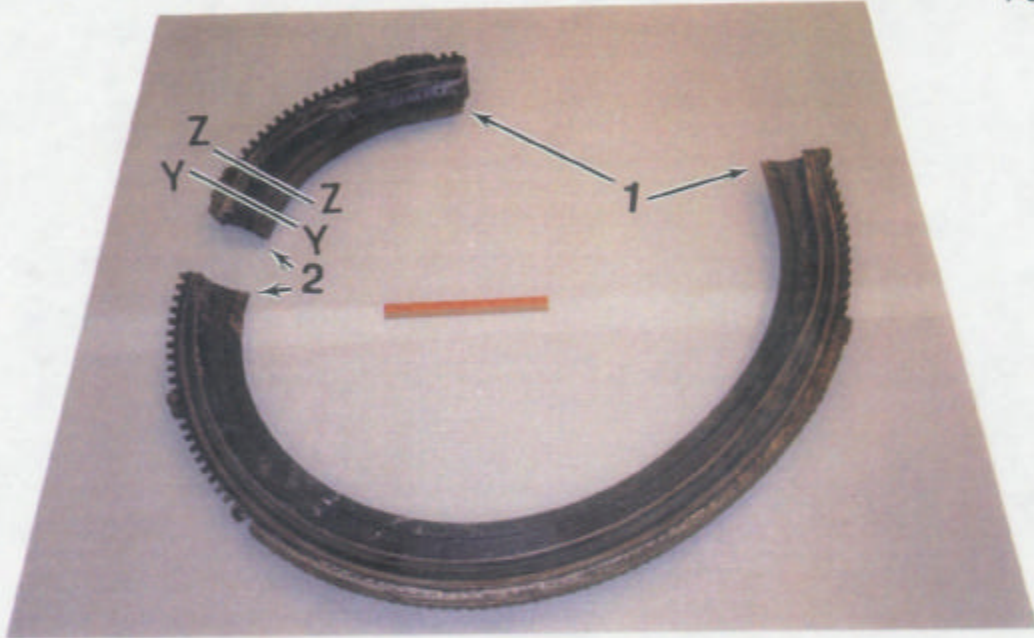
Figure 1. As-received disk that separated in the areas indicated by arrows "1" and "2".

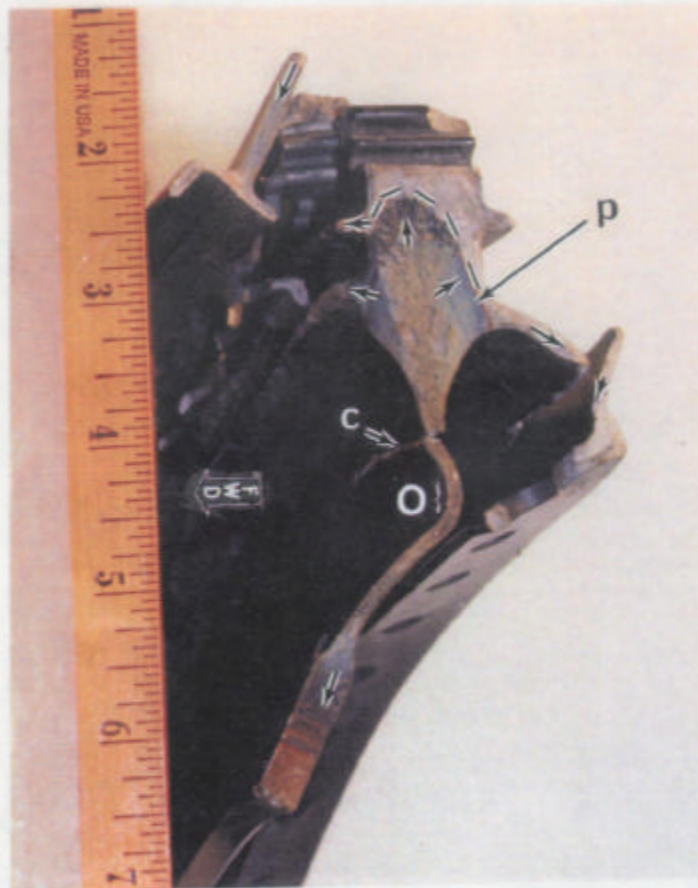
Figure 2. Photograph of fracture "2" on the smaller piece of the disk.

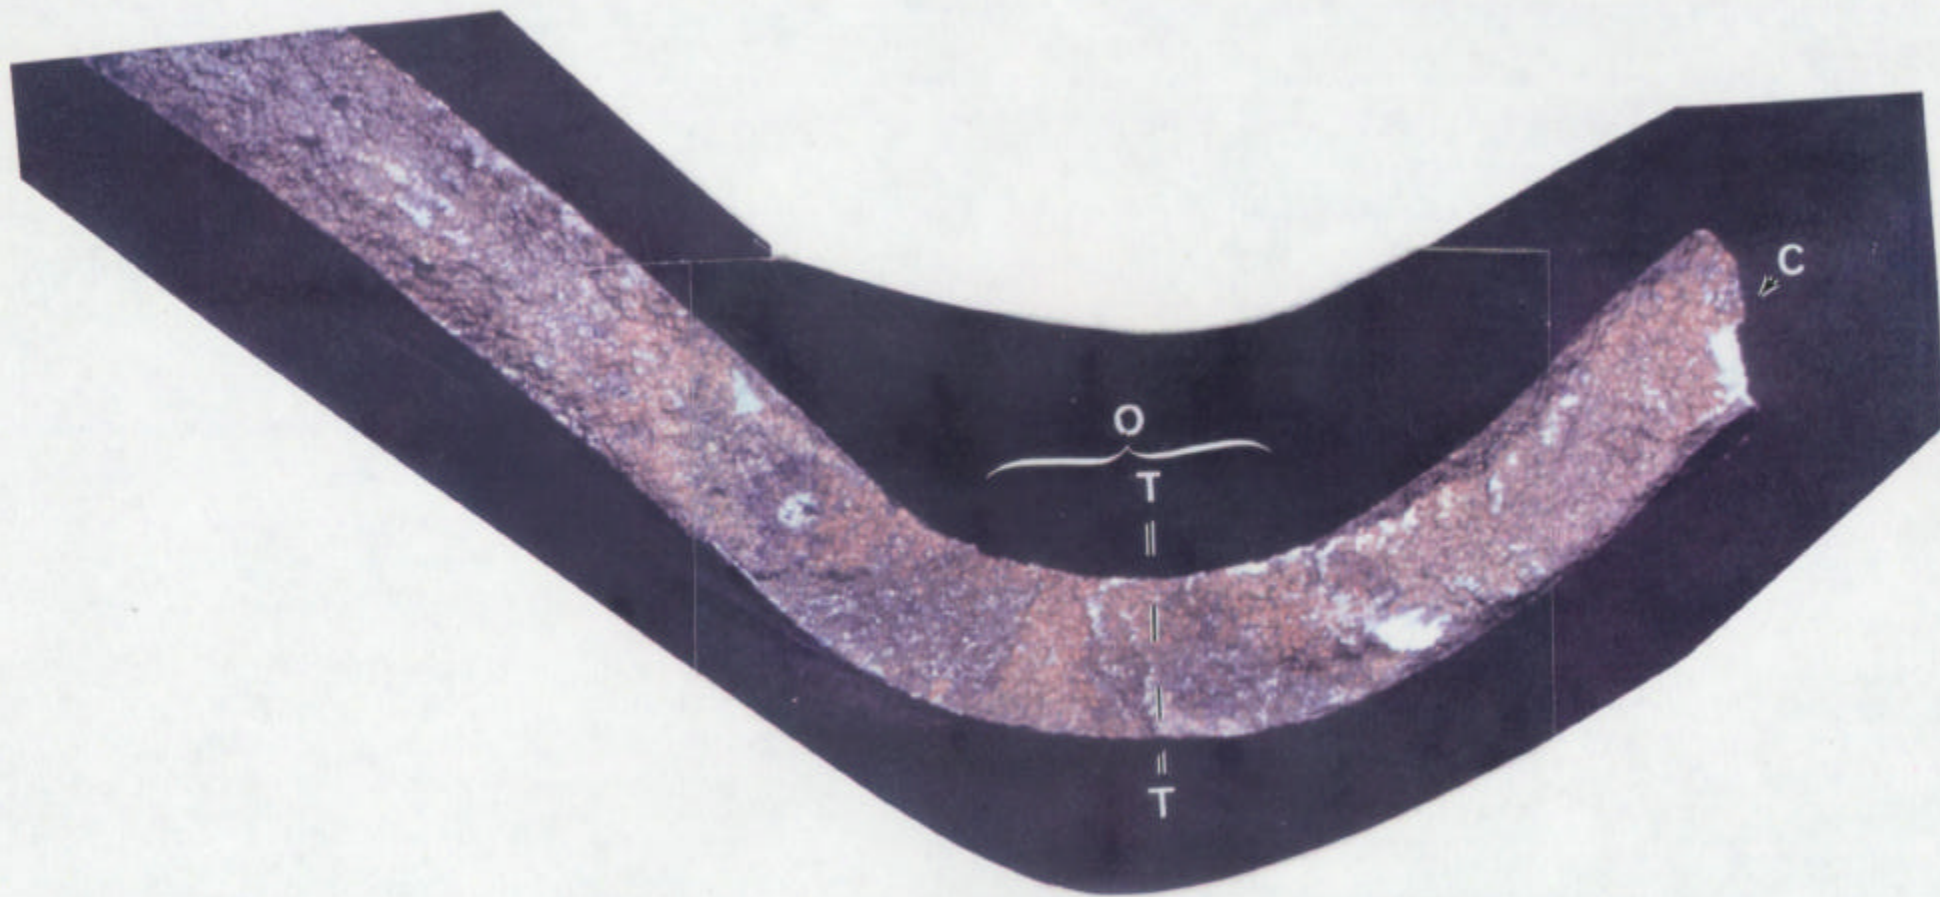
Figure 3. Close-up photograph of the fracture origin indicated by bracket "O". Arrow "C" indicates a circumferential crack that intersected the radial fracture face. (7.5X)

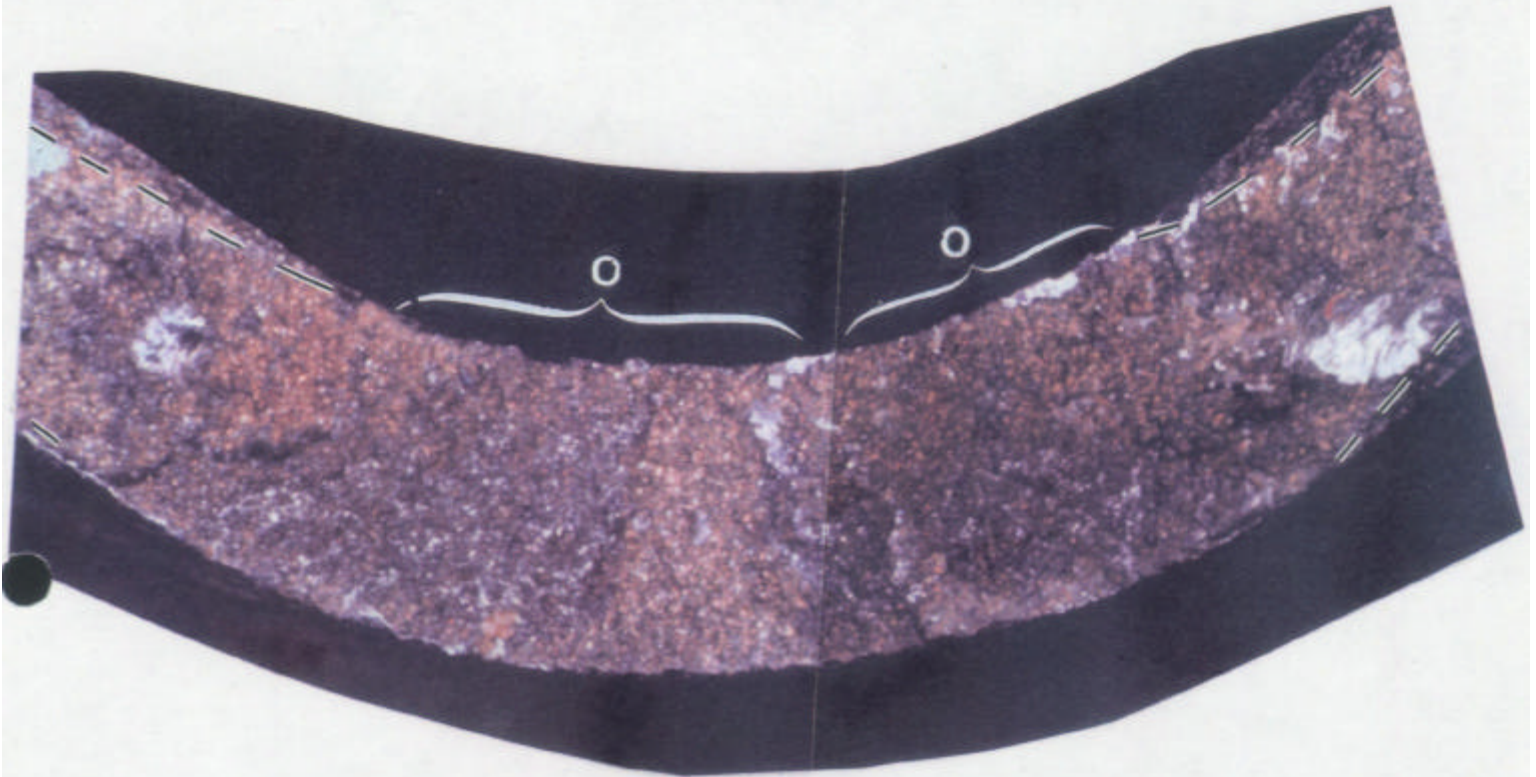
Figure 4. Higher magnification photograph of the fracture origin area, indicated by brackets "O" in figure 3. Areas between dashed lines and outside edges indicate location of shear lips. (15X)

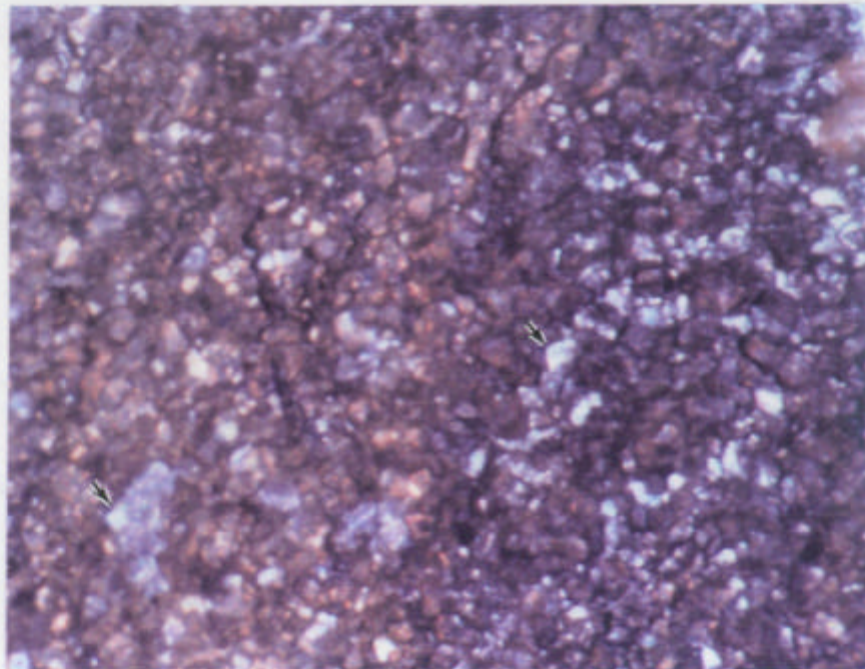
Figure 5. Close-up photograph of the granular features in the fracture origin area. (55X)

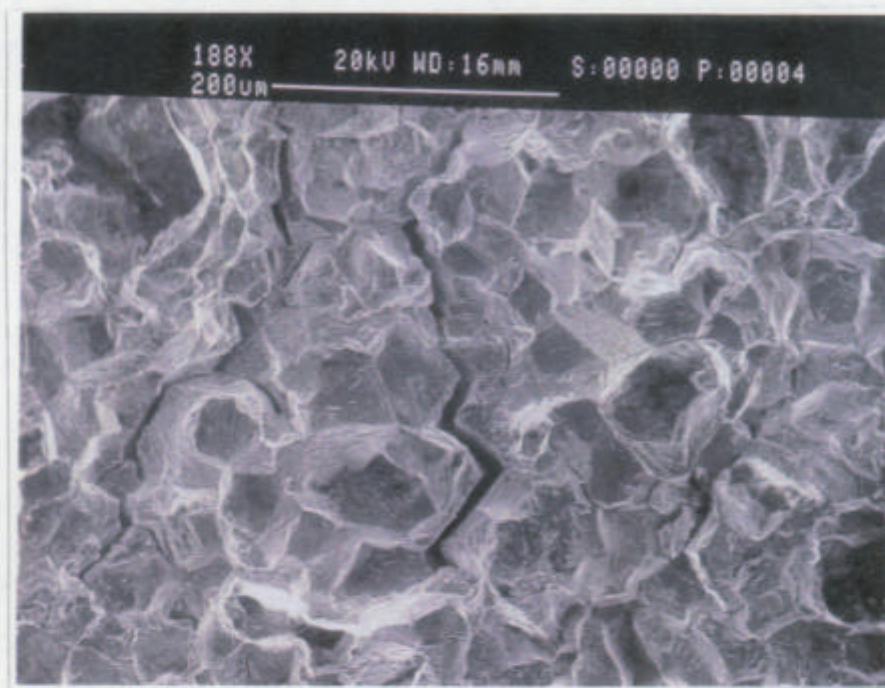
Figure 6. Scanning electron microscope (SEM) photograph of typical intergranular fracture features in the fracture origin area. (188X)

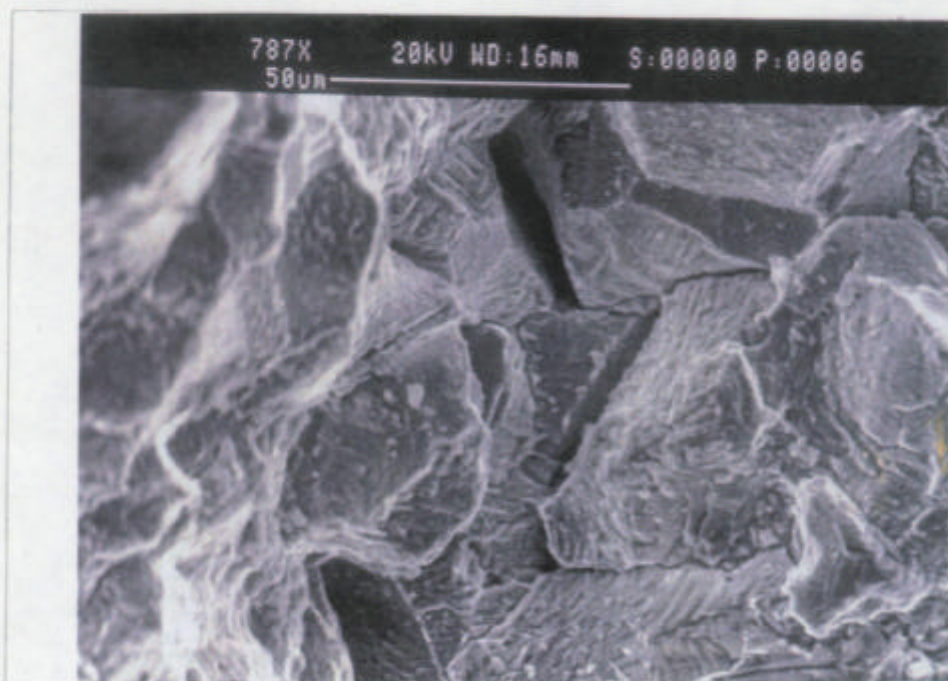
Figure 7. Higher magnification SEM photograph of the intergranular fracture features in the origin area. (787X)

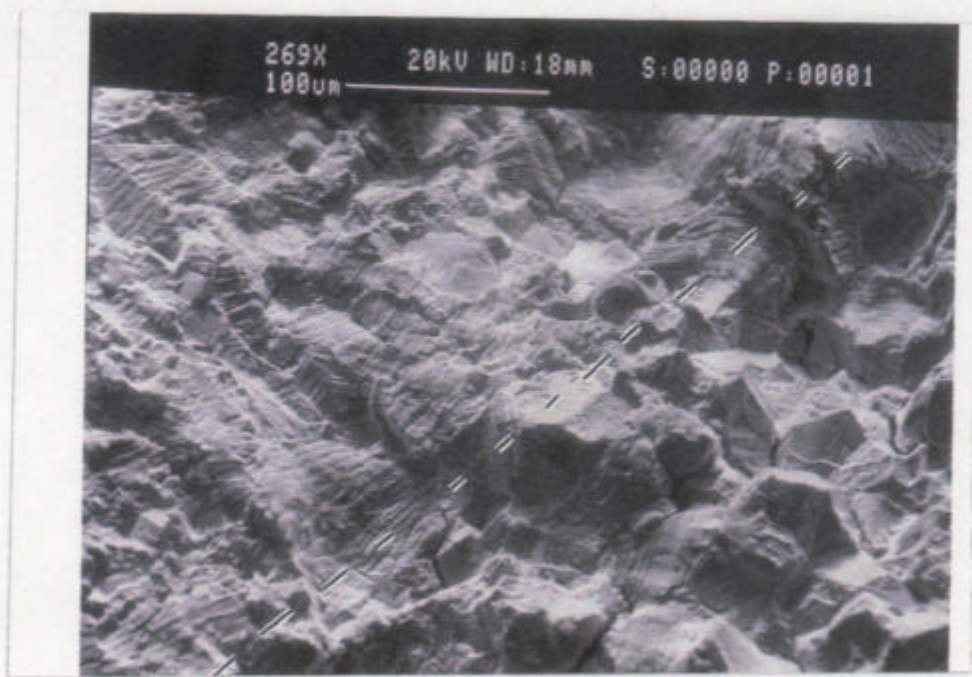
Figure 8. SEM photograph of the transition region, indicated by dashed line, between the shear lip at the forward edge of the disk (left of the dashed line) and the rim (right of the dashed line). Note the fatigue striations at the left and the granular features at the right. (269X)

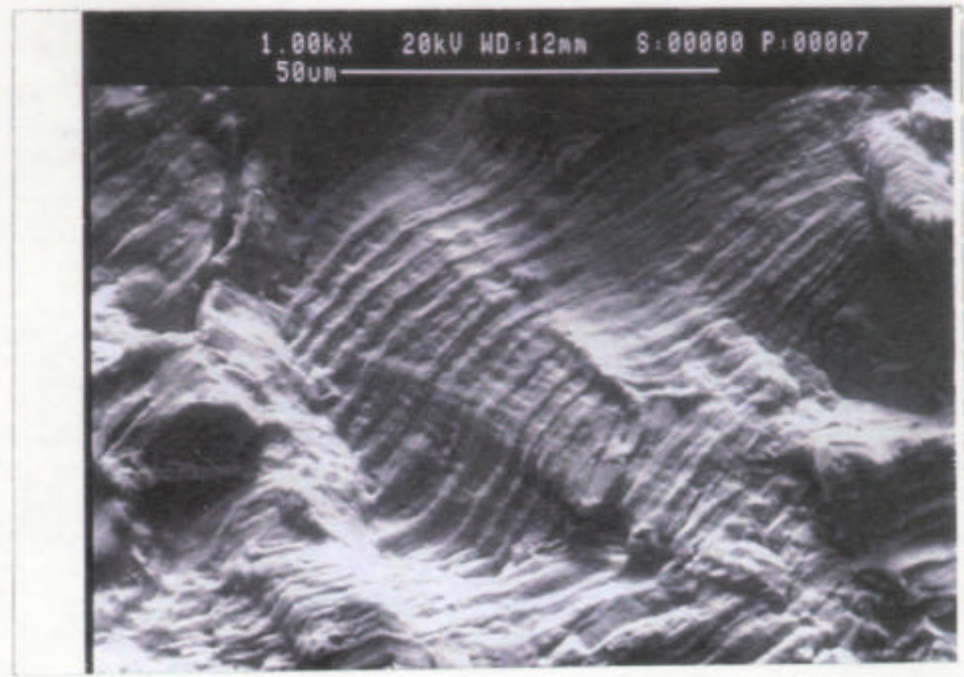
Figure 9. Higher magnification SEM photograph of the fatigue striations in figure 8. (1,000X)
