# Uncontained Engine Failure, Aircraft Incident Report, Japan Airlines Flight JL726, B747-300 JA8178, Tangerang, West Java, Indonesia, 5 September 2000

**AIRCRAFT INCIDENT REPORT**

Japan Airlines Flight JL726

B747-300 JA8178

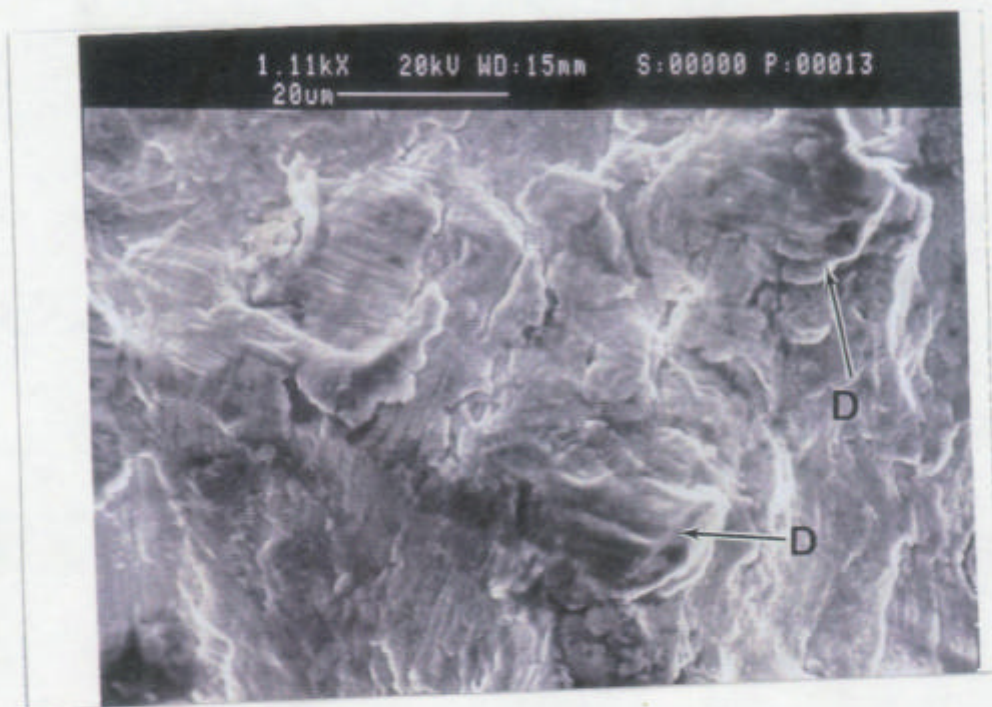
Figure 10. SEM photograph of the fracture features in the web in an area located between the fracture origin area and the bore showing mechanical damaged areas ("D") and striation-like features. (1,110X)

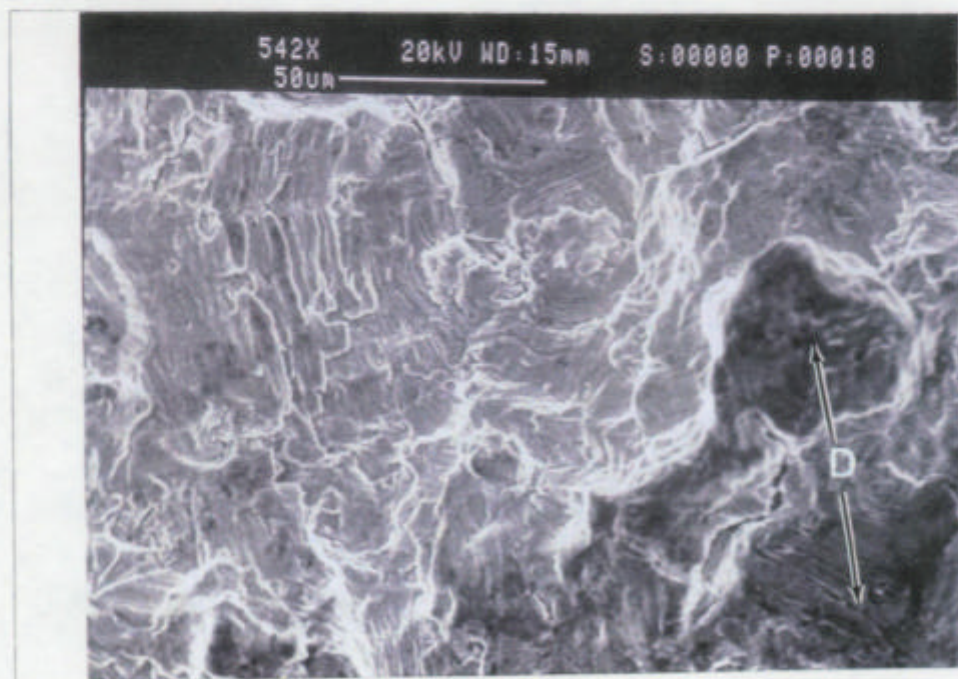
Figure 11. SEM photograph of the fracture features in the transition between the web and the bore showing mechanical damaged areas ("D") and striation-like features. (542X)

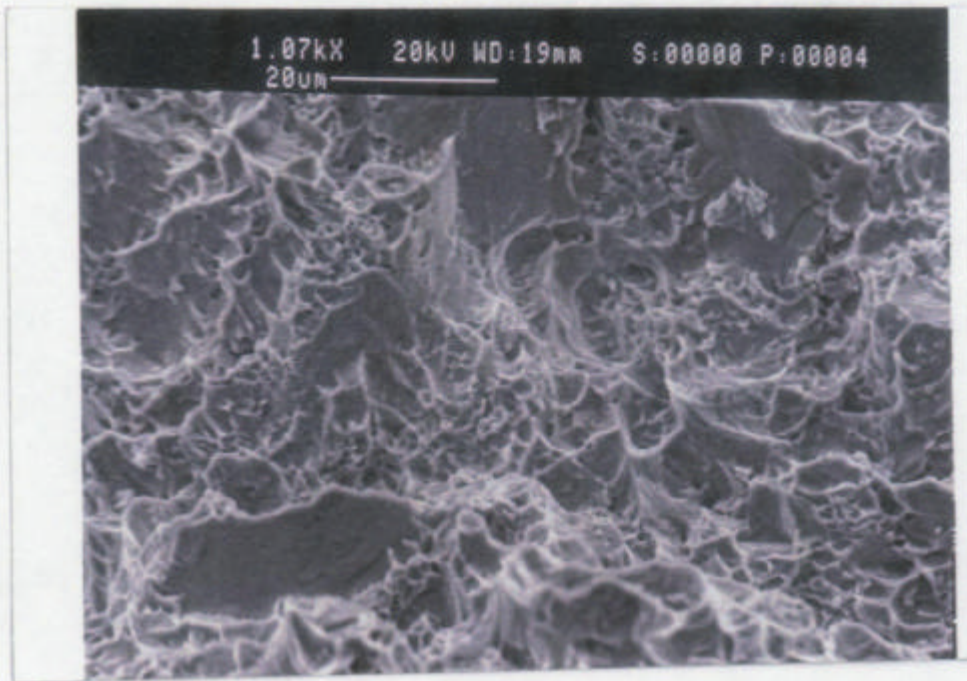
Figure 12. SEM photograph of ductile dimple features in the bore area (1,070X)
