Engine fire on takeoff, Air Zimbabwe, Boeing 707-330B, Z-WKU at Shannon Airport, Ireland, 1997-03-10

FINAL REPORT

AAIU Report No: 2004-023

Operator:	Air Zimbabwe
Manufacturer:	Boeing
Model:	707-330B
Nationality:	Zimbabwe
Registration:	Z-WKU
Location:	Shannon Airport, Ireland
Date/Time (UTC):	10 March 1997, 23.15 hrs

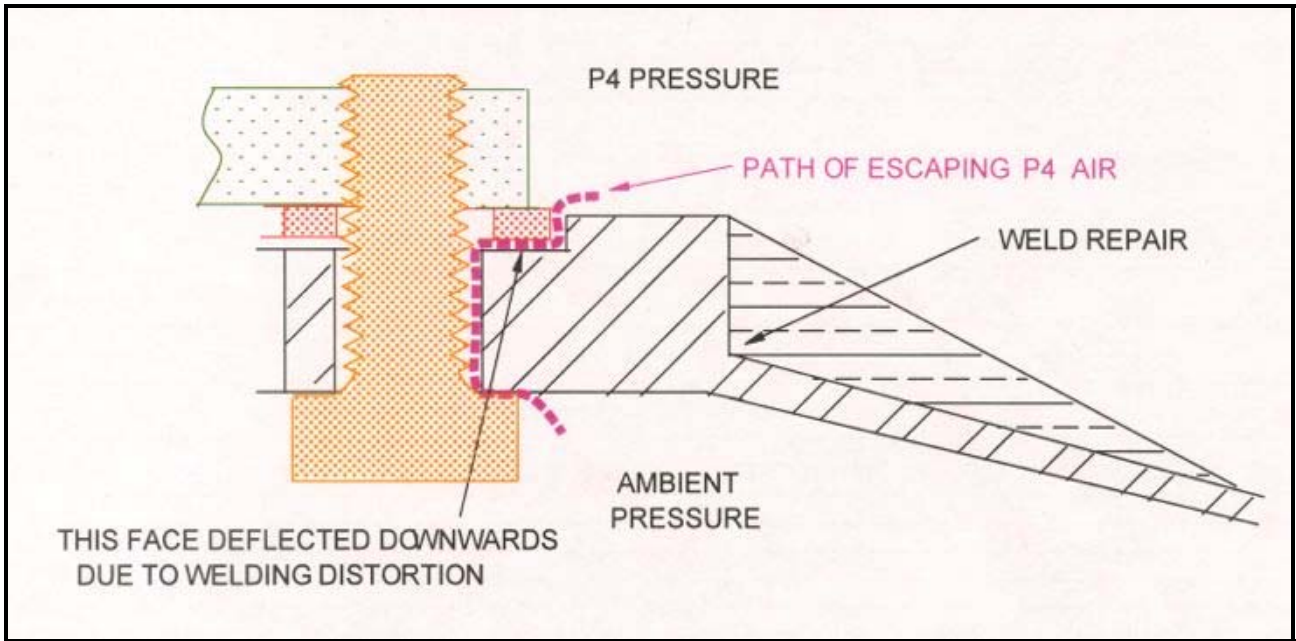
Appendix C

- 2.1.4** The distortion of the mounting face for the P&D valve allowed P4 air, at a pressure of up to 175 PSI above ambient atmospheric pressure, to leak past the copper gasket, into the bolt hole in the diffuser casing and to escape under the bolt head. Furthermore, the distorted mounting face and the distortion of the boss would have exacerbated the possibility of a leak under the bolt head. Initially this leak would have been extremely small. The initial path of this leak is shown in **Appendix C**.

ENLARGED VIEW OF THE BOLT AREA
SHOWING THE PROBABLE PATH OF
THE INITIAL LEAK

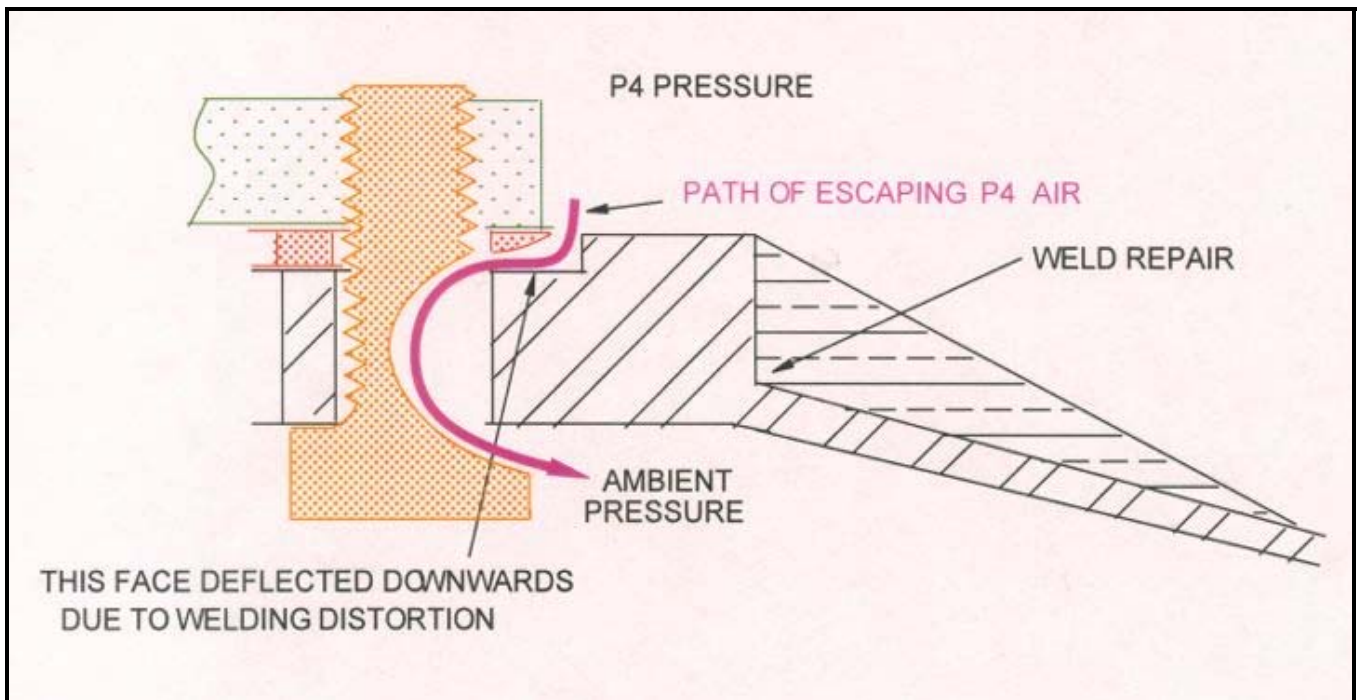
Appendix D

- 2.1.5** Over an extended period of operation this air leak, mixed with fuel, gradually eroded portions of the bolt, the bolt hole in the diffuser casing and the fuel manifold, producing a larger hole, and thereby increasing the rate of erosion. This situation is shown in **Appendix D**. The extent of the bolt erosion is shown in **Appendix F, Photo 1**.

ENLARGED VIEW OF THE BOLT AREA
SHOWING THE EROSION OF THE BOLT
CAUSED BY THE LEAK

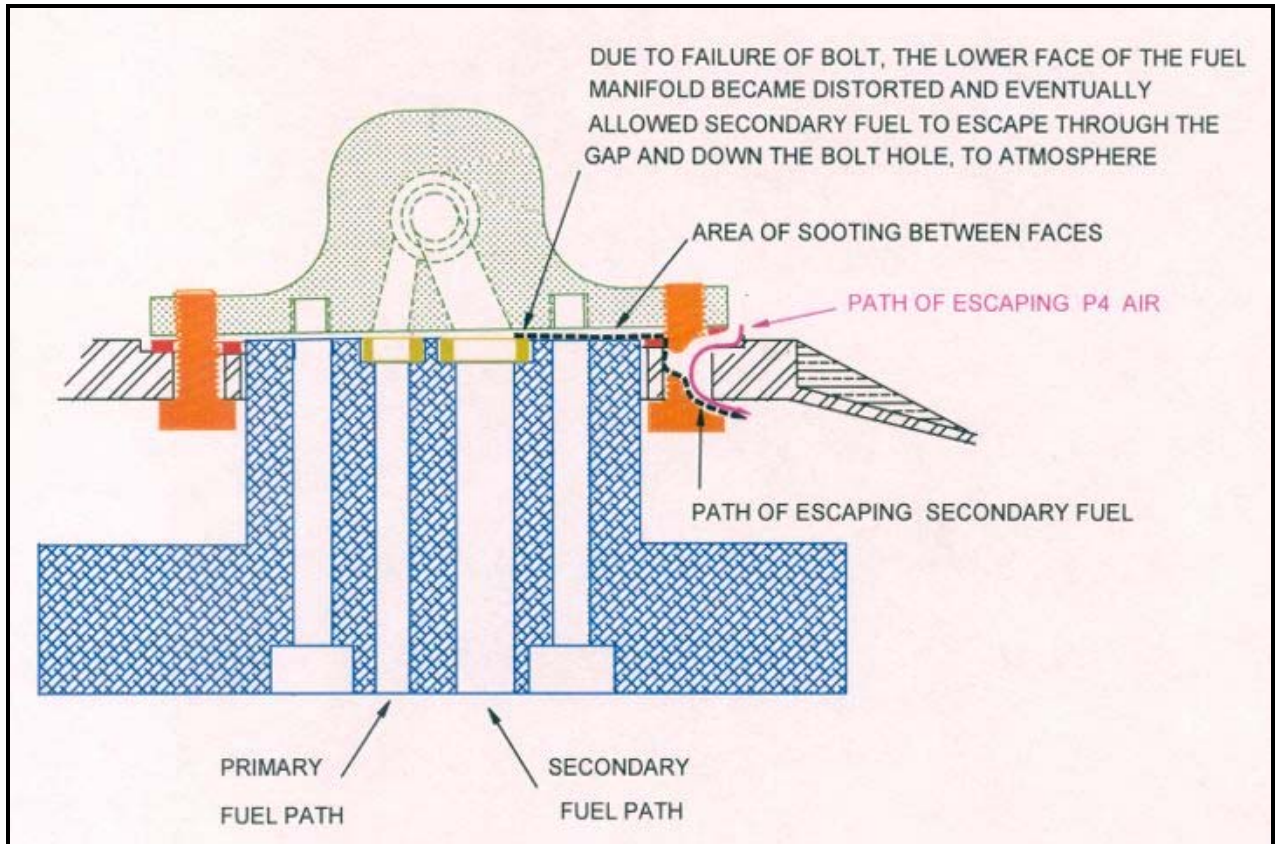
Appendix E

- 2.1.6** Ultimately the cross-sectional area of the bolt was reduced by P4 air/fuel erosion to such an extent that it failed in tension. This allowed the corner of the base of the fuel manifold to distort away from the P&D valve spacer assembly. This distortion would have been exacerbated by thermal stresses but also by the pressure of the secondary fuel; that is when the secondary fuel supply was activated, the fuel pressure assisted in opening up a gap between the fuel manifold face and the spacer, through which secondary fuel was able to escape. The burning on the surface of the manifold heat shield would have increased the normal thermal stresses on the manifold area. This burning was probably caused by a faulty fuel nozzle allowing fuel to drip onto the manifold which would have ignited and burned on the hot surface of the shield. The path of the fuel leak is shown in **Appendix E**.

ENLARGED VIEW OF THE P&D VALVE ASSEMBLY
SHOWING THE SITUATION
AFTER THE FAILURE OF THE BOLT

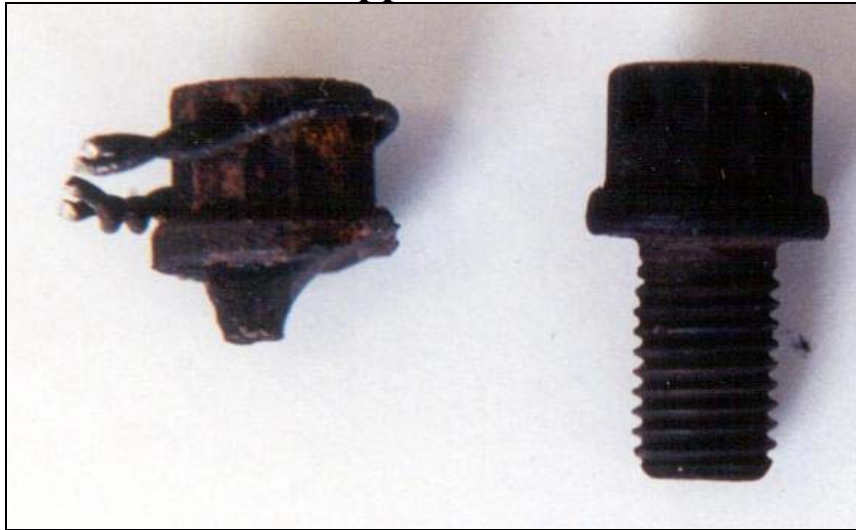
PHOTO 1

1.16.5 The fuel manifold was found to have suffered erosion type damage in the area surrounding the bolt-hole, which corresponded to the failed bolt. The hole in the diffuser casing, through which this bolt passed, had eroded in an elliptical pattern. The major and minor diameters of the worn hole were 3/8" by 5/8". The correct size of the hole should be nominal 5/16". Both the failed bolt head and the portion of the bolt threads that remained in the fuel manifold showed evidence of severe erosion. The condition of the failed bolt is shown in **Appendix F, Photo 1**. Measurements of the bearing face on the P&D valve mounting-boss on the inside of the diffuser casing, to which the fuel manifold was bolted, showed that the bearing face was not flat but distorted to the extent that the bearing area surrounding the failed bolt was, in places, up to .008", below the general level of the bearing face.

**VIEW OF THE ERODED BOLT (LEFT)
AND AN UNDAMAGED BOLT (RIGHT)**

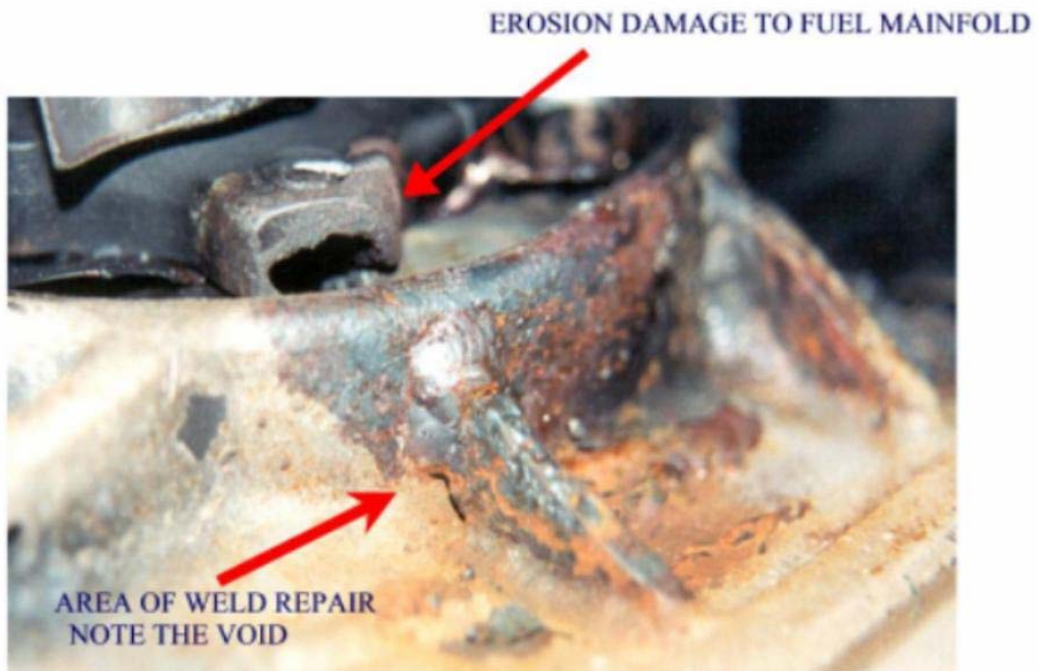
PHOTO 2

- 1.16.6** It was observed that a welding repair had been performed on the engine casing close to the area of the failed bolt. The repair consisted of the replacement/repair of two webs, which support the diffuser casing immediately to the rear of the fuel manifold boss. The repair weld showed evidence of abnormally high heating and failure to continuously fill the weld line, particularly close to the failed bolt. Inspection of the engines records failed to determine where and when this repair was performed. The repair of these webs is an approved P&W repair scheme.

- 2.1.13** The records of the diffuser casing do not show when the welding repair to the boss support was done. However, during the course of the pressuring and leak testing of the case following the repairs in September 1995, it would have been necessary to remove the P&D valve support. If the air leak had been present at that time, it is probable that erosion of the bolt and the bolt-hole would have been found. This would indicate that the welding repair to the supports did not pre-date September 1995. The repair area is shown in **Appendix F, Photo 2**.

3.1.2 The diffuser casing had undergone a welding repair in the area of the supports to the flanges of the P&D Valve Support Boss. This repair was poorly executed and caused distortion of the boss.

**PHOTOGRAPH OF THE INTERIOR OF THE DIFFUSER CASE SHOWING
THE P&D VALVE MOUNTING-BOSS& DETAILING THE EROSION
DAMAGE TO THE FUEL MANIFOLD AND THE DEFECTIVE WELD REPAIR**
