Jet blast injury, Boeing 737- 200, EI-CNZ, 21 February 1998.

AAIU Report No.2002/002
AAIU File No 2000/0031
Published 30/01/02

Aircraft Type and Registration: EI-CNZ Boeing 737- 200

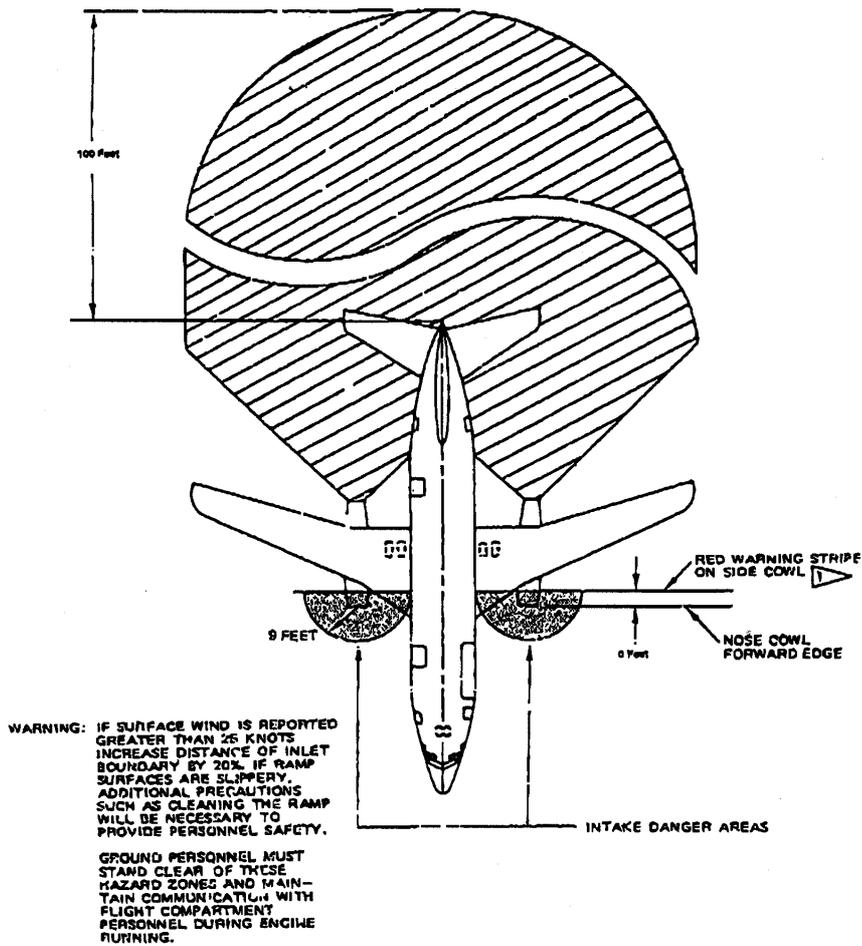
JT8B Turbofan Engine Hazard Areas

Under idle power from both engines the "Heat and Exhaust Velocity Area" extends from the engine exhaust rearwards from each wing-tip to a point a distance from the tail equal roughly to the fuselage length.(i.e. approx 100 ft.). Under idle power ear protection is required within 20 metres (approx 60ft.) of the engine intake. At idle thrust the engine inlet hazard area is bounded by a radius of 9ft from the intake and rearwards a distance of 6ft. (Appendix B). The aircraft manufacturer's Maintenance Manual states that technicians who enter the hazard areas should be in headset communication with the crew.

IDLE THRUST BOTH ENGINES OPERATING
