## Runway excursion on landing involving a Boeing 747-136, G-AWNN at Shannon Airport, on 24 October 1998

**AAIU Report No. 1999/015**  
**AAIU File No. 19980057**  
**Published 8/11/1999**

**Aircraft Type and Registration:** Boeing B747-136, G-AWNN

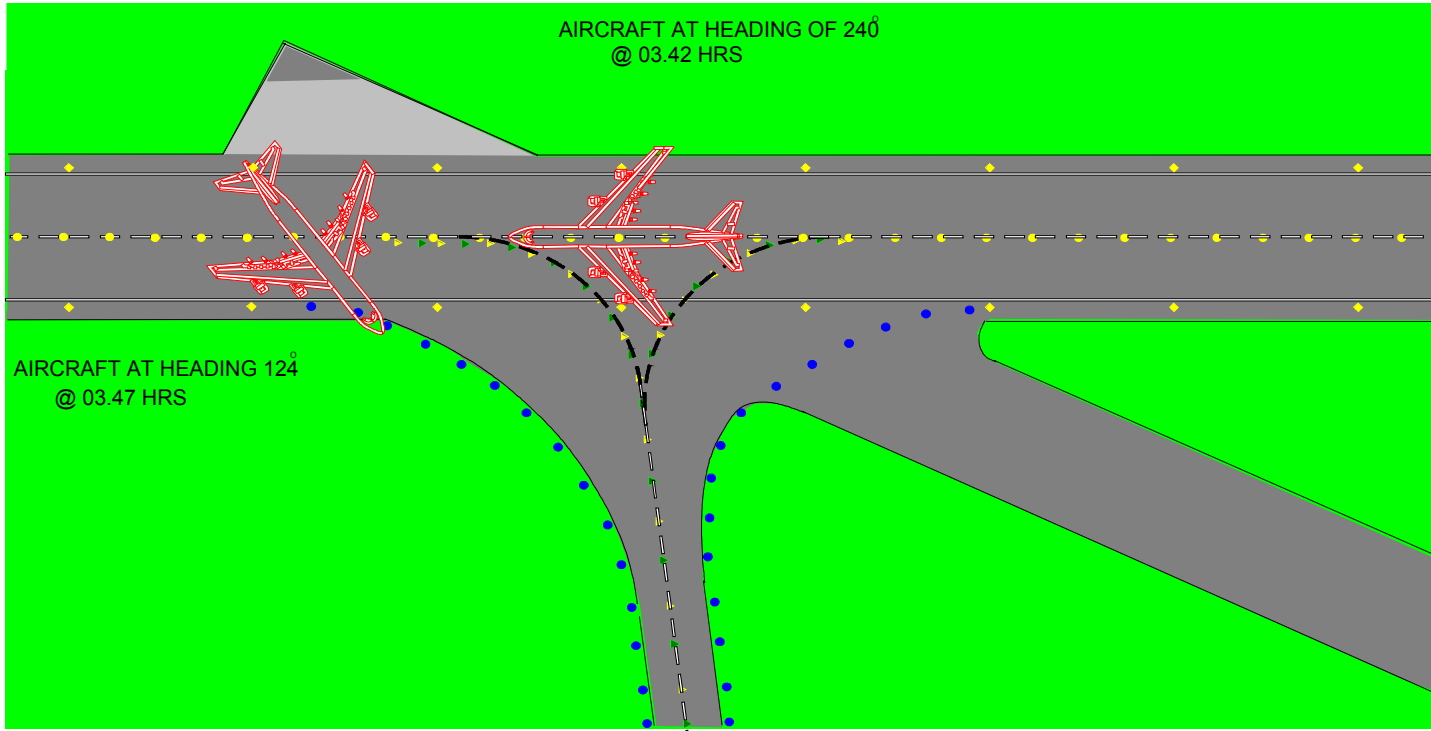
ANNEX A

To execute a turn on this runway the outboard starboard wheel truck would have to have passed within 1 metre of the right hand edge of the declared runway before the turn was executed. The body gear steering would have to be operative and the wind direction and speed favourable. As it was, the wind speed was 160°/24 kts, which was counteracting the turning process.

The crew failed to execute a 180° on the runway, just beyond the intersection of Runway 24 and Taxiway Alpha. In order to complete the turn the aircraft's heading would have to have reached 060°, whereas the final heading recorded in the turn was 124°. The runway and taxiway lights are correctly positioned in accordance with the ICAO recommendations. The blue taxiway edge lights follow the curvature of the taxiway. The curvature line is continuous and integrates into the white runway lighting system without any discontinuity. If the wheels of the aircraft were kept within the area bounded by the integrated lighting system the aircraft would have been free to continue its taxi. As it was, the aircraft's nose wheel breached this line destroying one of the lights in the process before coming to rest on the grass.
