## Ground collision between bus and MD-83, HB-INV, September 3, 1999, Dublin Airport

*AAIU Report No. 2000/013*  
*AAIU File No. 1999/0058*  
*Published.: 11/09/02*

<b>Aircraft Type and Registration:</b>	MD83,	HB-INV
<b>No. and Type of Engines:</b>	2 X JT8D-219	
<b>Aircraft Serial Number:</b>	49359	
<b>Year of Manufacture:</b>	1987	
<b>Date and Time (UTC):</b>	3 Sept '99	13.10 hrs
<b>Location:</b>	Stand 32 Dublin Airport	
<b>Type of Flight:</b>	Public Transport	
<b>Persons on Board:</b>	133	
<b>Injuries:</b>	Nil	
<b>Nature of Damage:</b>	Damage to left wing outer slat	
<b>Commanders Licence:</b>	Air Transport Pilots Licence	
<b>Commanders Age:</b>	60 years	
<b>Commanders Flying Experience:</b>	13,000 hours	
<b>Information Source:</b>	Aer Rianta Duty Officer AAIU Field Investigation

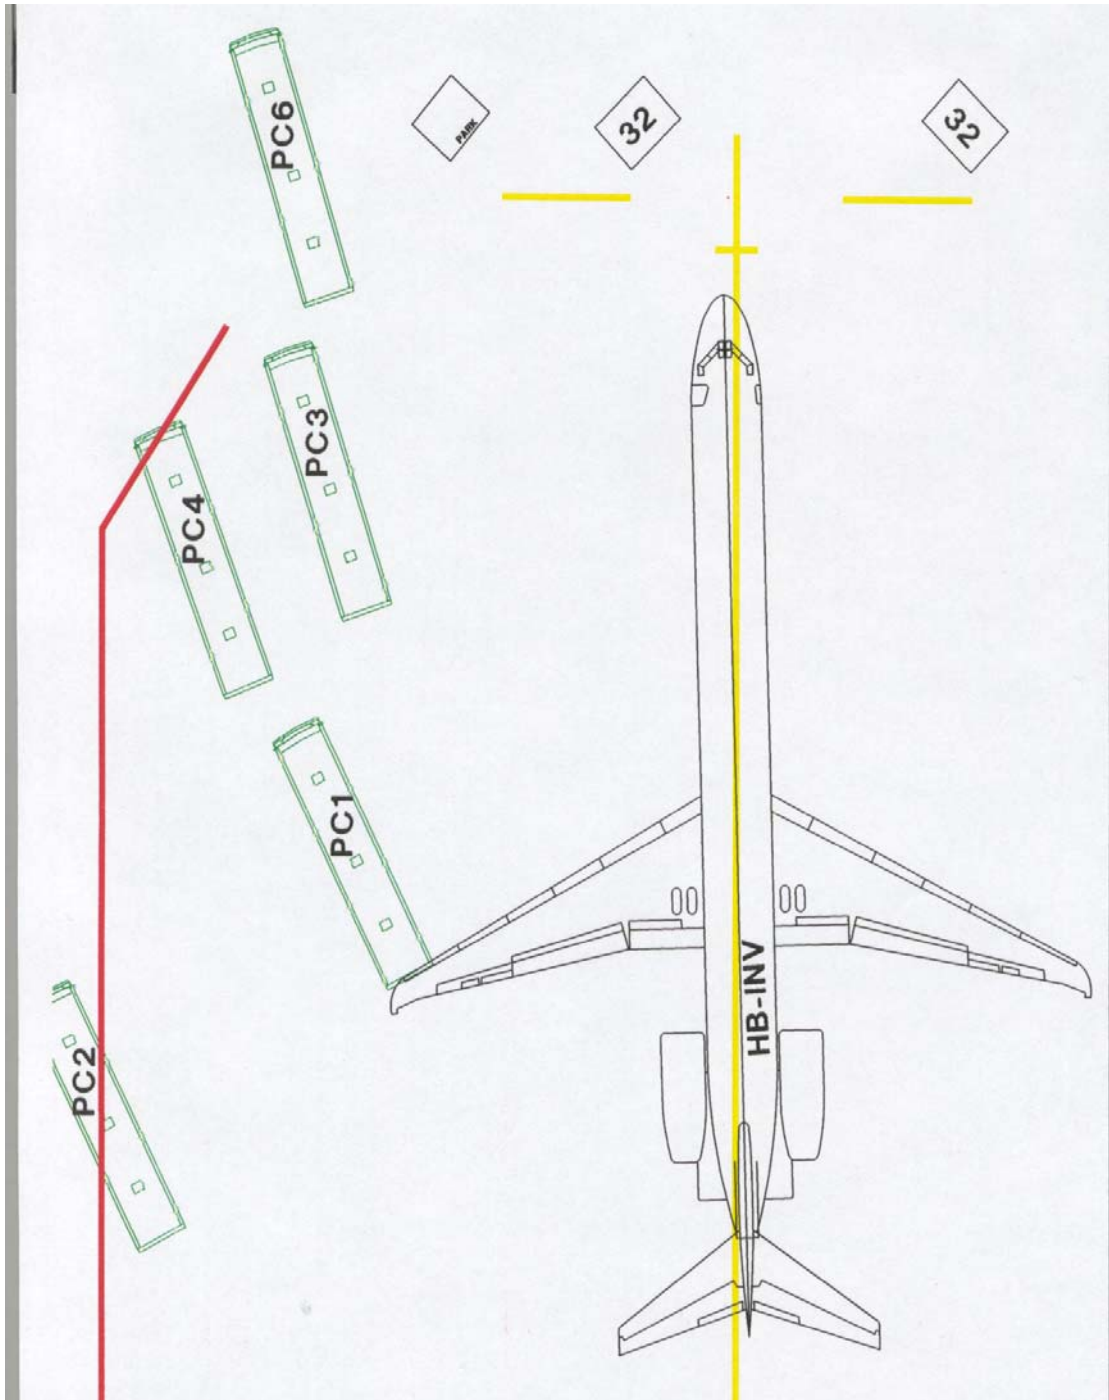
Because of the proximity of construction vehicles entering and leaving this site several aircraft operators refused to have their aircraft marshalled on to the adjacent Stand 31. Most were concerned about the likelihood of the effect of FOD (Foreign Object Damage) due to the nearby transportation of building materials. Stand 31 therefore became redundant and was used by an aircraft operator as a site for the parking of their buses. At the time of the incident there were buses parked in this vicinity, five of which were parked either partially or wholly on Stand 32.

The Captain of the aircraft, the Marshaller and the Wingman were all aware of the proximity of the buses to the yellow taxiline along which the aircraft was about to be manoeuvred. The left wing impacted the rear of the bus from the wing tip to a point approx. 2 metres inboard from the tip. The aircraft would have to have been this distance to the right of the taxiline in order to avoid colliding with the bus. A witness who was at an elevated site 200 meters away said that the aircraft appeared to taxi "at a quick pace". The Captain said that he taxied his aircraft at a "very low taxi speed". Neither the Marshaller or Wingman made a comment in their statements regarding taxi speed. The Marshaller would have been approx. 38 meters from the Wingman and therefore reliant on signals from him during the marshalling process. He observed the Wingman about to give a signal to stop which would indicate that he was alert to the danger involved. However, no signal to stop came from the Wingman.

Position of HB-INV and adjacent passenger vehicles at the time of the incident.

- 4.1 The Airport Authority should ensure that all passenger vehicles in use on the airside have a designated parking area. **(SR 39 Of 2000)**
- 4.2 The aircraft operators and ground handlers should ensure that all their passenger vehicles, in use on the airside, use the designated parking areas provided by the Airport Authority. **(SR 40 Of 2000)**
