Depressurization En Route, Airbus A320 (EI-CPD), en route near Cardiff, UK, January 26, 2004.

FINAL REPORT

AAIU Synoptic Report No:2005-020

Aircraft Type and Registration:	Airbus 321-200, EI-CPD
No. and Type of Engines:	2 x CFM 56-5B/3P
Aircraft Serial Number:	0841
Year of Manufacture:	1998
Date and Time (UTC):	26/01/04 @ 10.52 hours
Location:	En-route London to Dublin
Type of Flight:	Scheduled Transport
Persons on Board:	Crew - 8 Passengers -155
Injuries:	Crew - Nil Passengers - Nil
Nature of Damage:	LH air conditioning bellows ruptured No aircraft exterior damage
Commander's Licence:	ATPL
Commander's Age:	42 years
Commander's Flying Experience:	12,521 hours of which 1,540 were on type
Information Source:	Operators Air Safety Office

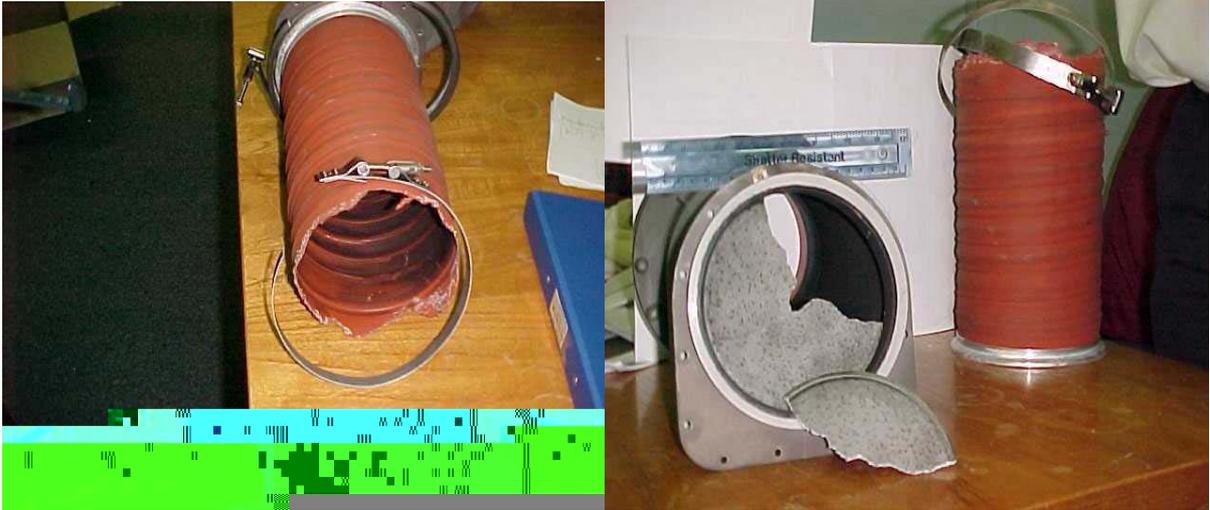
APPENDIX A

The metal clamp holding the forward bellows to the LH air conditioning condenser unit was found broken. The bellows had detached from the condenser and was found ruptured. The Pack Outlet Check Valve (POCV) flap downstream from the condenser was also found broken. This would have allowed the cabin air to exhaust to atmosphere through the ruptured bellows unit. In addition, a small 1.5 cm piece had broken away from the centre of the flap and was not found. The blow-out panel had opened.

The fractured POCV was sent to the subcontractor for examination and report. On one side of the flap they discovered scratches caused by roughing/cleaning carried out by the casting manufacturer. These scratches should not be evident. Metallographic inspection of the fracture also revealed some abnormal inclusions in the material in the cracked area. They concluded that these inclusions and possibly abnormal severe conditions caused the flap to fracture.

1. The clamp on the condenser in the left hand air conditioning bay fractured, causing the associated bellows unit to rupture
2. The rupture set up an oscillation in the airflow through the Pack Outlet Check Valve, which caused the valve flap to impinge on the valve stops. Foreign inclusions in the flap casting were a contributing factor in its subsequent fracture and failure.
3. The ground inspection failed to find the ruptured bellows during the initial trouble shooting at London LHR (in accordance with aircraft manufacturer's TSM Task 21-50-00-810-801)

The photo on the left shows the broken clamp and the frayed end of the bellows unit. The photo on the right shows the broken check valve. The scratches on the flap casting and the missing centre portion can also be seen.

The clamp, check valve and bellows were replaced and the LH duct and condenser were checked for debris with nil findings. The LH air conditioning pack was operated as per the aircraft maintenance manual (AMM) and found satisfactory. The aircraft was flown back to Dublin with that pack inoperative. The damaged parts were returned to the aircraft manufacturer for inspection.
