Runway excursion while taxiing, ATR 72 (EI-RED), December 15, 2004

FINAL REPORT

AAIU Synoptic Report No: 2005-013

Aircraft Type and Registration:	ATR 72 – 202, EI-RED
No. and Type of Engines:	2 x Pratt and Whitney PW 124B
Aircraft Serial Number:	373
Year of Manufacture:	1994
Date and Time (UTC):	15 December 2004 @ 10.47 hrs
Location:	Eastern end of Runway (RWY) 26 Galway Airport (EICM)
Type of Flight:	Scheduled Public Transport
Persons on Board:	Crew - 4 Passengers - 31 + 1 Child
Injuries:	Crew - Nil Passengers - Nil
Nature of Damage:	Nil
Commander's Licence:	Irish ATPL issued by the IAA
Commander's Details:	Male, aged 64 years
Commander's Flying Experience:	Approximately 21,000 hours, of which 3,000 were on type
Information Source:	The Operator, AAIU Incident Report Form submitted by Captain, Field Investigation.

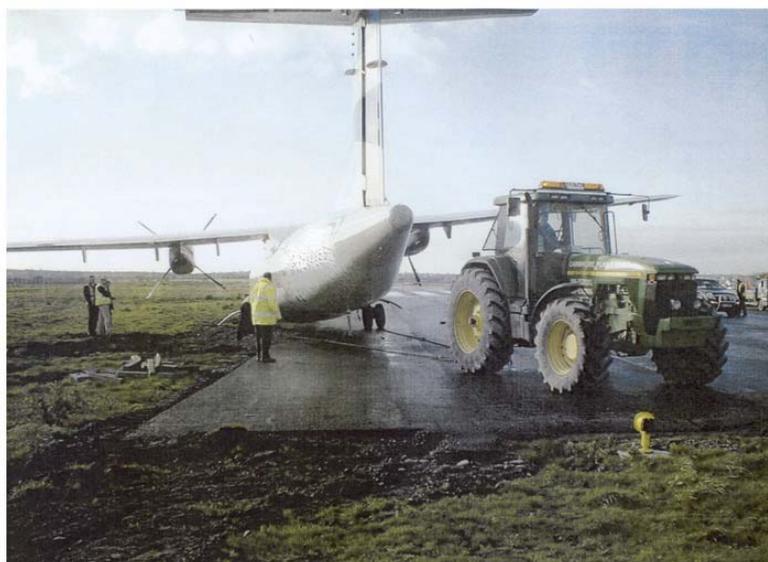
EI-RED exited the ramp through Taxiway Bravo and backtracked along the centreline of RWY 26 towards the displaced threshold³. On reaching the displaced threshold, the aircraft commenced a reversal of direction within the area between the displaced threshold and the end of the runway, by initially turning left off the centreline and then right. The turn was normal until approximately through 90° (right) when it was noticed by the PF that the turn was somewhat wide, but not excessively so. The turn was continued. Neither flight crew member was aware of a pavement excursion until it was felt that the aircraft was not turning normally, followed quickly by the LH MLG leaving the runway. The aircraft was immediately stopped and Air Traffic Control (ATC) was advised. The No. 1 engine was shut down, while the No. 2 engine was left in HOTEL mode (engine running with prop brake engaged). The Captain made a public address (PA) advising the passengers that the aircraft had left the runway and was stuck in situ. The passengers and crew made a normal exit from the rear port door and were ferried back to the terminal building. The Captain reported that the passenger's reaction was calm and that no injuries or trauma occurred. In addition, the Captain did not report any skidding or slipping, while performing the turn manoeuvre.

An inspection of the site determined that, as the aircraft's turn progressed through approximately 90° (facing south), the NLG departed the paved surface. As the turn continued west, the NLG tracked along the grass close to the runway edge. The LH MLG then left the paved surface by 0.5 of a metre (m) and continued for approximately 3m until the aircraft was stopped. No damage was caused to the aircraft or the undercarriage. Some wheel rutting damage was caused to the ground adjacent to the runway edge.

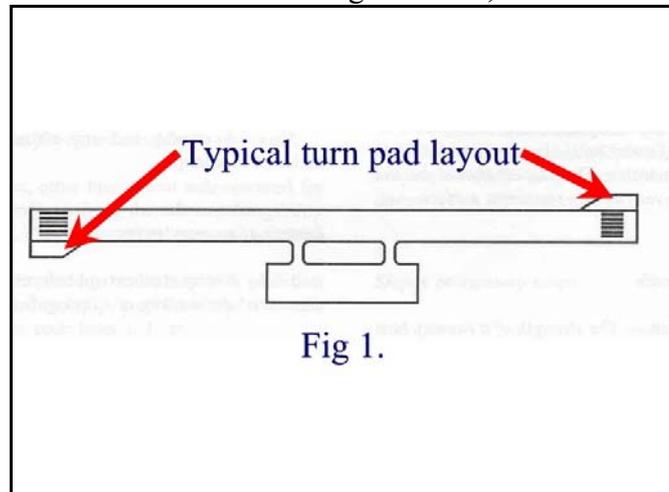
A graphic illustration of a runway turn pad is presented below as Fig 1. The initiation of the turn would be facilitated by locating the turn pad on the left side of the runway, since the left seat is the normal position of the pilot-in-command. Guidance on the design of runway turn pads is available in the ICAO Aerodrome Design Manual, Part 1

However, the Investigation does recognise that the main advantage of a taxiway, taxiway turnaround or a turn pad, is that the aircraft can turn/intercept directly onto the runway centreline and that a turn pad will also provide more pavement to conduct the manoeuvre, thereby increasing the safety margin.

In the spirit of the ICAO Recommendation for Turn Pads, the Investigation concludes that for any further runway development in Galway, the Airport Management should consider the inclusion of Turn Pads at either end of the runway. A Safety Recommendation has been made to that effect.

- 3.1** The Galway Airport Management Board should consider, in any future runway extension or improvement plan, the inclusion of Turn Pads at either end of the runway. **(SR 07 of 2005)**

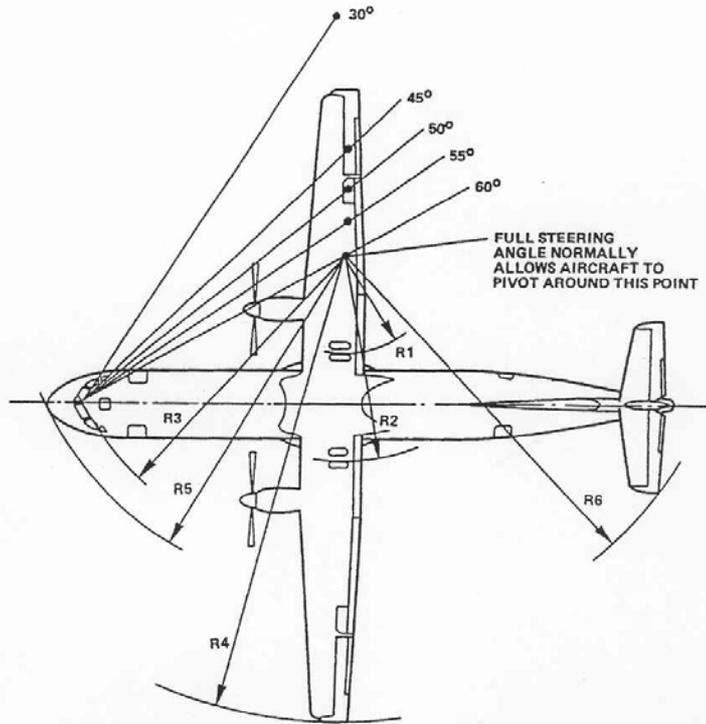
APPENDIX A

Chapter 4 of the ATR 72 Flight Crew Operational Manual (FCOM) provides information on airplane turning capability and manoeuvring characteristics. Section 4.2 provides a figure and table showing the turning radii (R), with no slip angle, for various steering angles ranging from 30° to 60° (**Appendix A**). R2 measures the turn radius, from the centre point of the turn radius to the outer main undercarriage wheel. R3 of the table measures the turn radius from the same pivot point to the nose wheel.

It is clear from Appendix A, B and Table 1, that an aircraft the size of the ATR 72 is well capable of carrying out a 180° turn on a 30m wide runway such as Galway, once the steering angle is greater than 45° and up to 60°. However, when using the shallower steering angles (45°- 50°), it does require that the reversal of direction be initiated relatively close to the runways' edge. Where this is not done and/or if the steering angle is set below 45° or a higher angle is not maintained throughout the manoeuvre, safety margins are likely to be compromised. In the case of EI-RED, it is considered that, any one or a combination of all three of these factors, contributed to the aircraft leaving the paved surface. While it is considered unlikely that the nose wheel suffered from some loss of traction during the turn manoeuvre on the DAMP surface, the Investigation cannot entirely rule this possibility out.

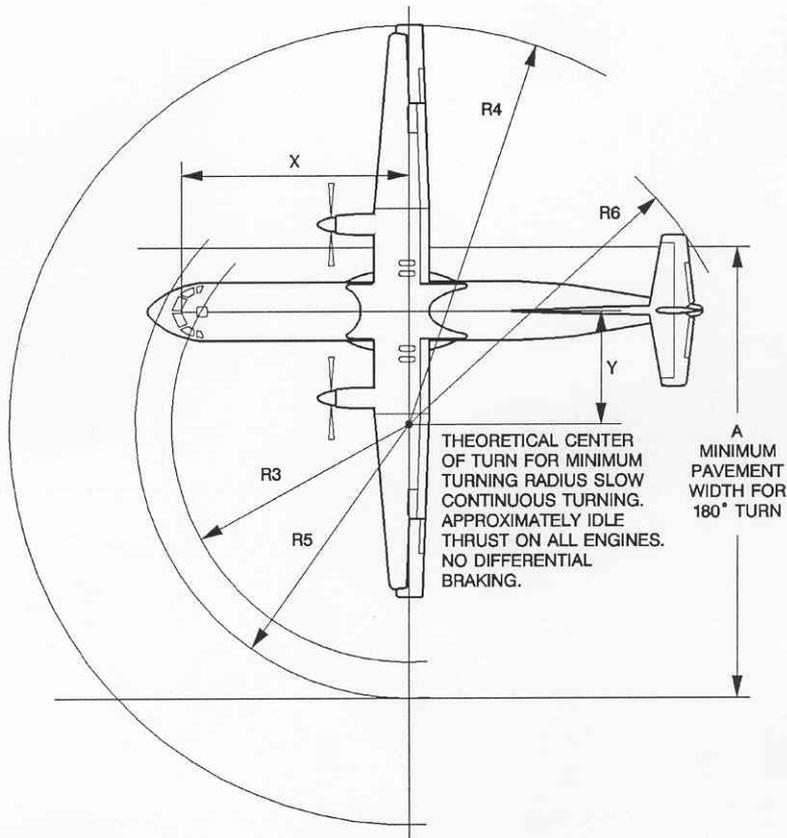
APPENDIX B

Additional information is provided in the FCOM with regard to turning capability on the ground (**Appendix B**). Using a 60° turning angle the minimum pavement width for an 180° turn is given at A as 21.40m.
