Flight into terrain, Air New Zealand McDonnell-Douglas DC-10-30 ZK-NZP, Ross Island, Antarctica, November 28, 1979

AIRCRAFT ACCIDENT

REPORT No. 79-139

McDONNELL-DOUGLAS DC10-30 ZK-NZP

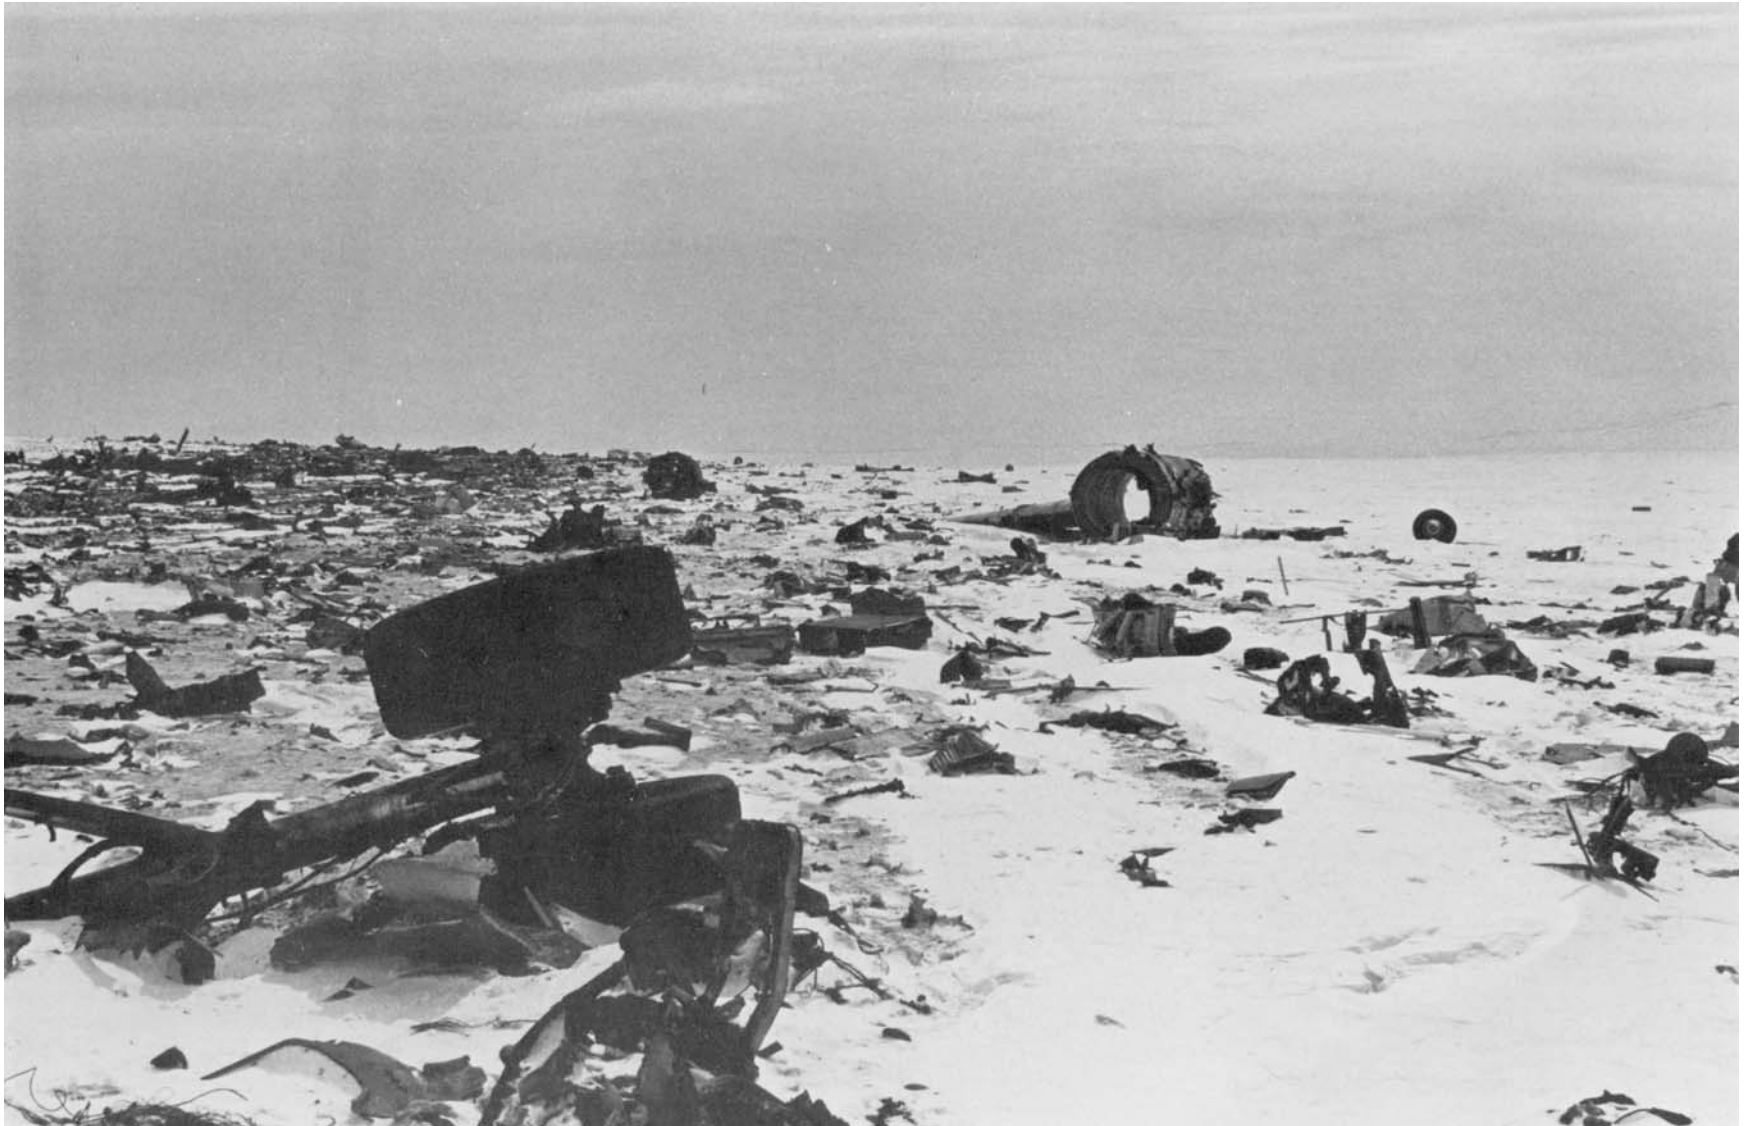
FIG 1 WRECKAGE OF ZK-NZP LOOKING NORTH OVER LEWIS BAY

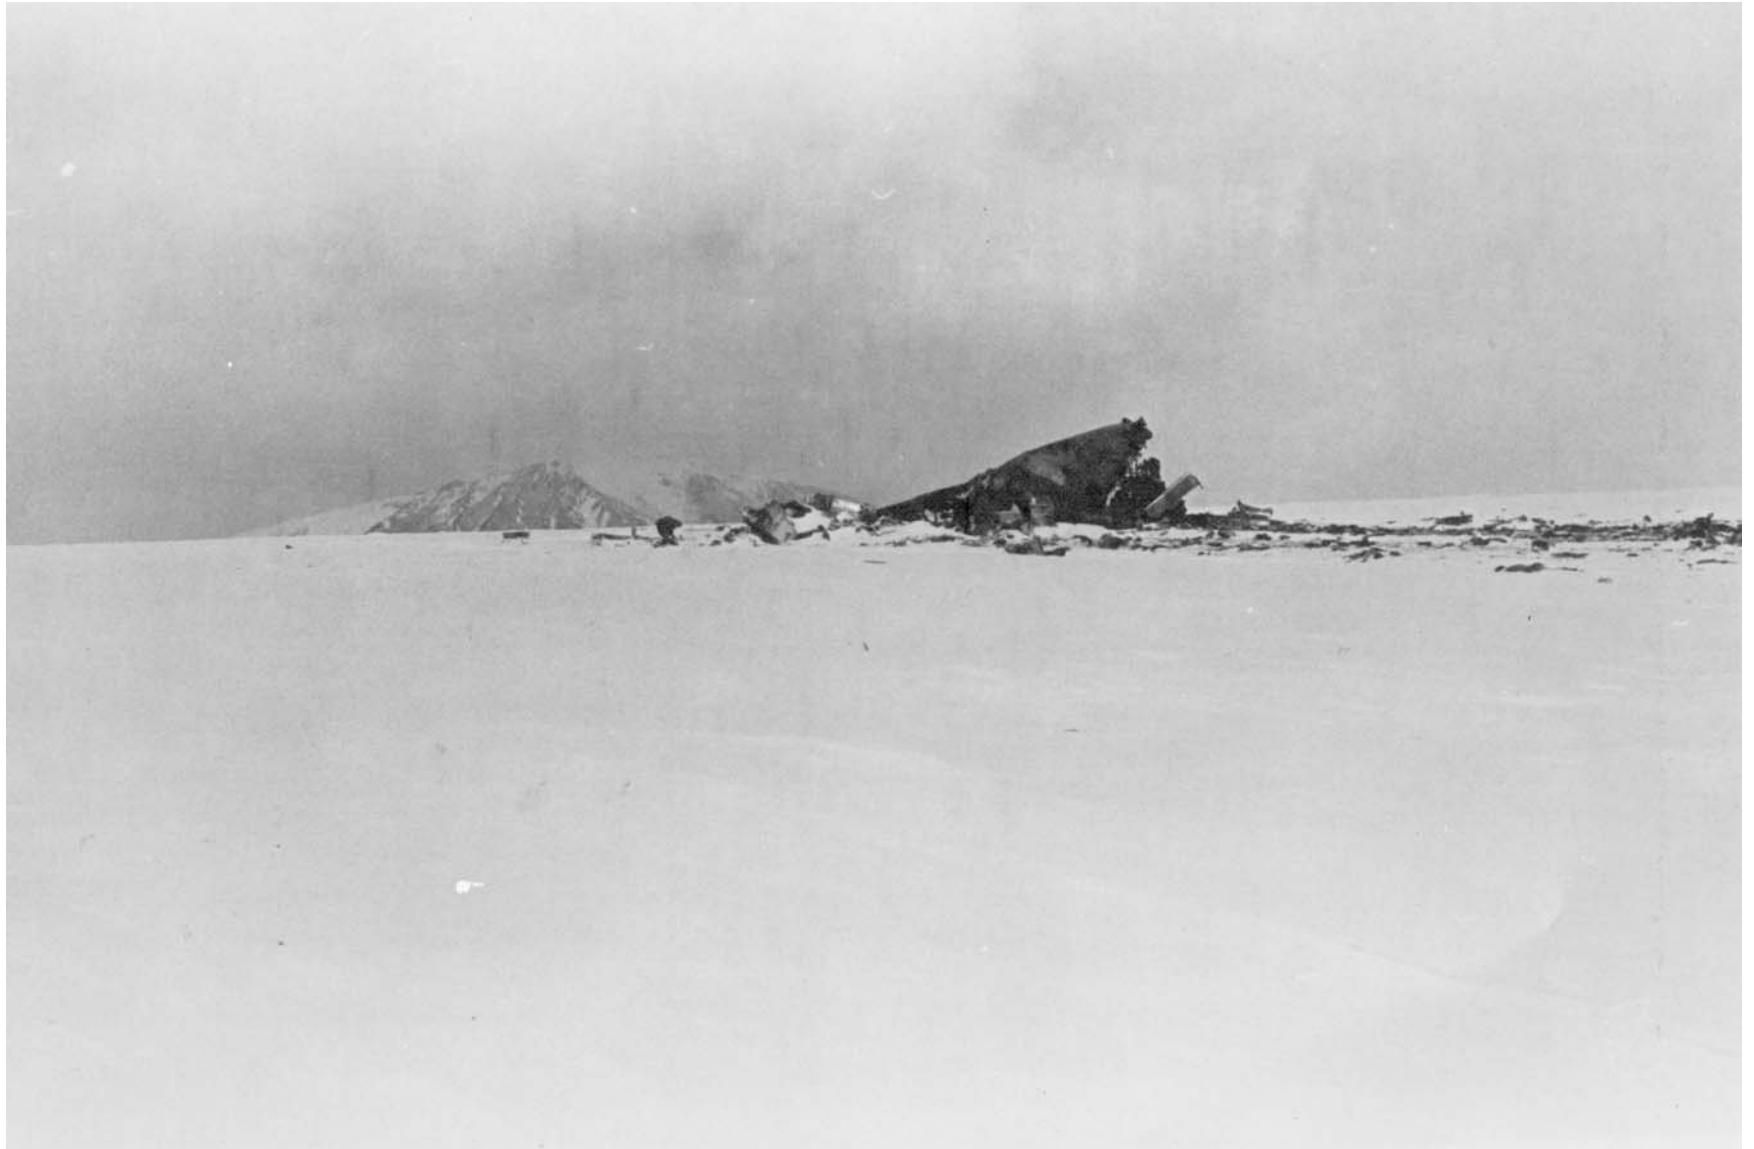
- 1.12.10 The largest portion of the aircraft remaining was the complete constant section length of the damaged cabin section which remained attached to the wing's centre and inboard sections. This portion was at the forward end of the wreckage train and was involved in a persistent, intense and deep seated fire.

FIG 2 LOOKING SOUTHWEST PAST BURNT OUT CABIN TOWARDS MT EREBUS

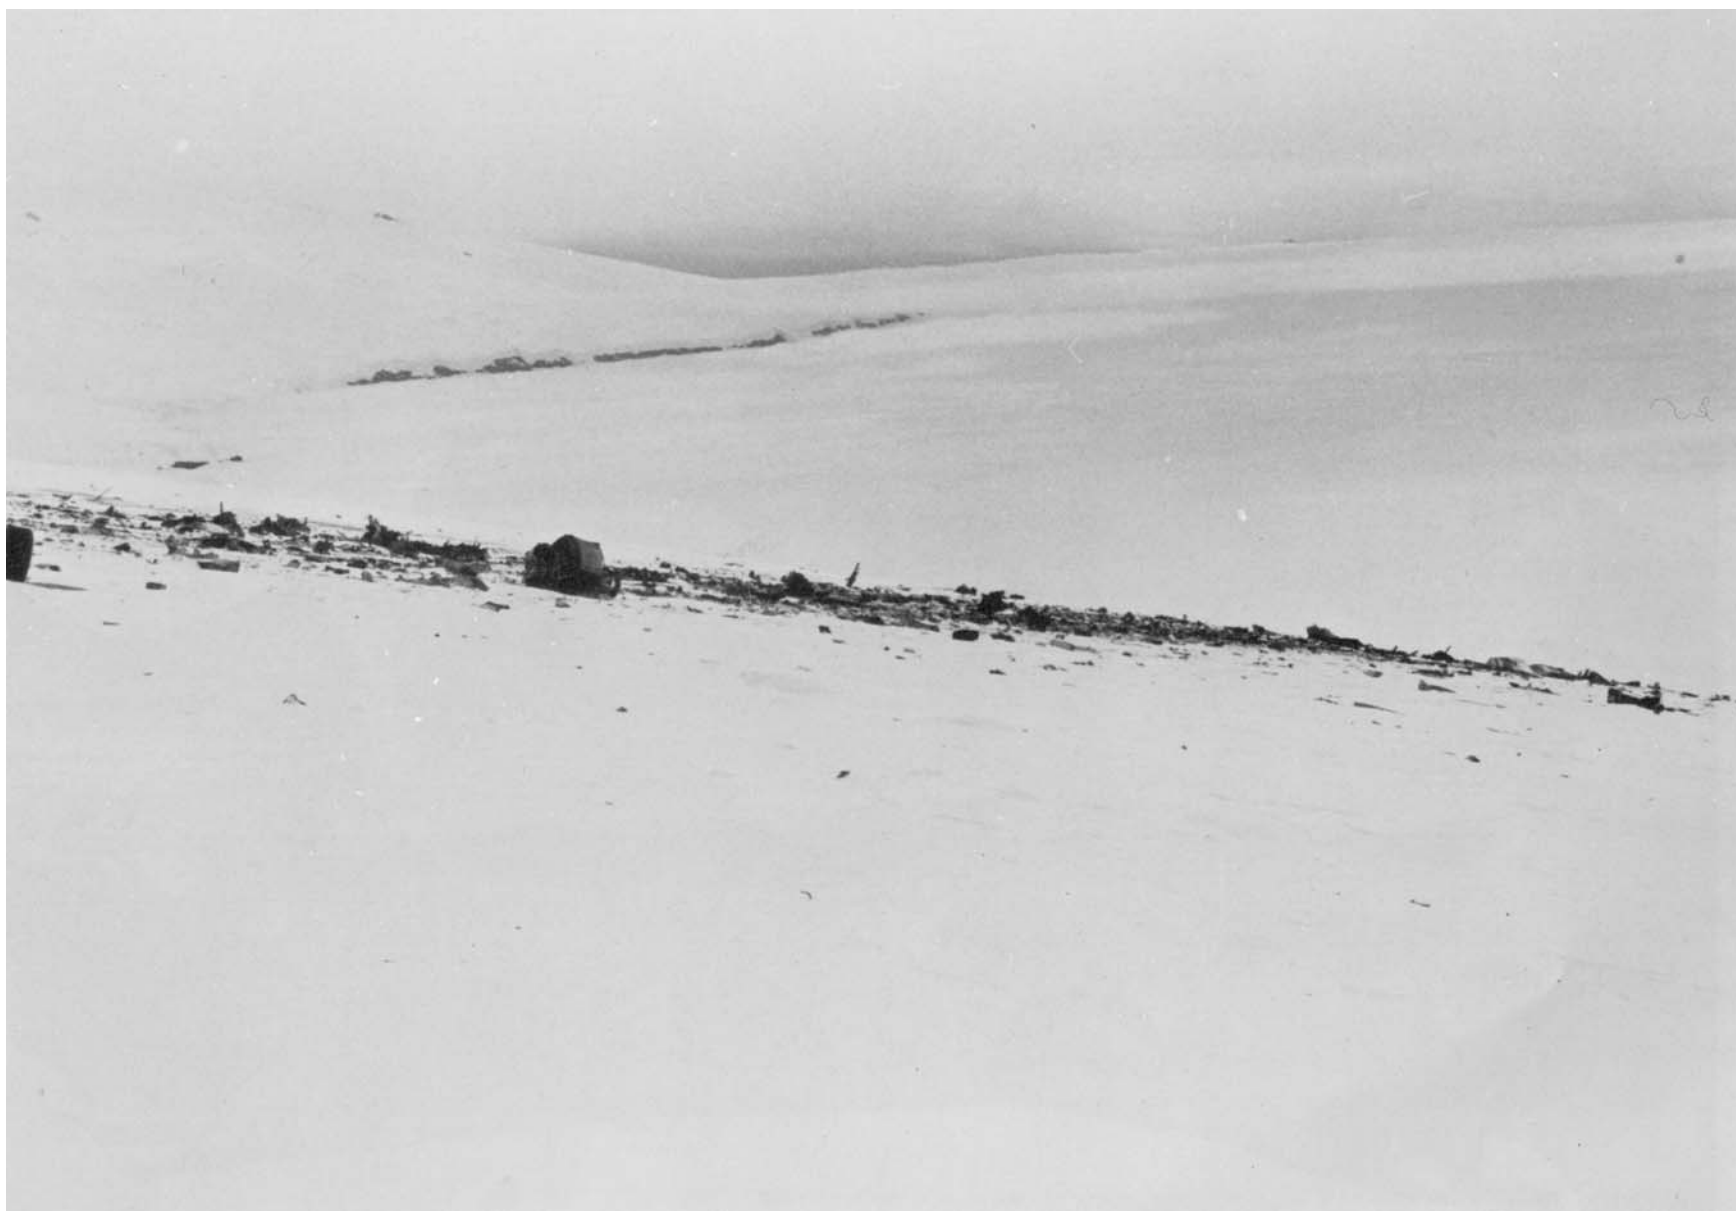
FIG 3 LOOKING WEST ACROSS WRECKAGE OF ZK-NZP TOWARDS NORTH-WEST SHORE OF LEWIS BAY

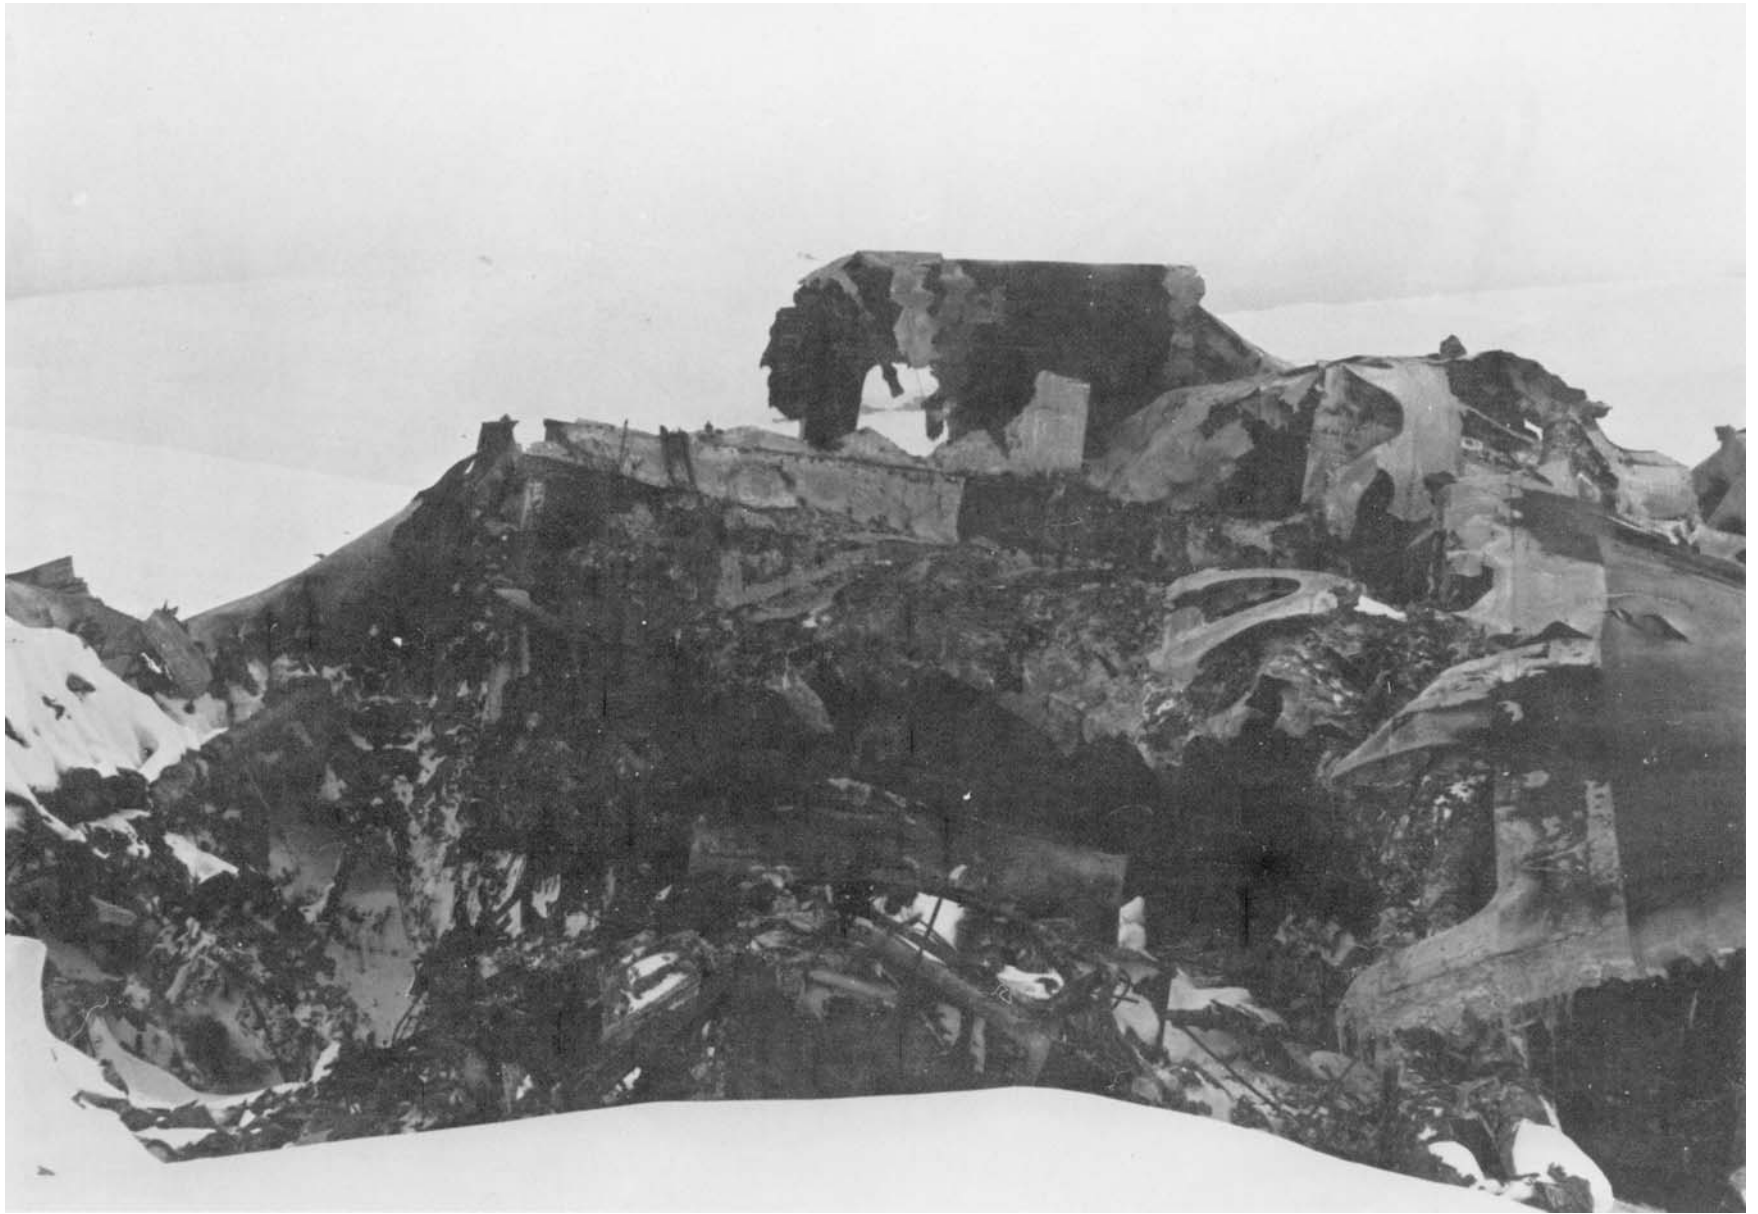
- 1.14.1 The evidence in the wreckage trail indicated that a fire was ignited immediately after the impact and that a persistent fire raged in the centre section of the fuselage but aft of the front galley. The residual fuel in the left wing tanks which were the only fuel tanks to retain their essential integrity probably sustained this conflagration. The source of ignition was not determined.
- 1.14.2 The fire did not involve the fuselage interior immediately after impact and many of the victims showed no evidence of being burnt.
- 1.14.3 The fire burnt itself out before the wreckage was located therefore no fire fighting equipment was involved.

FIG 4 AFTERMATH OF INTENSE FIRE IN CABIN AREA

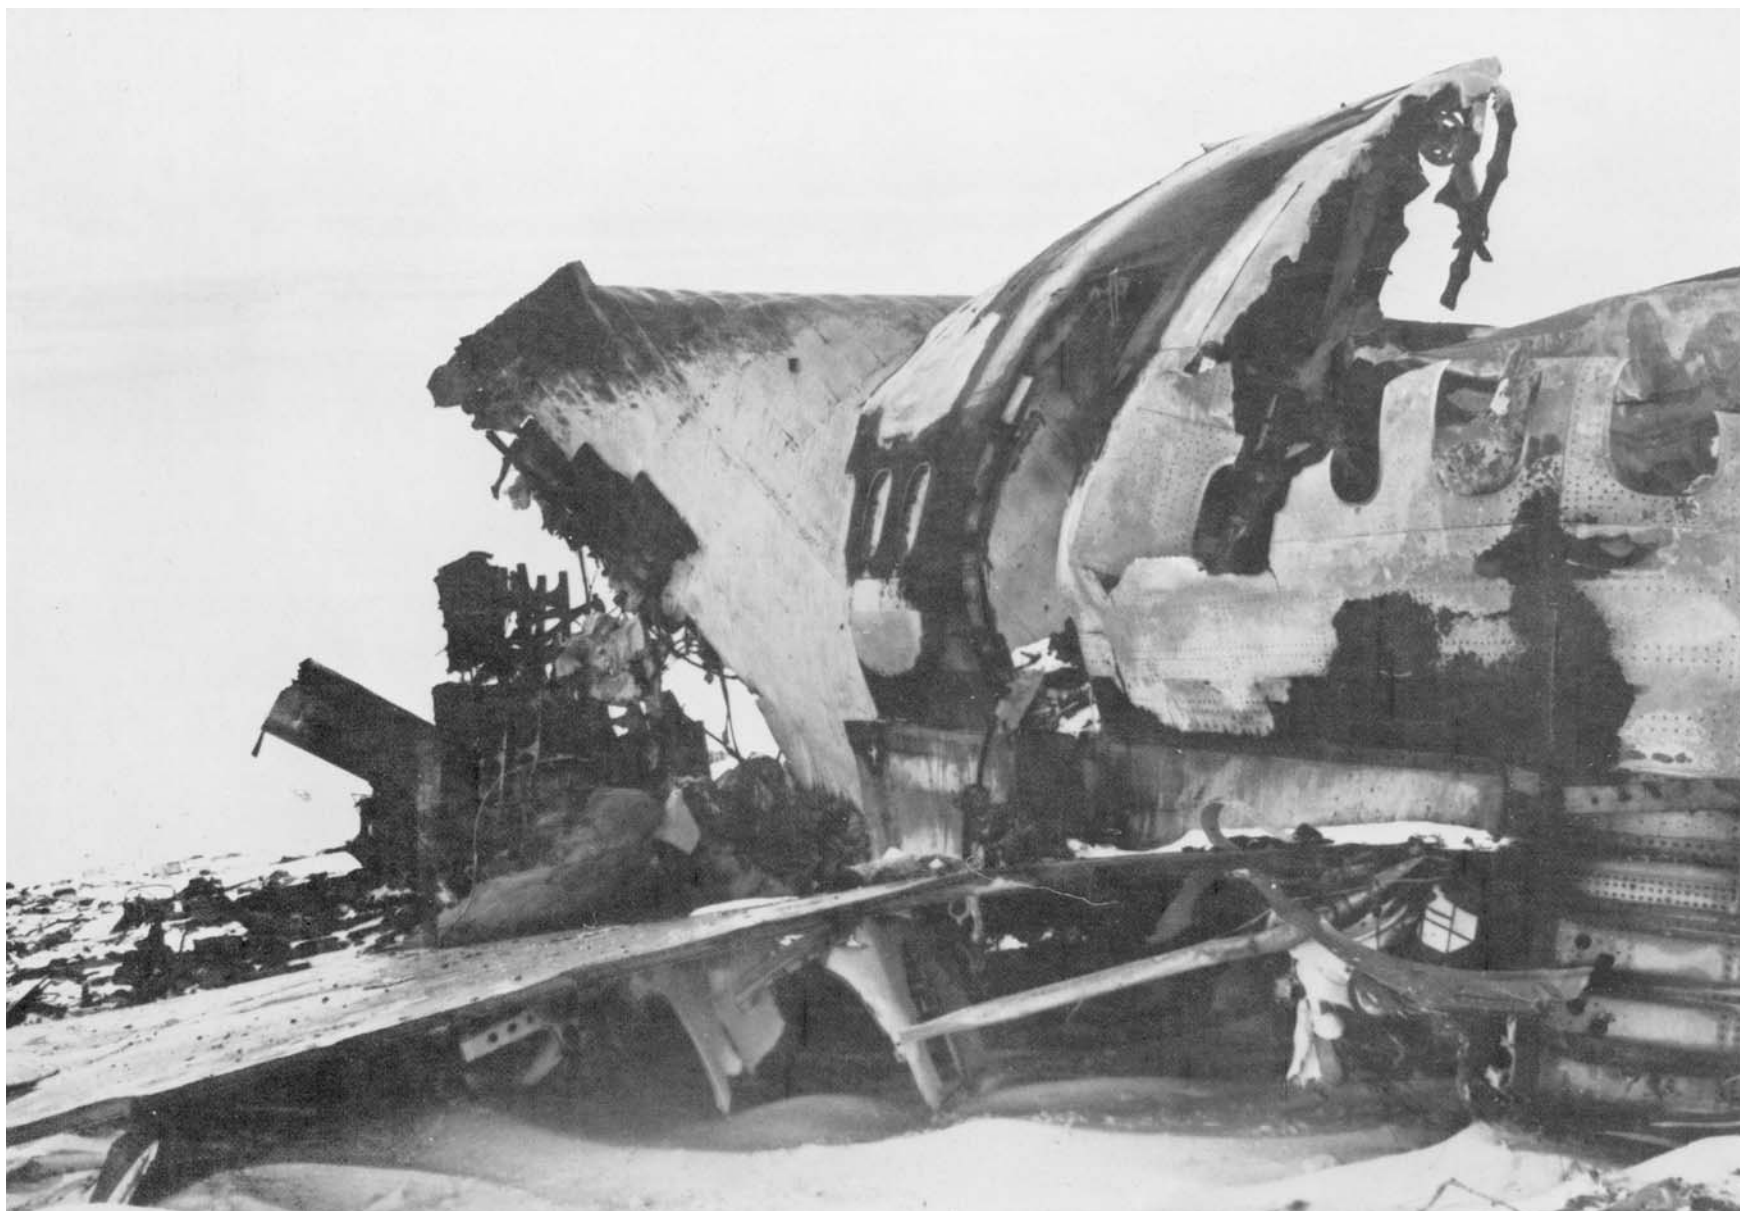
FIG 5 TOP OF RIGHT WING AND RIGHT CABIN SIDE OVER WING DOOR AREA
