Airmiss incident between a Boeing 737-200 ZK-NAZ and Piper PA38-ZK-PAH at Wellington on 6 April 1992

No. 92-010

AIRMISS INCIDENT

**Boeing 737-200 ZK-NAZ
and
Piper PA38 ZK-PAH
at Wellington**

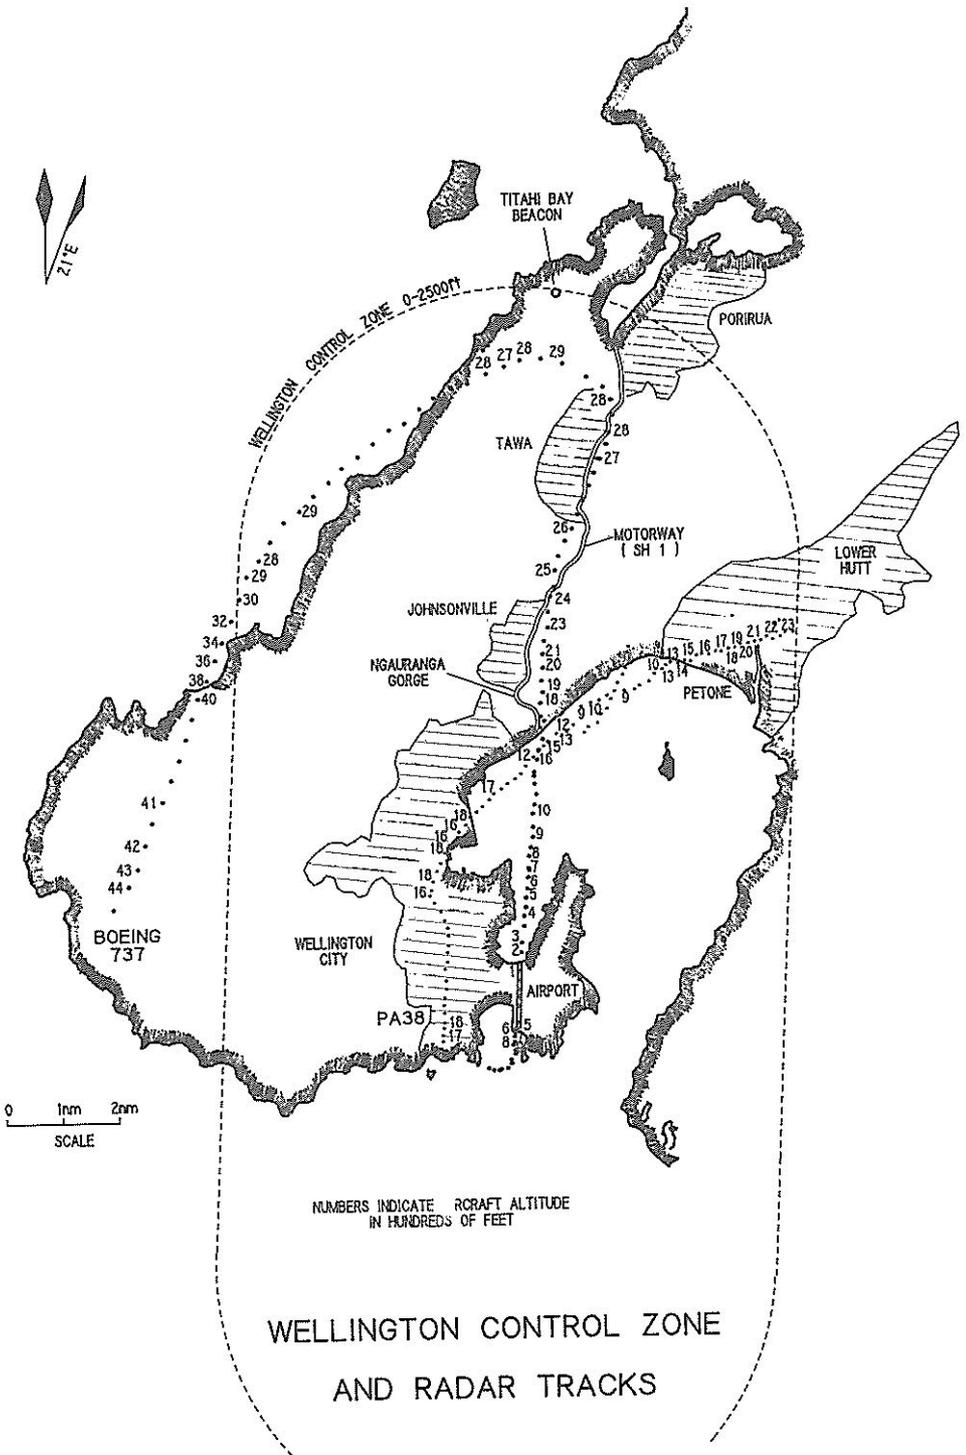
1.1.4 Each aircraft operating within the Wellington Control Zone (see Diagram 1) required an ATC clearance and aircraft operating under IFR were provided with separation from all other aircraft by Air Traffic Control (ATC).

1.2.2 While NZ410 was on its downwind leg towards Titahi Bay, ZK-PAH had flown towards Ngauranga (see Diagram 1). NZ410 turned short of the Titahi Bay NDB, and joined the ILS approach path so that the ILS could be used to monitor the visual approach. Meanwhile ZK-PAH asked for and was given clearance to proceed to Petone.

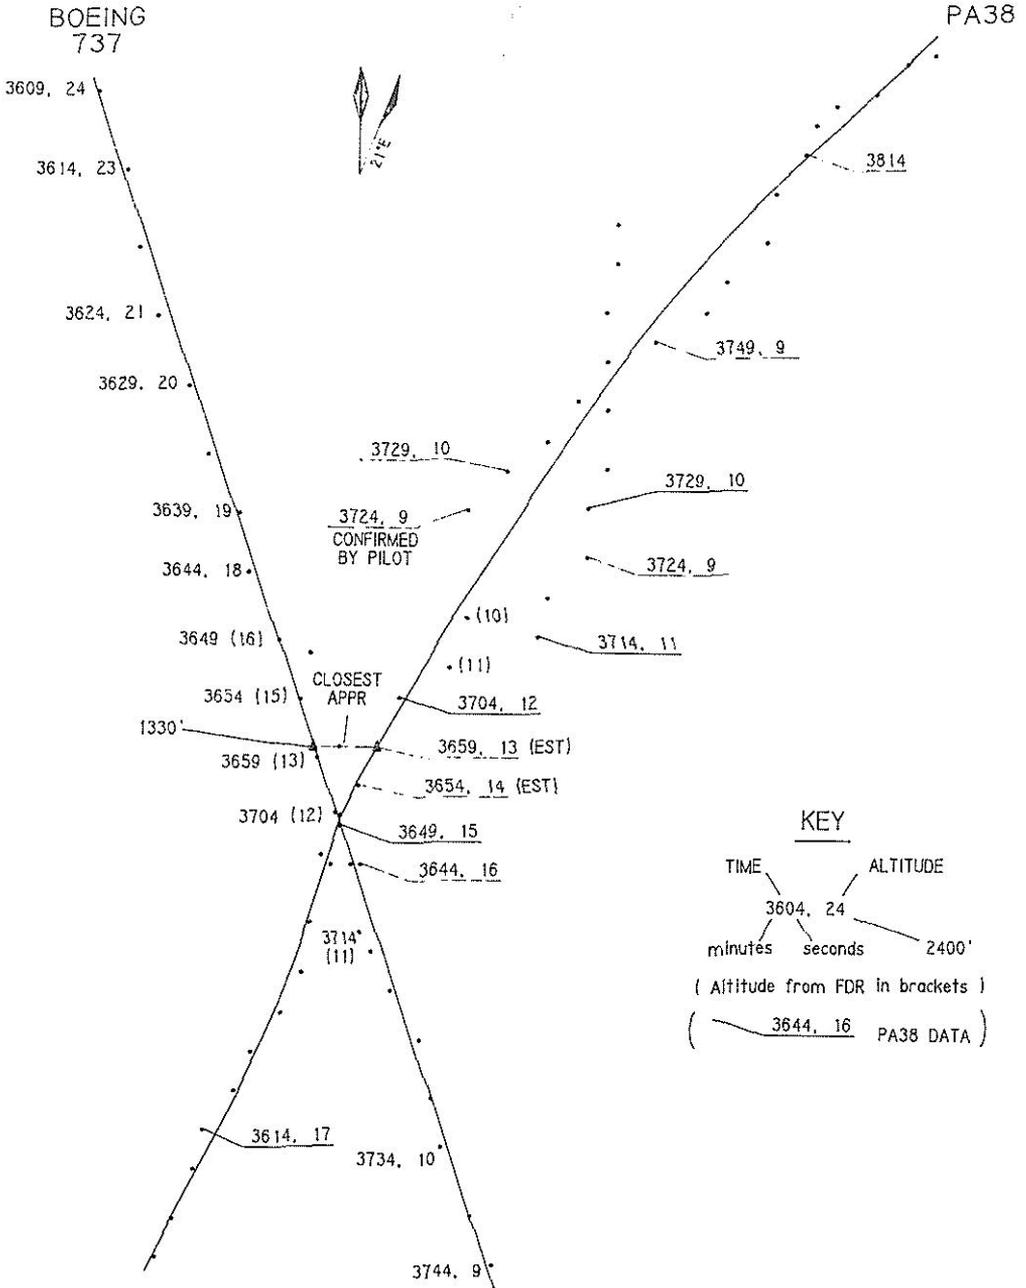
DIAGRAM 2

RADAR TRACKS AND DETAILS

1.8.4 The radar tracks of the two aircraft are shown, superimposed on a map of Wellington, at Diagram 1, while an enlargement showing the details of the airmiss, is shown at Diagram 2.

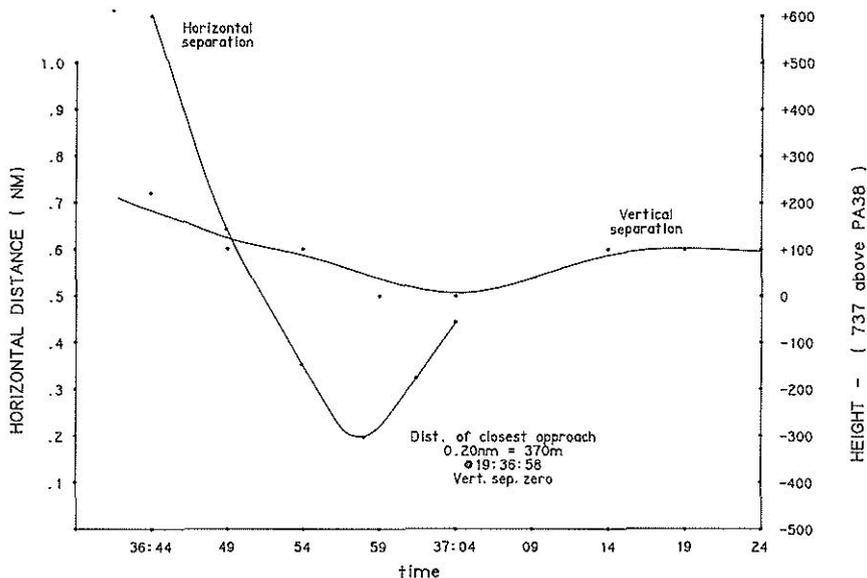
DIAGRAM 3

MISS DISTANCE

2.1.1 The PA38 crossed the B737's projected flight path at 1936:49; at that time the PA38 was 100 feet below the B737, which was at 1600 feet. The B737 was 0.6 nm from the cross-over point and this distance represented 8 seconds at the combined closing speed of the two aircraft. The point of closest approach was found to occur at 1936:58. The horizontal passing distance was recorded as 0.20 nm (370 m); the semi-spans of the B737 and PA38 totalled 20 m so the separation was about 350 m. Both aircraft were then at about the same height. A plot of vertical and horizontal separation against time is shown at Diagram 3.
