Proximity incident, Infraction of minimum separation between the aircraft G-KATA and OY-CNP in the airspace above Malmö/ Sturup airport, M County, on the 22nd of August 2002

Investigative Body: Swedish Accident Investigation Board (AIB), Sweden

Report RL 2003:27e

Case L-083/02

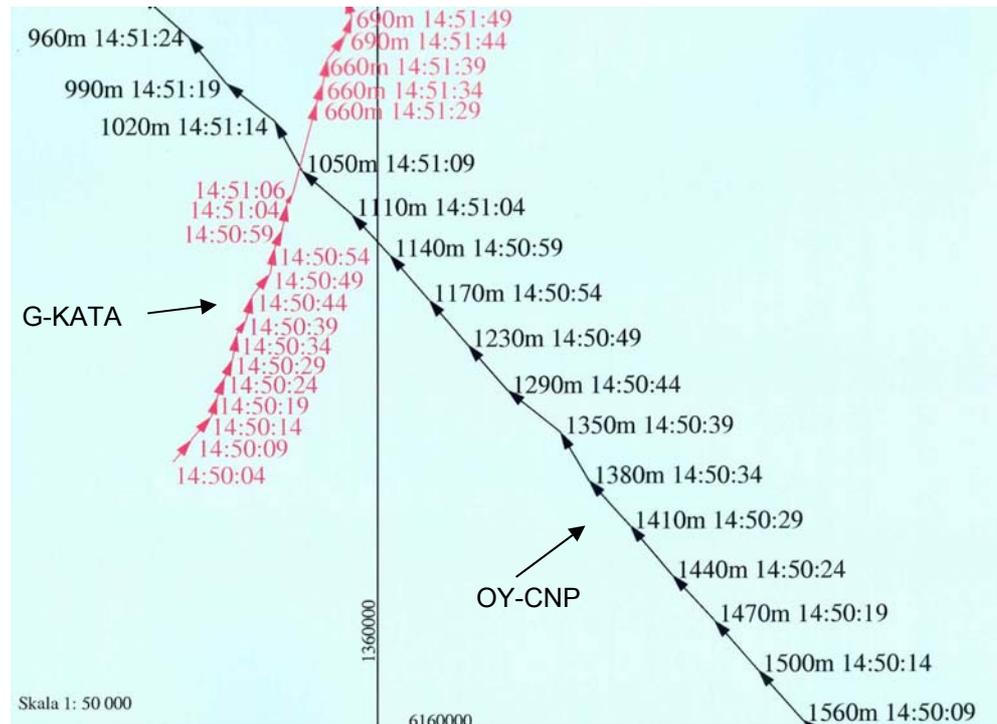
The flight paths of the two aircraft have been registered by MUST and are presented in the figure below. From the register, it has been calculated that the minimum distance between the two aircraft was approximately 130 meters horizontally and 420 meters vertically, which occurred at 14:51:09 hours (see next page).

Remark: The heights given are for the standard air pressure of 1013.2 hPa and are not adjusted for the actual air pressure at the time of the incident.

According to the MUST register, the aircraft came as close as approximately 130 meters horizontally and 420 meters vertically, which means that the infraction of minimum separation was serious from a flight safety point of view.
