Proximity incident, Infraction of minimum separation between the aircraft SE-IBX and TS-INC in the airspace north of Gothenburg/Landvetter airport, O County, Sweden, on the 5th of November 2002

Report RL 2003:31e

***Infraction of minimum separation
between the aircraft SE-IBX and
TS-INC in the airspace north of
Gothenburg/Landvetter airport,
O County, Sweden, on the 5th of
November 2002***

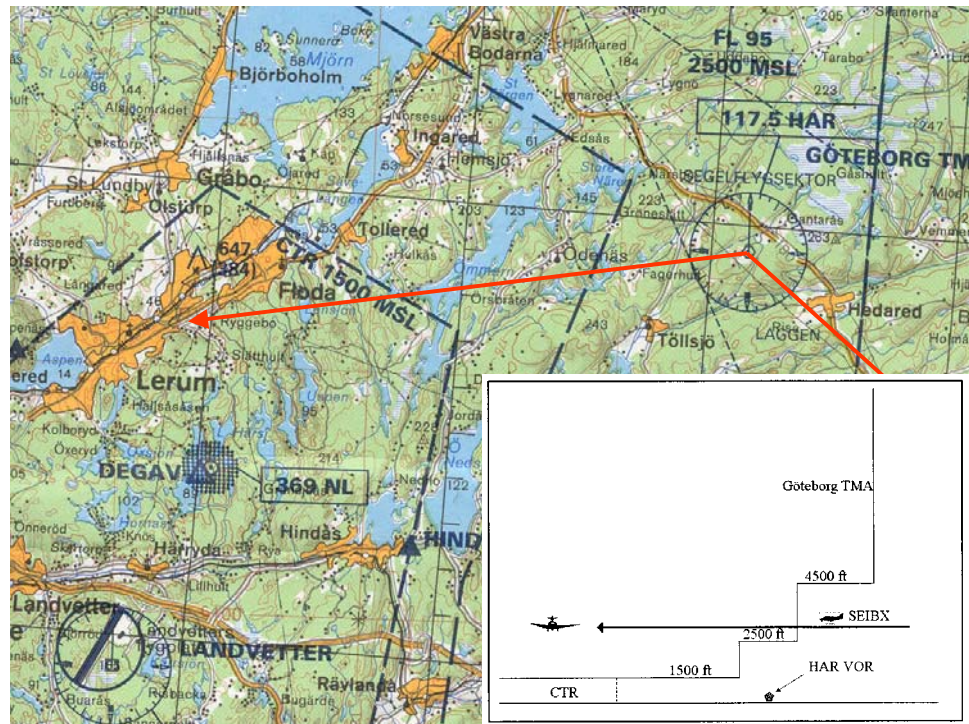
The aircraft SE-IBX was equipped for instrument flight. During the flight towards Gothenburg the pilots used the VOR station HAR as a navigational reference. They were aware of the fact that they must obtain clearance from the air traffic controller before they were allowed to fly within the controlled airspace surrounding Gothenburg/Landvetter airport. They were of the opinion that the air traffic controller had issued such a clearance in connection with their initial contact with Gothenburg Control when they were cleared to continue at an altitude of 3,000 feet (914 m); since the route of flight to Säve implied a penetration of the terminal area. (See depiction below.)

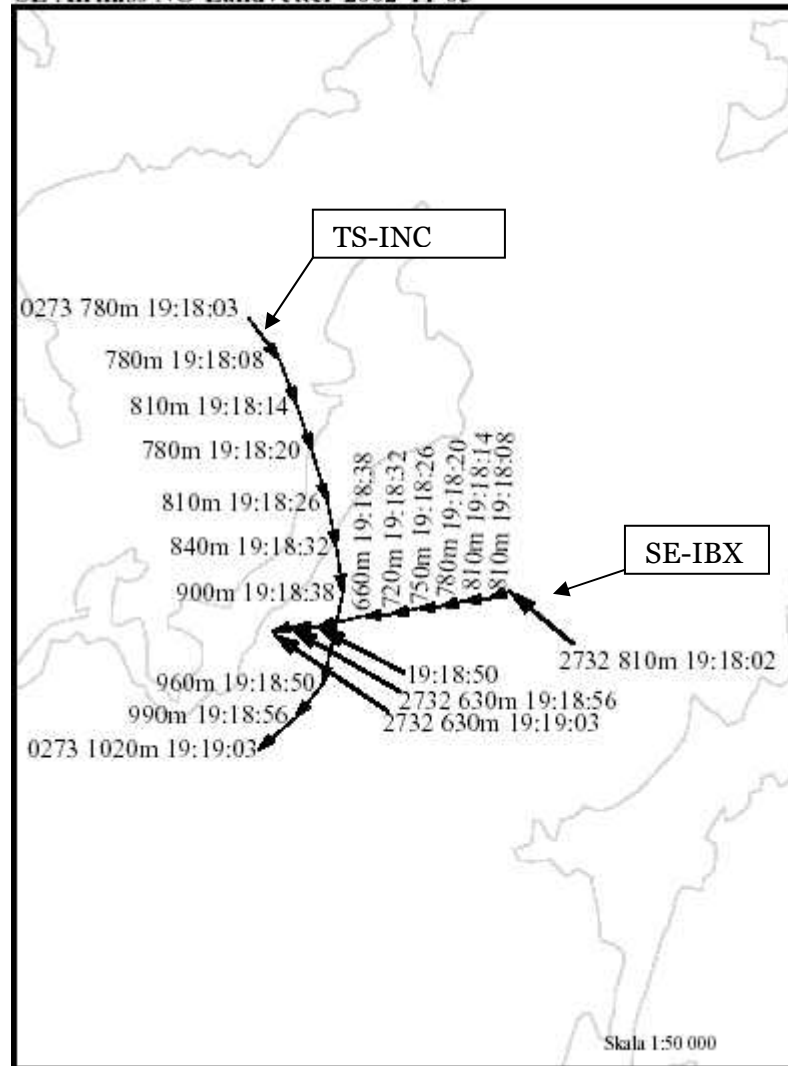
SE Airmiss NO Landvetter 2002-11-05

The incident occurred approximately 20 km north of Gothenburg/Landvetter airport at approximately 984 meters above ground level. The flight paths of both aircraft have been recorded by MUST and are presented below.

It has been calculated from the recording that the minimum distance between the two aircraft was 117 meters horizontally and about 300 meters vertically and this occurred at time 19:18:42. At that time aircraft TS-INC had a ground speed of 320 km/h and had initiated a climb. Aircraft SE-IBX had a ground speed of 160 km/h and had initiated a descent. When the aircraft were at the same altitude of 3,000 feet (914 m) they were approximately 1 NM (1,852 m) from each other.
