Wiper failure, Accident involving aircraft SE-RDL at Londonderry/Eglinton Airport, U.K., on 18 July 2003

Report RL 2004:30e

**Accident involving aircraft SE-RDL
at Londonderry/Eglinton Airport, U.K.,
on 18 July 2003**

Case L-32/03

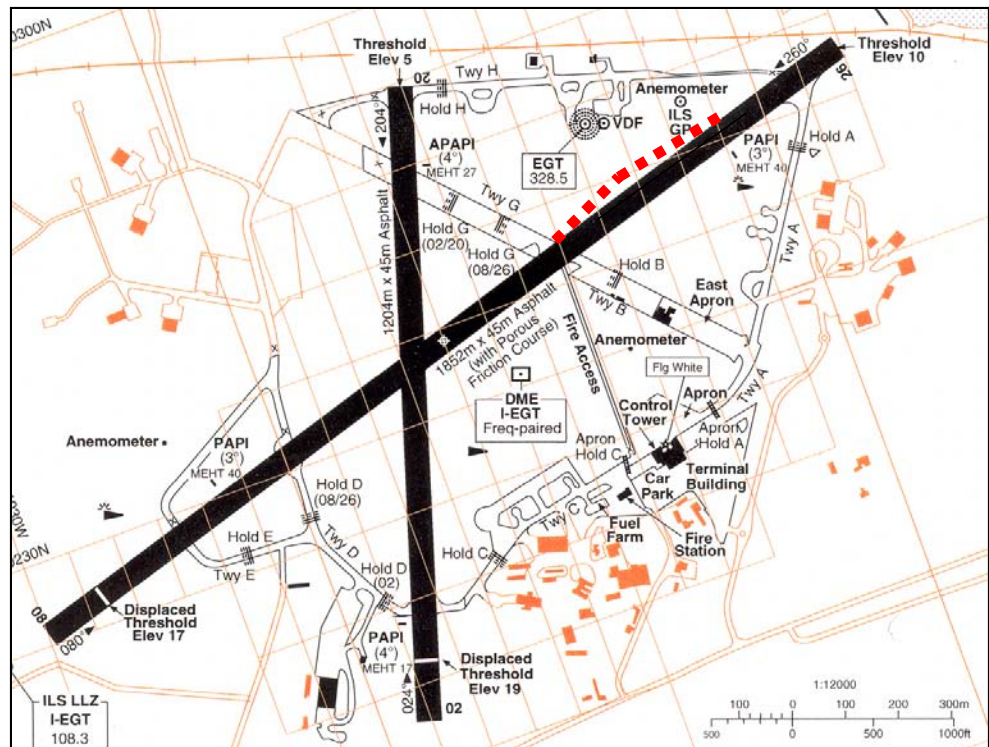
The accident occurred during landing at Londonderry/Eglinton Airport, runway 26. Approximately 270 m from the runway threshold the aircraft's

right main wheels ran off the edge of the runway. The aircraft then rolled with the right undercarriage on the grass alongside the runway and the nose wheel on the gravel surface for approximately 370 m before all the main wheels had returned to the runway (see below).

Runway excursion

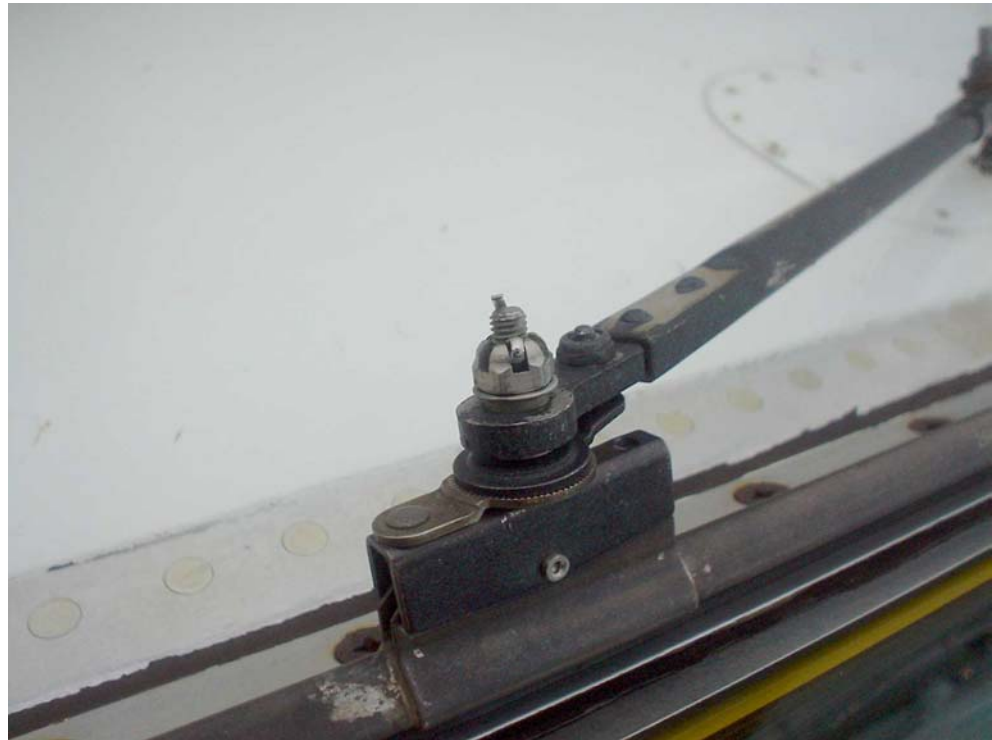
The windscreen wiper is fixed to the wiper arm with a bolt and locking nut. The contact surface is provided by two knurled washers, permitting adjustment of the blade at fixed angles in relation to the wiper arm (see photo).

In the technical examination carried out after the Accident, it was found that, with moderate force, the wiper blade could be turned in relation to its arm, and that the locking nut could be tightened a further two flats (120°) after the split pin was removed.

Apart from periodic checking of windscreen wiper function in connection with inspection on the ground, there is no prescribed check of the wiper blade lock onto its arm.

Mounting of the windscreen wiper

- to act internationally for the harmonisation of ICAO recommended standards with the Swedish standards for standard settings of high-intensity approach and runway lights and if not possible, to act for the harmonisation of the Swedish standards with ICAO recommended standards (*RL 2004:30e R1*).
- to ensure that periodic functional checks of windscreen wipers on aircraft in commercial traffic are carried out under “load” (*RL 2004:30e R2*).

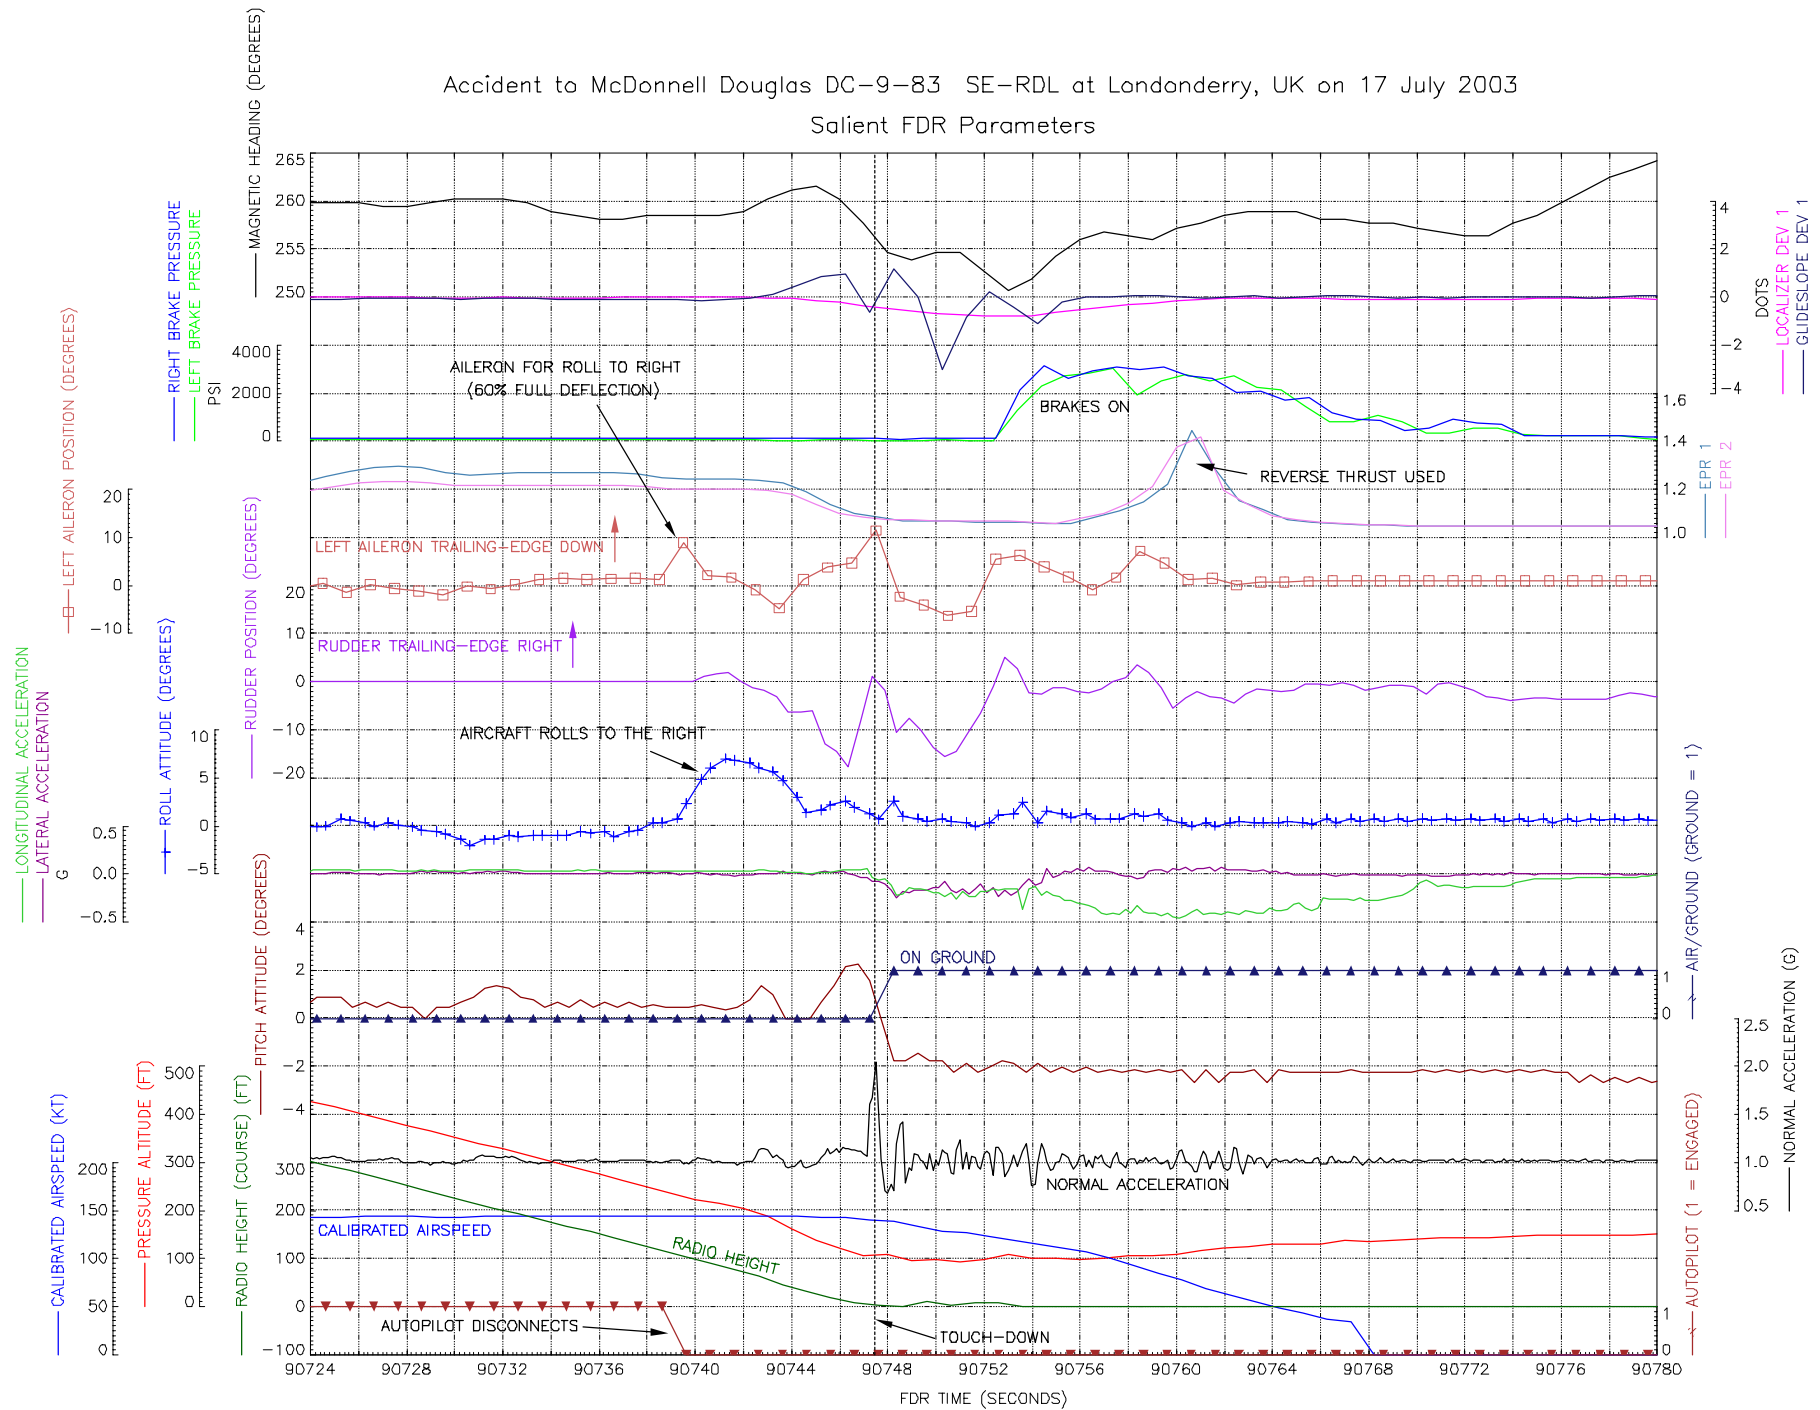
Salient FDR Parameters

The DFDR data shows that the calculated speed on touchdown was approximately 140 knots and that the course was 256°. The stretch along which the right main wheel was outside the runway was measured as 370 m. Using recorded G forces in the horizontal plane and assuming that the touchdown was with the right main wheel 18 m to the right of the centre-line, it was calculated that, on touchdown, the aircraft had a lateral speed (at right angles to its length) of about 13 m/s.
