## Runway excursion, Incident involving aircraft SE-DNU at Ängelholm Airport, M county, Sweden, on 15 April 2004

## **Report RL 2005:14e**

**Incident involving aircraft SE-DNU  
at Ängelholm Airport, M county, Sweden,  
on 15 April 2004**

Case L-06/04

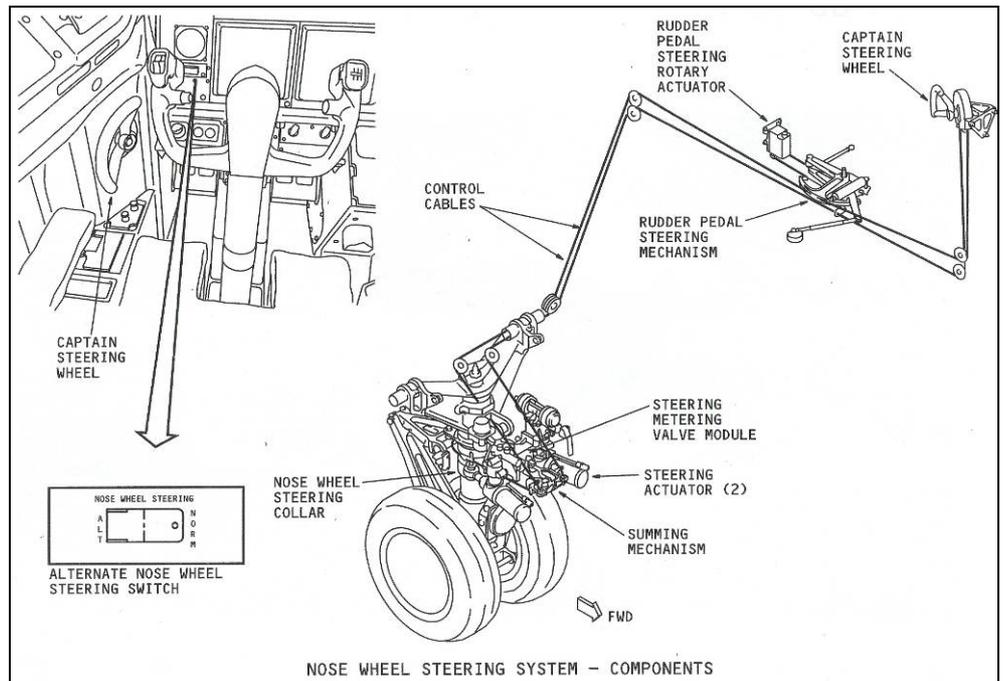
*Nose Wheel Steering System*

The manufacturer's view is that these cases, including the present incident, were caused by a momentary jam in the nose wheel steering control system, the "steering control loop". The example given is that a very small debris in the hydraulic system can cause a 'pilot valve' in the Steering Metering Valve Module to jam momentarily, whereupon the nose wheel turns. The fault disappears of its own accord during further steering or in connection with troubleshooting, when it is assumed that the debris is washed away. The system then functions without remark.

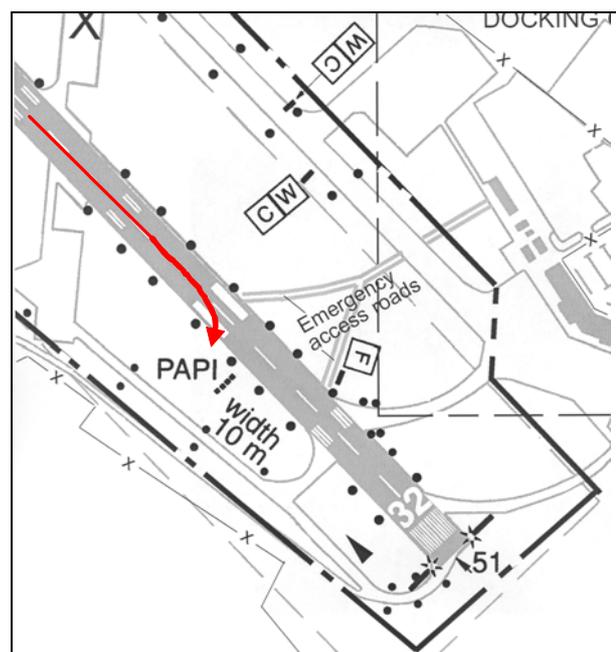
Site of occurrence

The aircraft left runway 14 to the right about 300 metres from the further threshold. From the centre of the runway, approximately 120 metres from where the aircraft finally ended up, rubber skid marks from the nose wheel and left main wheel can be clearly seen.

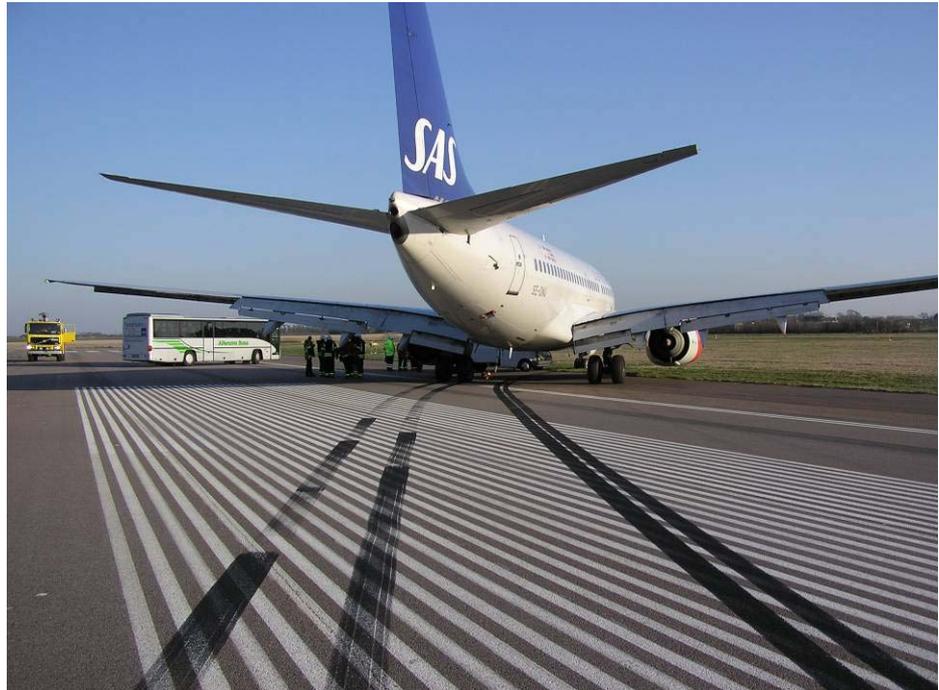
*The aircraft*

The aircraft was undamaged. It stopped with the nose wheel on the grass about one metre from the runway verge and the main wheels approximately on the verge.

Wear marks on the nose wheel and left main wheels showed that they had been subjected to strong lateral forces and braking forces in connection with the aircraft's leaving the runway.

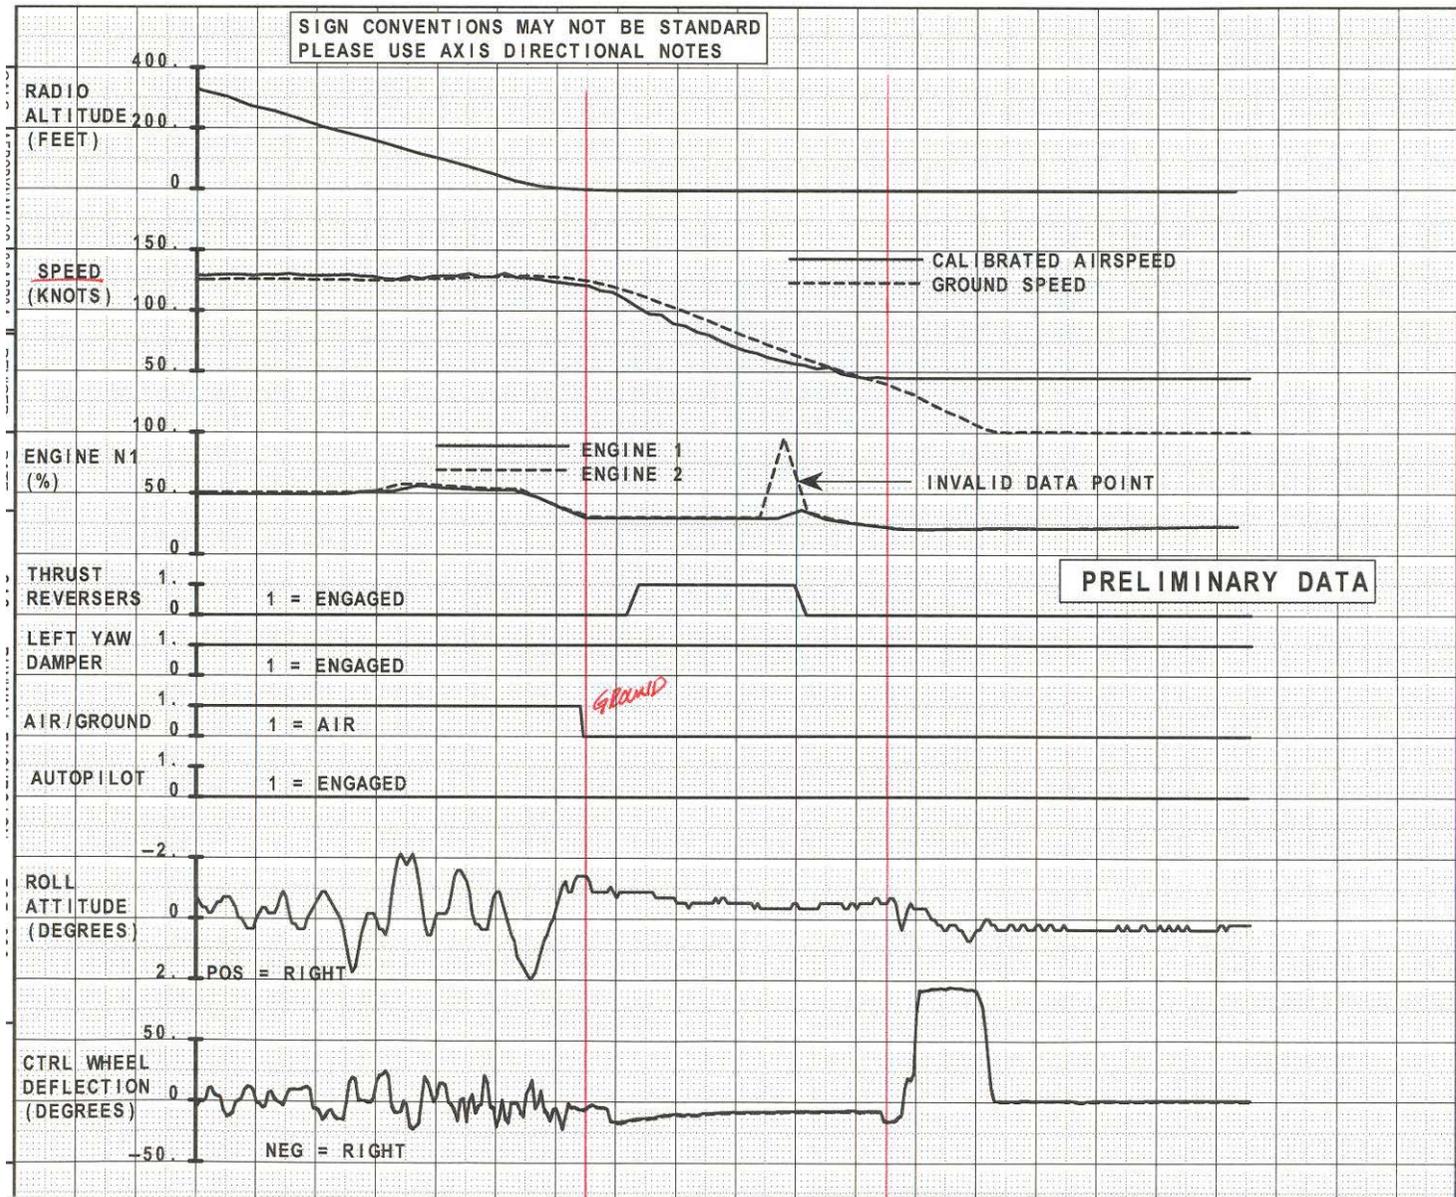
FDR diagram

It can be seen from the diagram that, about 25 seconds after touchdown, the aircraft started to yaw markedly to the right. Calculated speed was then about 40 knots. Shortly thereafter the rudder was turned to the left and heavy braking was applied to the left main wheel. The yaw to the right continued and stopped when the aircraft came to a standstill on a magnetic course of about 174 degrees.
