Runway excursion after landing, involving a Boeing 747SP, B-18253, at Chiang Kai-shek International Airport on September 2, 1999

Aircraft Incident Report

Number: ASC/AIR-2000/01

Occurrence: Runway excursion after landing

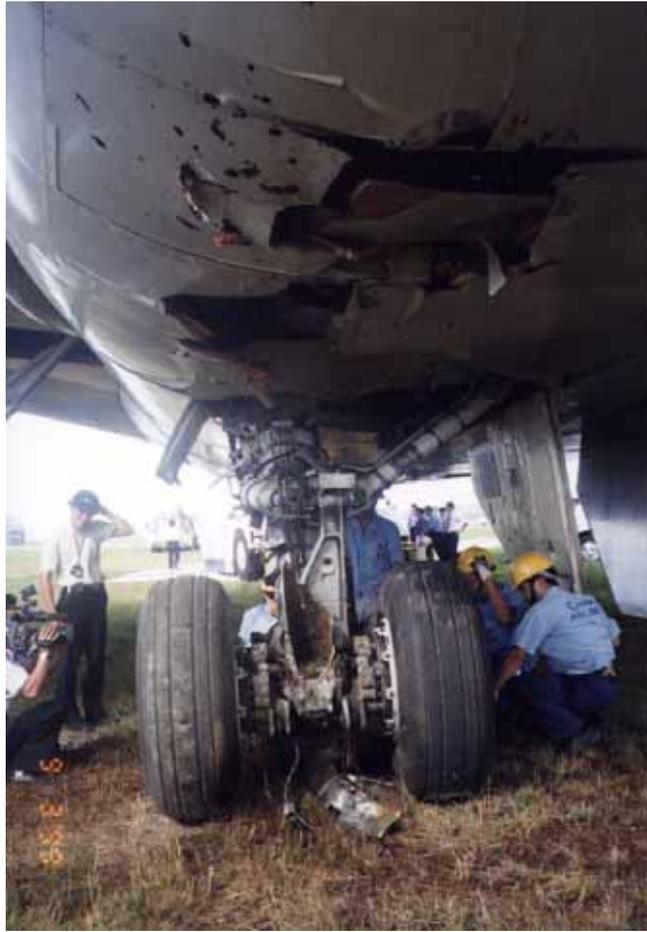
Fig. 1-1 Damage to Fuselage

A 26ft x 10ft lower fuselage skin immediately adjacent to the left body gear, including the hydraulic lines, were damaged (Fig. 1-1). Some parts of the nose gear assembly and both nose tires were damaged (Fig. 1-2). The axles of the front and rear trucks of the left body gear were snapped (Fig. 1-3 & 1-4). Scrubbed marks were found at the bottom of #1 engine cowling. Please refer to Fig. 1-5 & 1-6 for the outlook of the aircraft and gear locations.

1. Bulkhead at left lower fuselage STA 1480 was torn or deformed;
2. Fairing panel support at lower fuselage STA 1480 was cracked and deformed;
3. Skin between #38 and #41 frames at left fuselage from STA 1480 to STA 1740 was cracked, wrinkled or dented in varying sizes, while the frames and stringers were also snapped, dented and deformed in varying degrees;

4. Skin between #42 and #45 frames at left fuselage from STA 1740 to STA 1800 was cracked, wrinkled or dented in varying sizes, while the frames and stringers were also snapped, dented or deformed in varying degrees;

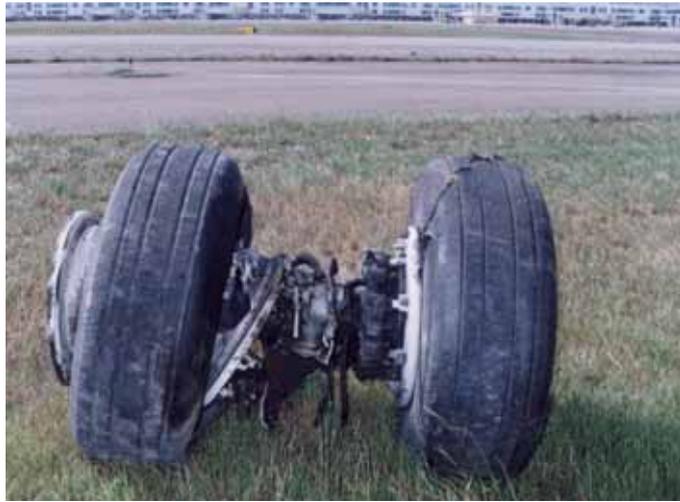
Fig. 1-3 Damage to Front Truck of Left Body Gear

1. Front truck: The front truck was separated from the gear, and found 5 meters to the left of the manhole. The axle snapped at a 45° angle, severing the cables and hydraulic lines (Fig. 1-22).
 - Left front wheel (#5) : The flange was separated from the hub, and the brakes were squeezed as a result. The inner tire bead was broken and blow off from it's seat, while the outer tire bead was push off it's seat and shifted inward. A 45° gash was found to run across the tread, from the inner sidewall to outer sidewall, causing the tire to deflate.
 - Right front wheel (#6) : The inner hub was slightly deformed. The brakes appeared to be normal. Cut at a oblique angle, the tire was deflated.

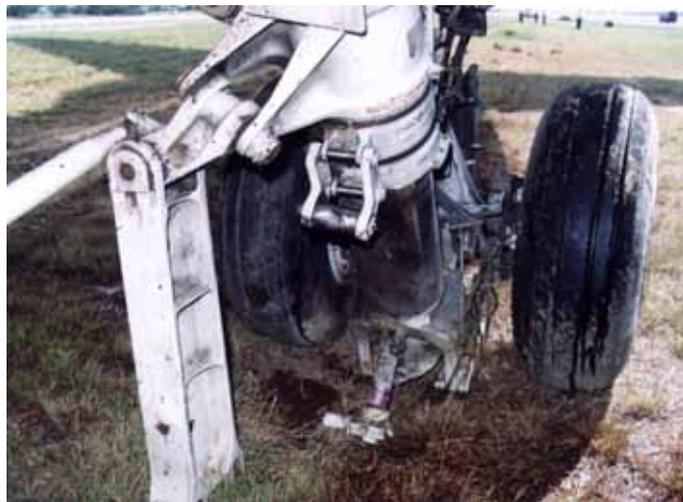
Fig. 1-4 Damage to Rear Truck of Left Body Gear

- Rear truck: The axle snapped at a 45° angle (Fig. 1-23).

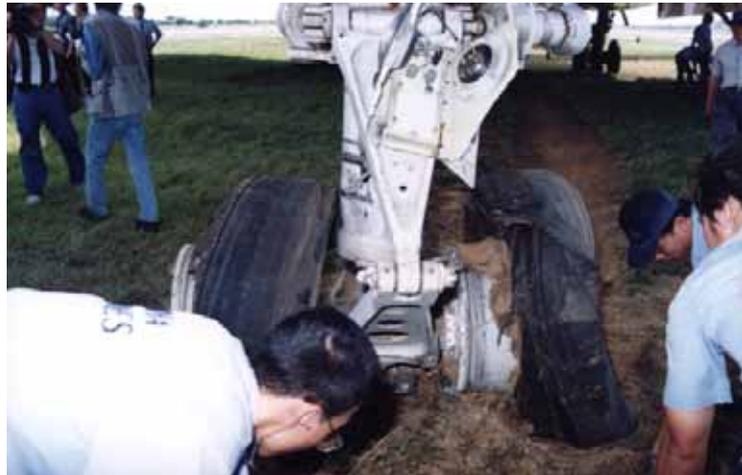
Fig. 1-7 Landing Light Separated

1. Nose gear: No visible damage to the structure and shock strut. The landing light was separated, while the squat switch was deformed and displaced (Fig. 1-7).

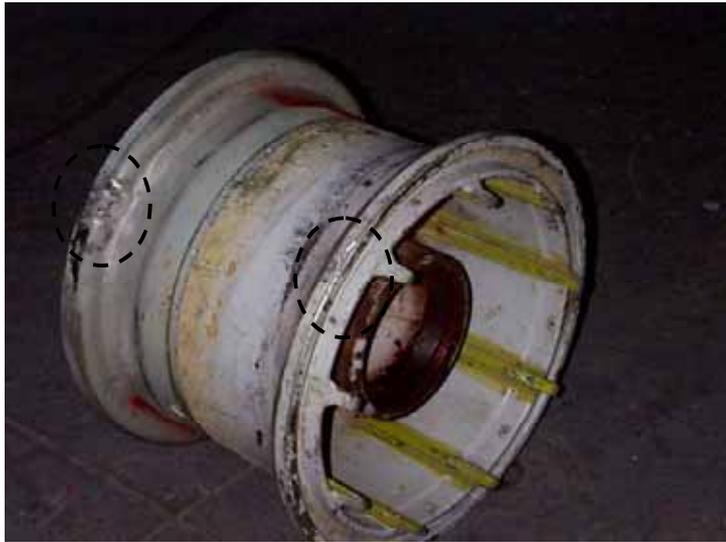
2. Left nose wheel hub: Spot-like abrasion marks were found on both left and right flanges at about the same height (Fig. 1-8). Spots where both flanges (Fig. 1-9 & Fig. 1-10) were impacted were dented and deformed. The right side of the hub was covered with mud (Fig. 1-11).

Fig. 1-8 Spot-like Abrasion Marks (circled areas)

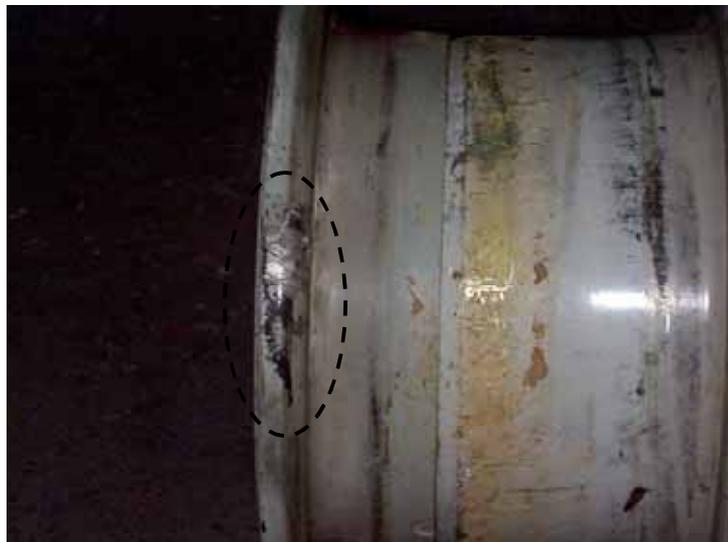
Fig. 1-9 Left Flange Dented and Deformed (circled area)

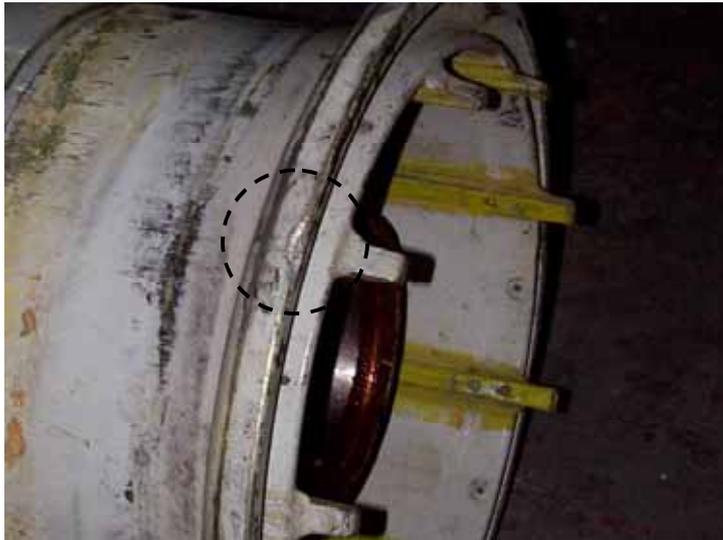
Fig. 1-10 Right Flange Dented and Deformed (circled area)

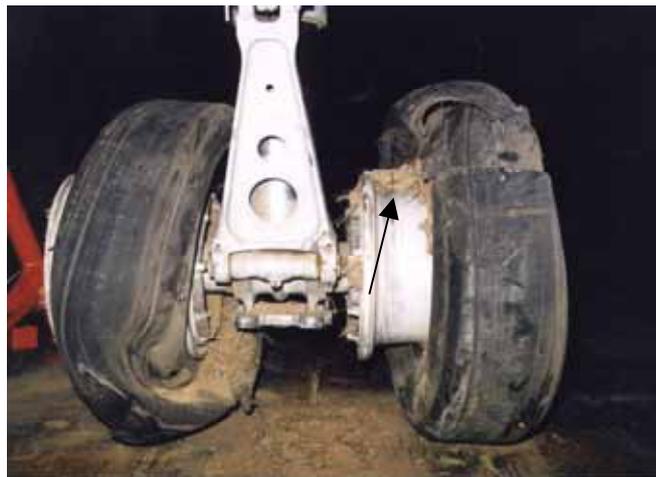
Fig. 1-11 Left Wheel Hub Covered with Mud (pointed area)

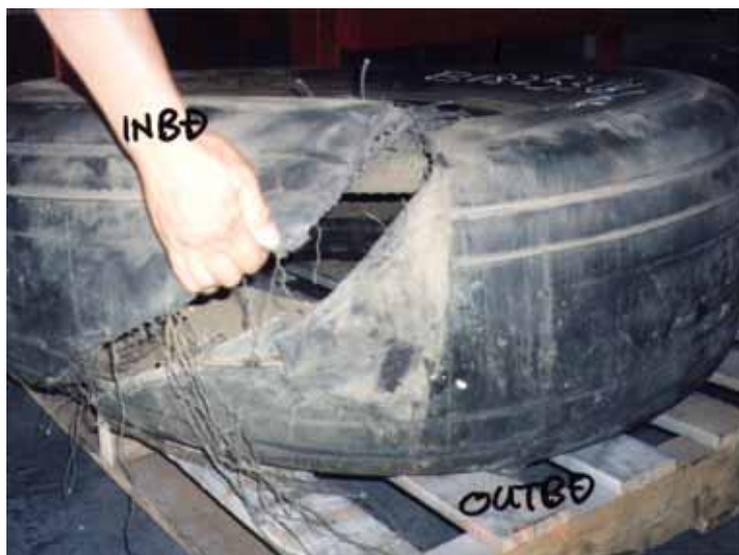
3. Left nose tire: Cracks on the right sidewall was straightly parallel with the cords. A 45° cut by foreign objects inclined from the sidewall to the entire tread, forming a 32" scratch. The dismantled right sidewall slipped to the left, and the tire is deflated (Fig. 1-12). A ring of white marks were observed on the left sidewall near the rim line (Fig. 1-13), while the entire tread was covered with abrasion marks vertical to the grooves (Fig. 1-14). A ring of

Fig. 1-12 Left Tire Damage and Tread Abrasion

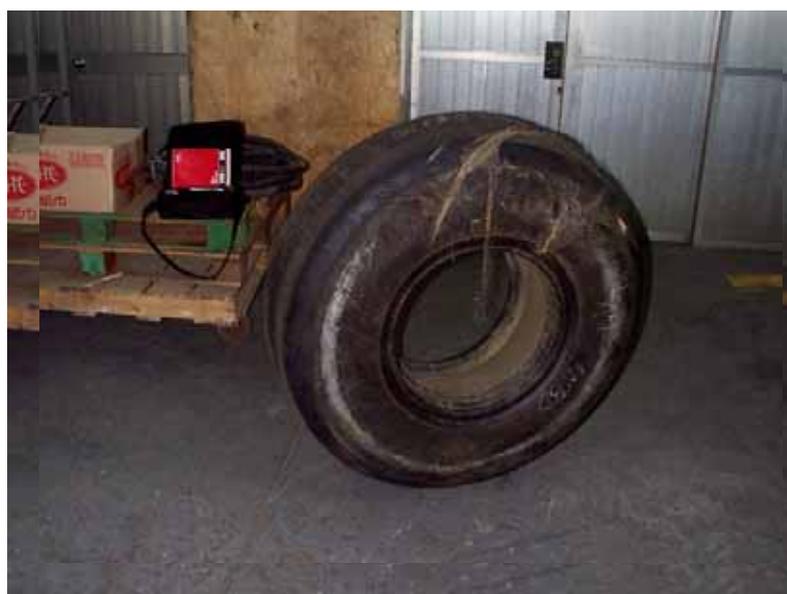
Fig. 1-13 White Marks on Left Sidewall

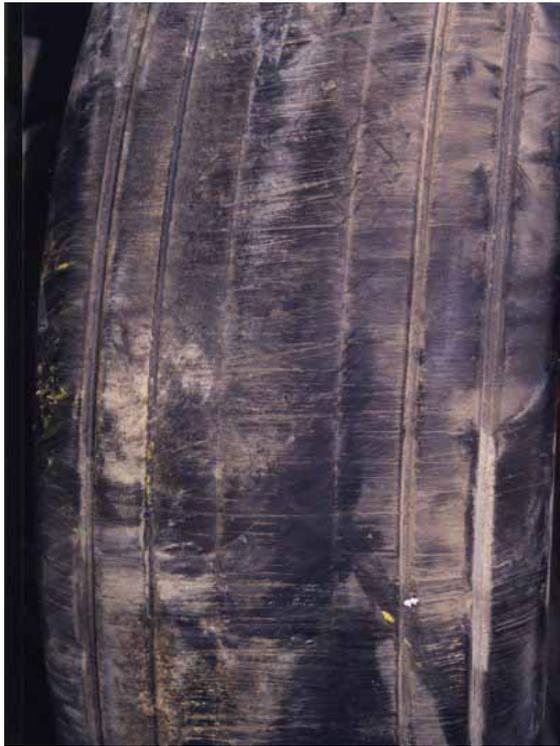
Fig. 1-14 Tread Covered with Abrasion Vertical to Grooves

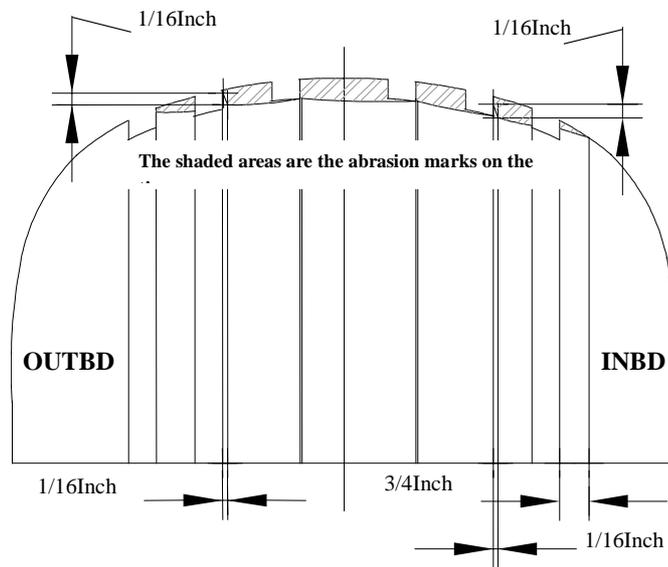
abrasion marks 3/4" in width were also observed on the right tread shoulder. The 2nd and 5th grooves from the outer shoulder were approximately 1/8" in depth, and tread rubber to the right of both grooves rose approximately 1/16" for the entire circumference, while the 3rd and 4th grooves were completely worn out. (Fig. 1-15).

Fig. 1-15 Wear on Left Tire Tread

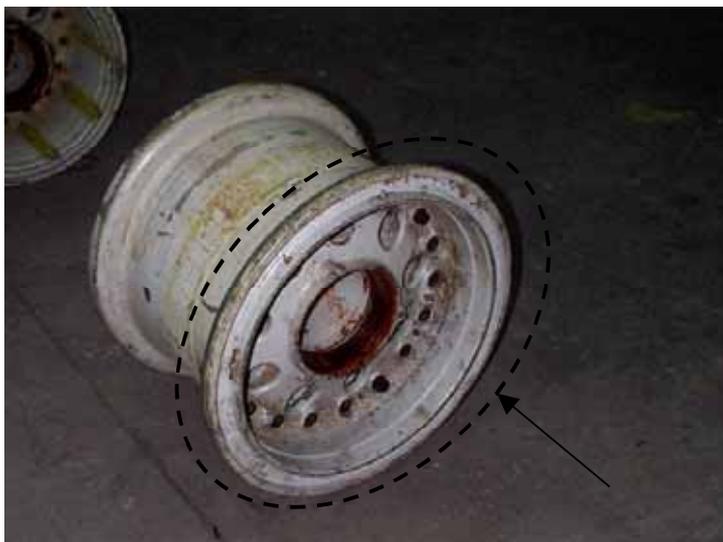
4. Right nose wheel hub: Scratch marks were found on the deformed right flange (Fig. 1-16). The hub was covered with mud (Fig. 1-17).

Fig. 1-16 Deformed Flange

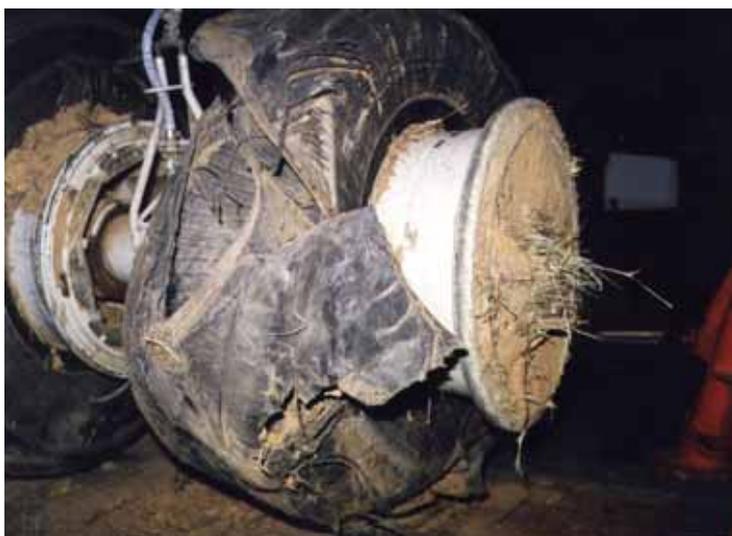
Fig. 1-17 Hub's Right Side Covered with Mud

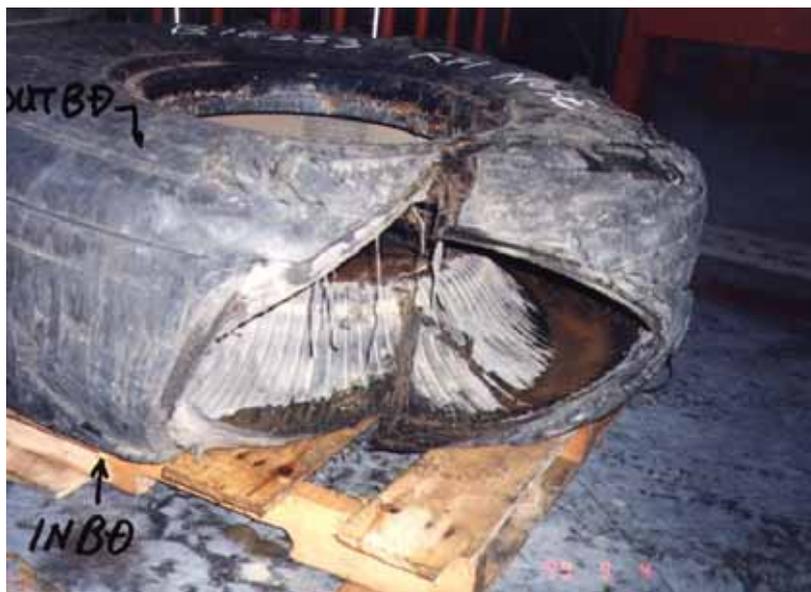
5. Right nose tire: Bulged, delaminated tire surface and 6” to 12” cuts caused by foreign objects were found on the right sidewall which slipped off the nose gear hub to the left. Abrasion marks covered the entire right tread shoulder, and extended to the right sidewall. A 24” kite-shaped tread was ripped off the tire, creating an 18” hole (Fig. 1-18) where white marks were found on the right-hand side edge. Immediately in front of the hole on the tread was a fan-shaped abrasion mark, the depth of which decreased as it extended from right to left (Fig. 1-19). Similar to those seen on the right wheel, abrasion marks vertical to the grooves covered the ripped off tire casing (Fig. 1-20), which was found between the manhole and where the aircraft came to stop. The 2nd groove from the outer shoulder was approximately 1/8” in depth, and part of the tread rubber to the right of the groove rose approximately 3/16”, while the 3rd and 4th grooves were completely worn out. (Fig. 1-21).

Fig. 1-18 Damaged Right Tire and Tread Abrasion

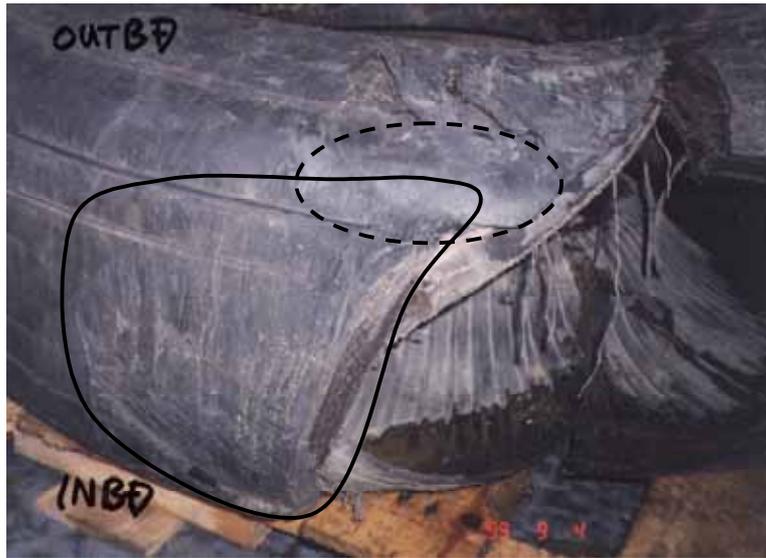
Fig. 1-19 Fan-shaped Abrasion and White Marks

(abrasion is enclosed by full line; marks are enclosed by dotted line)

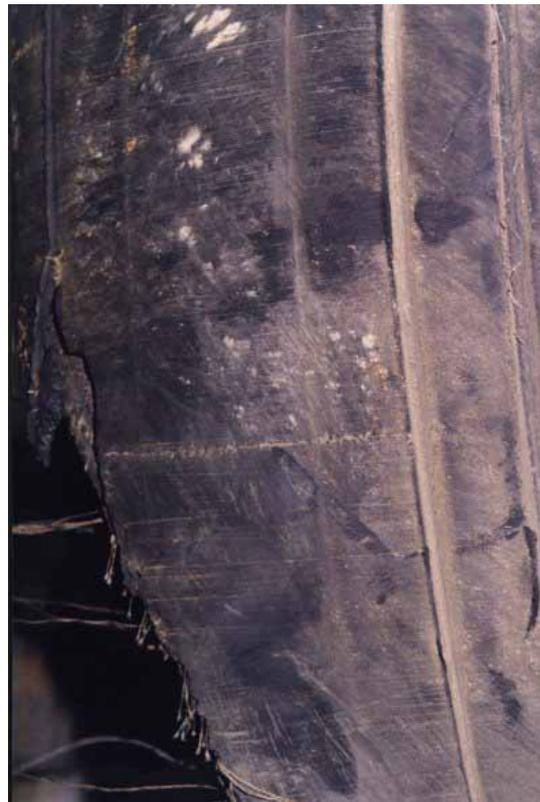
Fig. 1-20 Abrasion Vertical to Grooves

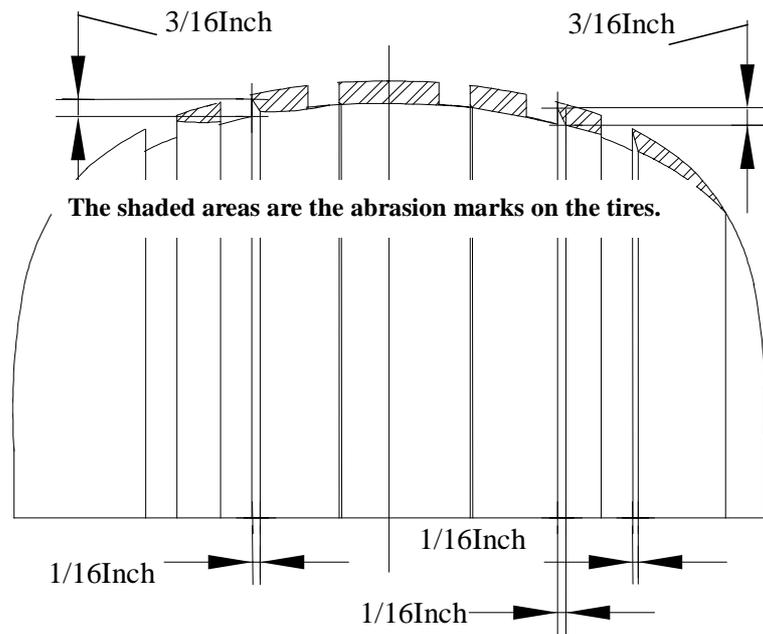
Fig. 1-21 Abrasion on Right Sidewall

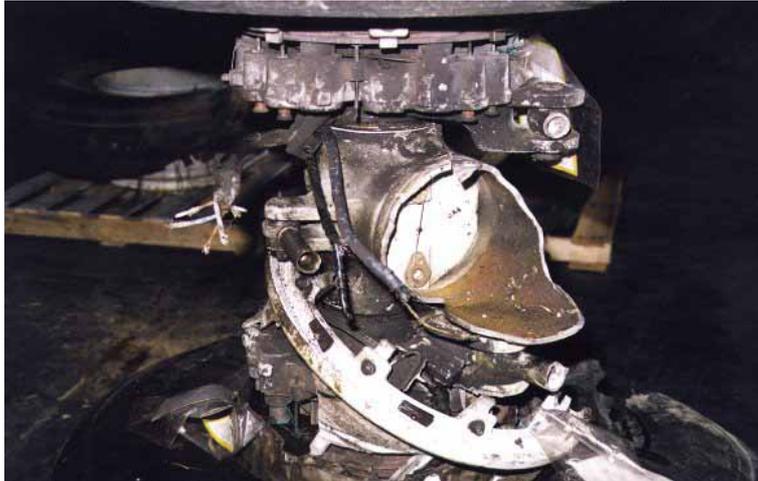
Fig. 1-22 Damage to Front Body Gear Truck

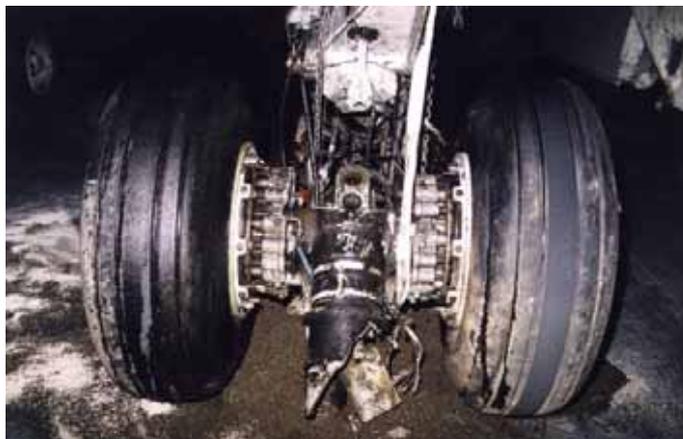
Fig. 1-23 Rear Truck Snapped at 45° Angle

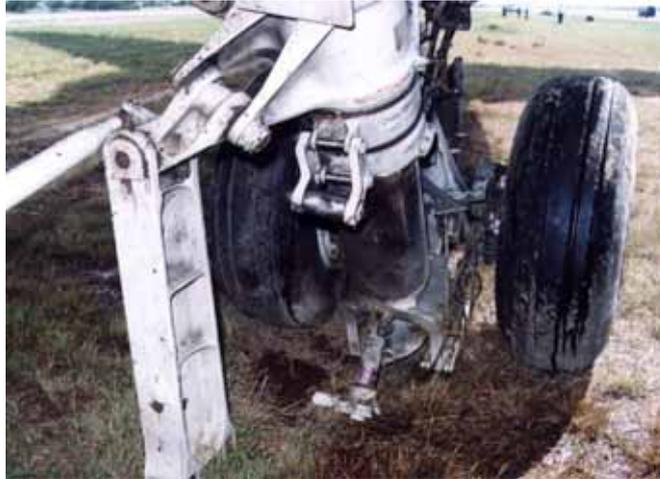
The hub, brakes and tire of #7 and #8 wheels appeared to be intact.

Tire pressure was normal (Fig. 1-24) .

Fig. 1-24 Damage to Rear Body Gear Truck

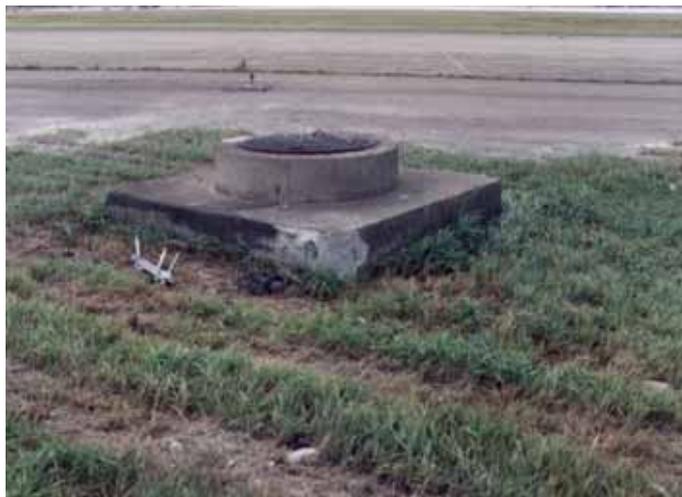
Fig 1-25 Concrete Manhole

The protruding manhole to the left of Runway 06 is an indirect cause of the occurrence. The location, structure and construction of the manhole failed to meet both domestic specifications, as well as those recommended by the International Civil Aviation Organization (ICAO), causing serious damages to the deviated aircraft when its landing gear collided with the manhole.

The protruding concrete manhole located on the grass strip adjoining Runway 06 and Taxiway S5 can be seen on Fig. 1-25. Collision marks caused by foreign objects and a band of black rubber deposits were found on the side of the manhole facing Taxiway S5 (Fig. 1-26). Two taxiway lights were damaged by the wheels.

3. The CAA should examine if the location, design, construction and structure of all fixed structures (including concrete manholes) around the runway strips at CKS Airport are in compliance with international standards, so as to protect the safety of any deviated aircraft; and
4. The CAA should assess whether the transverse slopes of the runway strips at CKS Airport are in compliance with specifications recommended by the ICAO, so as to protect the safety of any deviated aircraft.

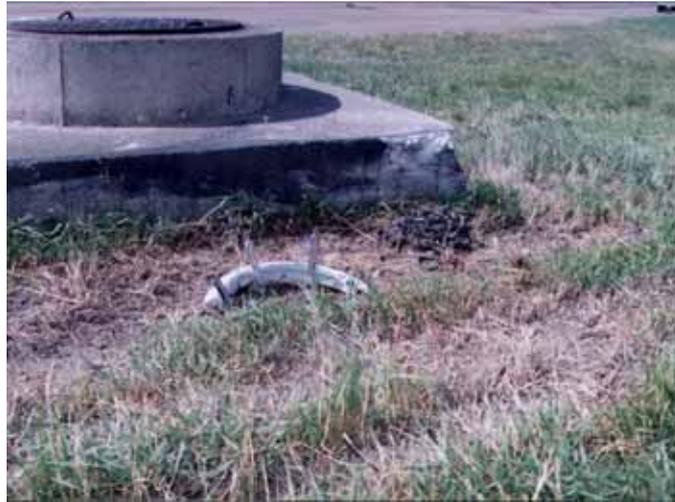
Fig. 1-26 Abrasion Marks and Rubber Deposits

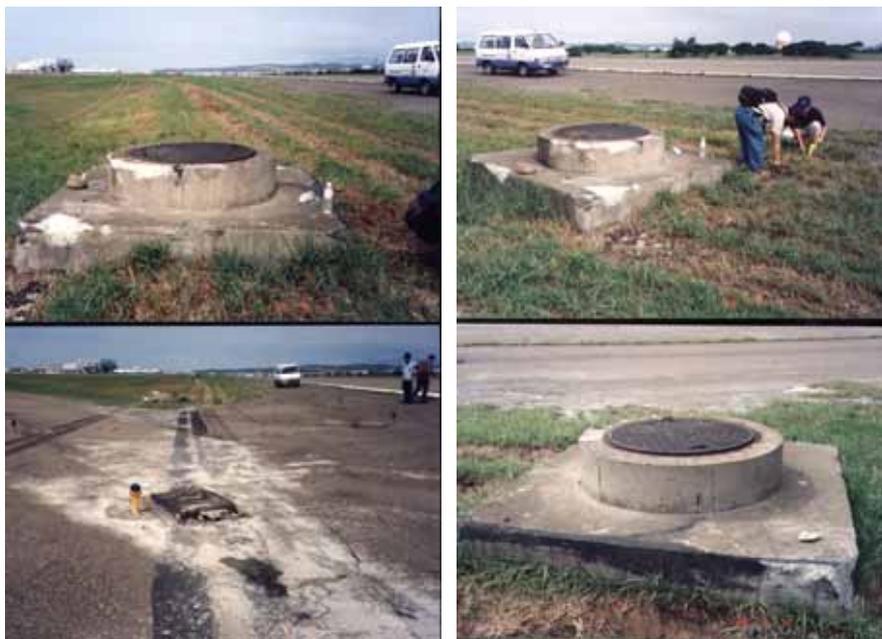
Grassed areas around the manhole slope at a 10° to 12° angle.

Fig. 1-30 Manhole Struck by Nose Gear

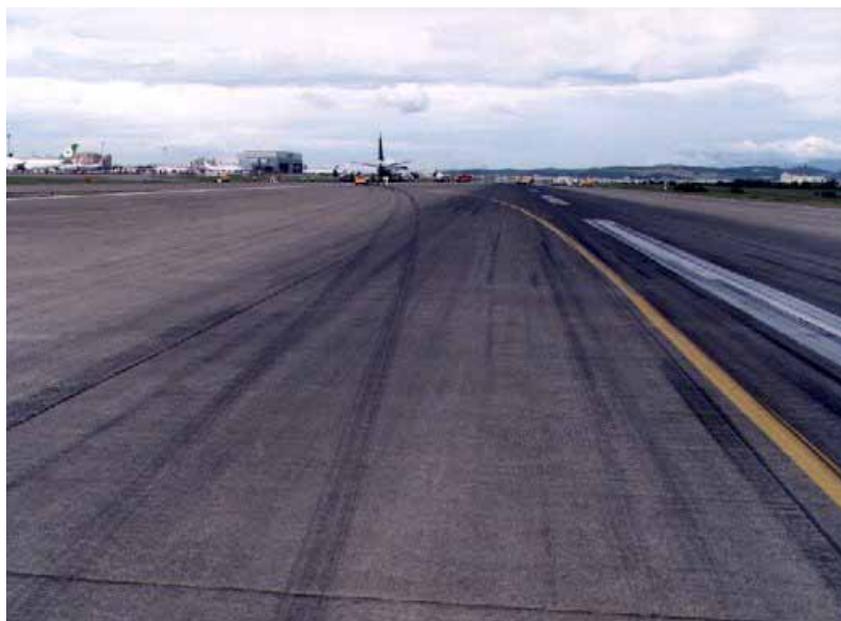
- Nosewheel: Two strips of dark nosewheel tracks were discovered after the aircraft deviated from the runway's centerline. The track left behind by the right wheel was visibly darker and wider.
- Mainwheel: No tracks were discovered at this time.

Fig. 1-33 Ground track between 0-150 meters.

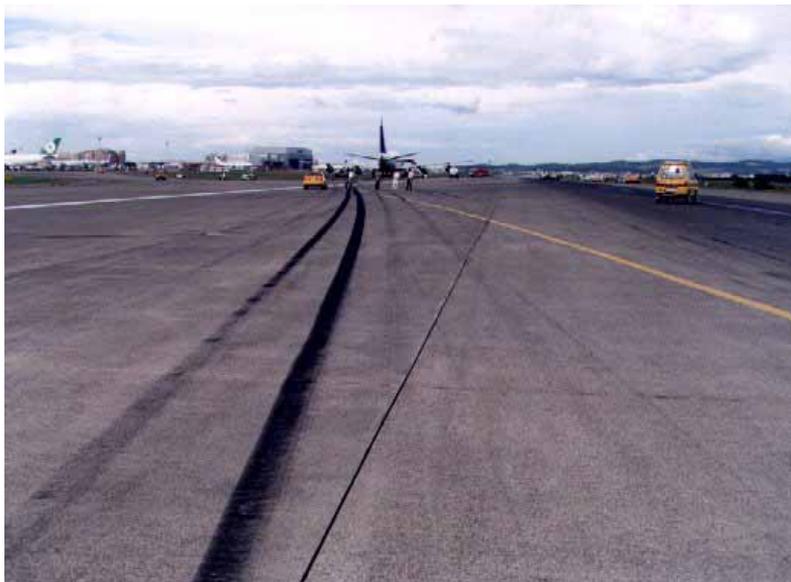
- Nosewheel: The right nosewheel track was widened and became darker in color; the right half side of the track started to become less visible. The track distance between the two nosewheels was narrower gradually.
- Mainwheel:
 - Right Body Gear: Two traces of lightly visible wheel tracks started to appear.
 - Right Wing Gear: No tracks were discovered.
 - Left Body Gear: Two traces of lightly visible wheel tracks started to appear.
 - Left Wing Gear: No tracks were discovered.

Fig. 1-34 Ground track between 150-180 meters.

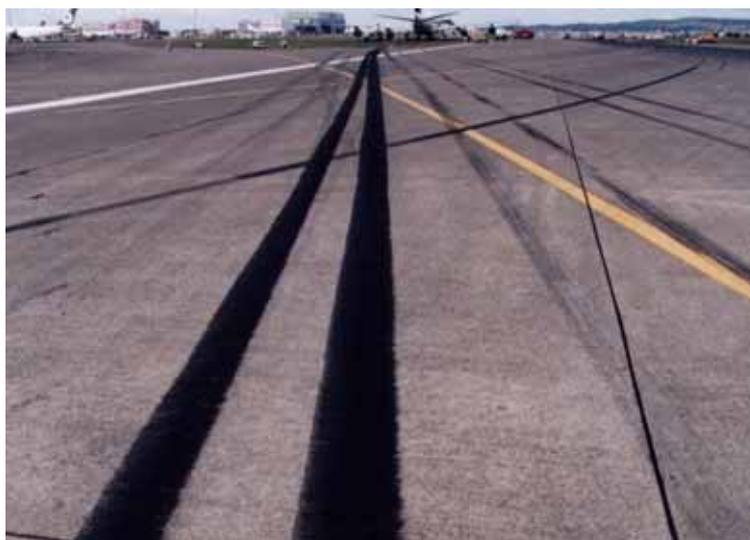
- Nosewheel: The left nosewheel track was darker and wider. The right nosewheel track was wider than the left nosewheel track. The track distance between the two wheels was narrower gradually.
- Mainwheel:
 - Right Body Gear: The two tracks became darker in color, with alternating dark and light strips in the tracks.
 - Right Wing Gear: Two strips of wheel tracks started to become visible and evident.
 - Left Body Gear: The two strips of wheel tracks started to form into four strips of smooth wheel tracks.

Fig. 1-35 Ground track between 180-250 meters.

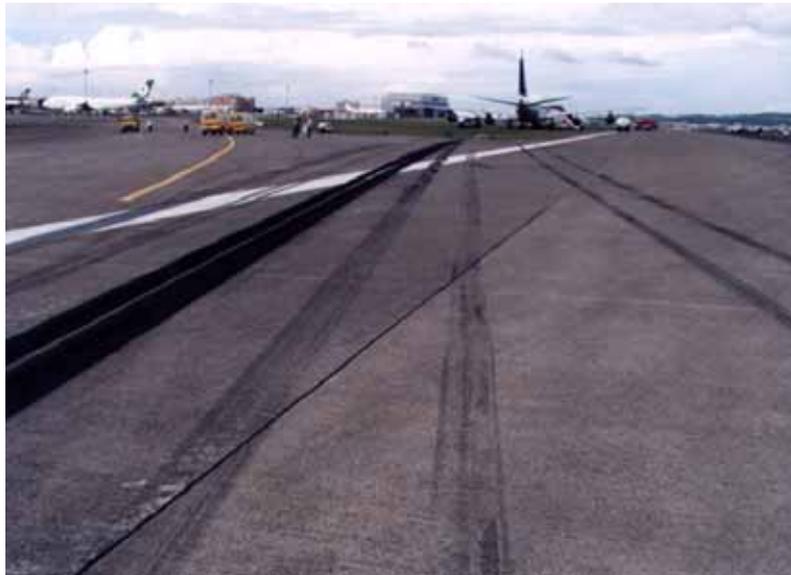
- Nosewheel: The left and right nosewheel tracks continued to be wider and become darker. The gap continued to become smaller.
- Mainwheel:
 - Right Body Gear: The two strips of wheel tracks were overlapped by another two strips of wheel tracks, and their colors became darker.
 - Right Wing Gear: Two strips of wheel tracks were clearly visible as was before.
 - Left Body Gear: The four strips of wheel tracks were smooth and the distance between them widened.

Fig. 1-36 Ground track between 250-325 meters.

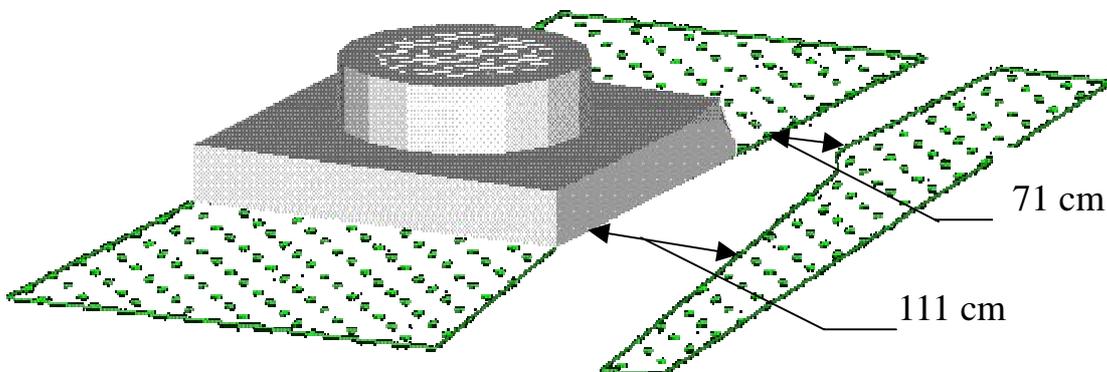
After running off the runway, the nosewheel left a 111-cm wide track on the grass area, and scrapped a protruded concrete manhole. The nosewheel left a 71-cm wide track (Fig. 1-38) on the grass area after it cleared off the protruding manhole.

Fig. 1-38 Nosewheel tracks on the grass area.

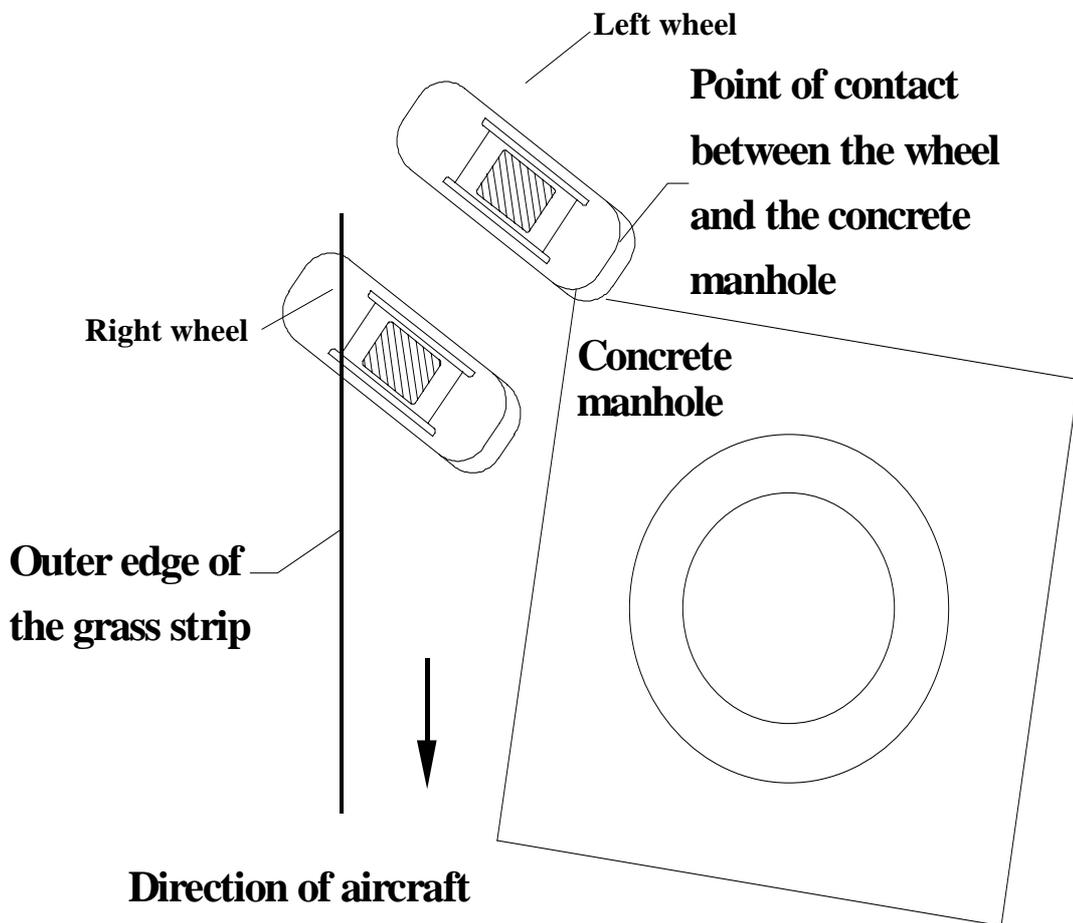
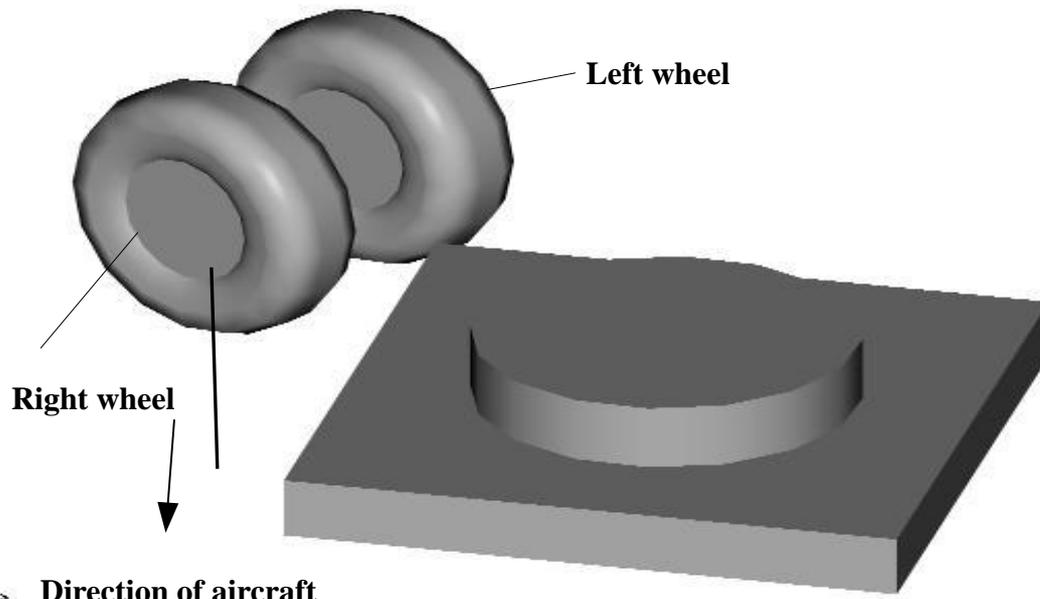
As shown in Figures 2-6 and 2-7, the right side of the left wheel came into collision with the concrete manhole. From the wreckage, a rupture of the right sidewall due to collision with a foreign object was discovered, where the cut was parallel to the base of the concrete manhole. After the collision with the base of the manhole, the left tire continued to roll and slip forward until the right wheel came into collision with the

manhole base. From the wreckage, a hub of white marks was discovered on the right sidewall of the left tire, and black tire marks were discovered on the base of the manhole. The marks should be the result of the right sidewall scrubbing against the manhole after the left tire has ruptured.

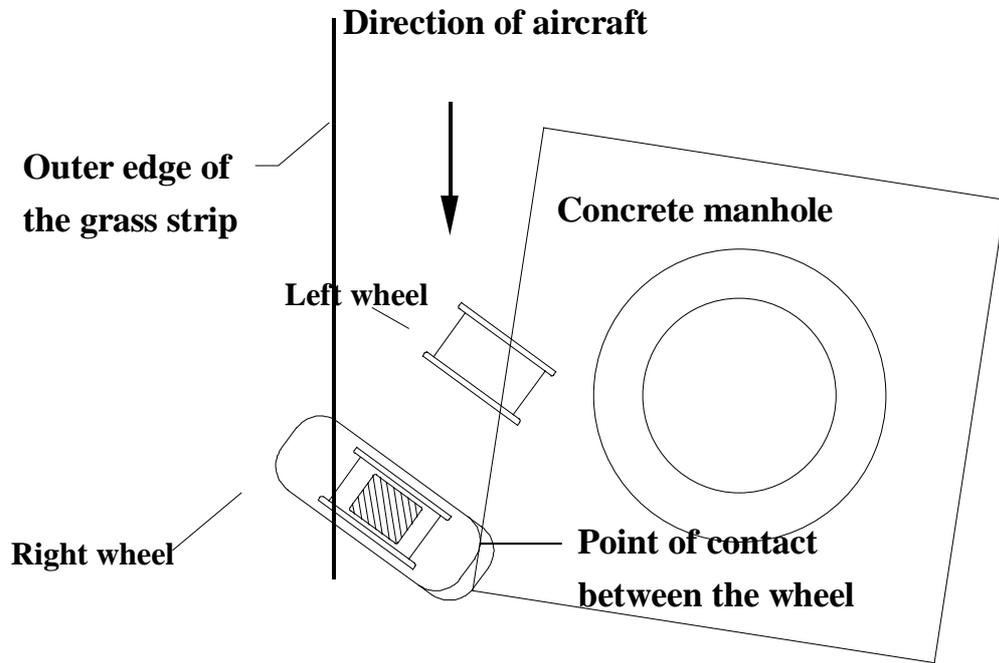
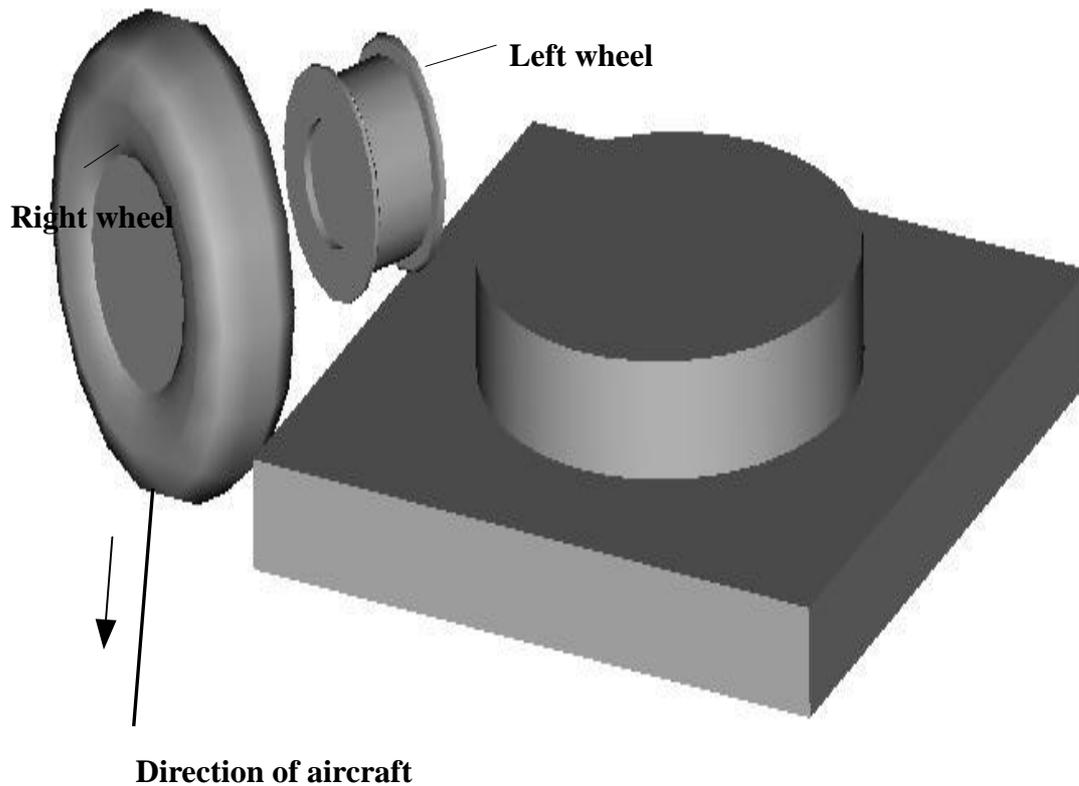
As shown in Figures 2-8 and 2-9, the right wheel left shoulder came into contact with the outer edge of the base of the manhole first; thus the remaining travel distance would only damage the tread and the left sidewall. From the wreckage, white marks were discovered on the right wheel left shoulder, which might have resulted from the collision with the base of the manhole. The fan-shaped scratch marks on the tread should be the result of the short contact between the cylindrical-shaped tread and the flat-surfaced manhole base. Since the left wheel hub was elevated due to the height of the right wheel, it was higher than the cement manhole base and therefore did not come into contact with cement base.

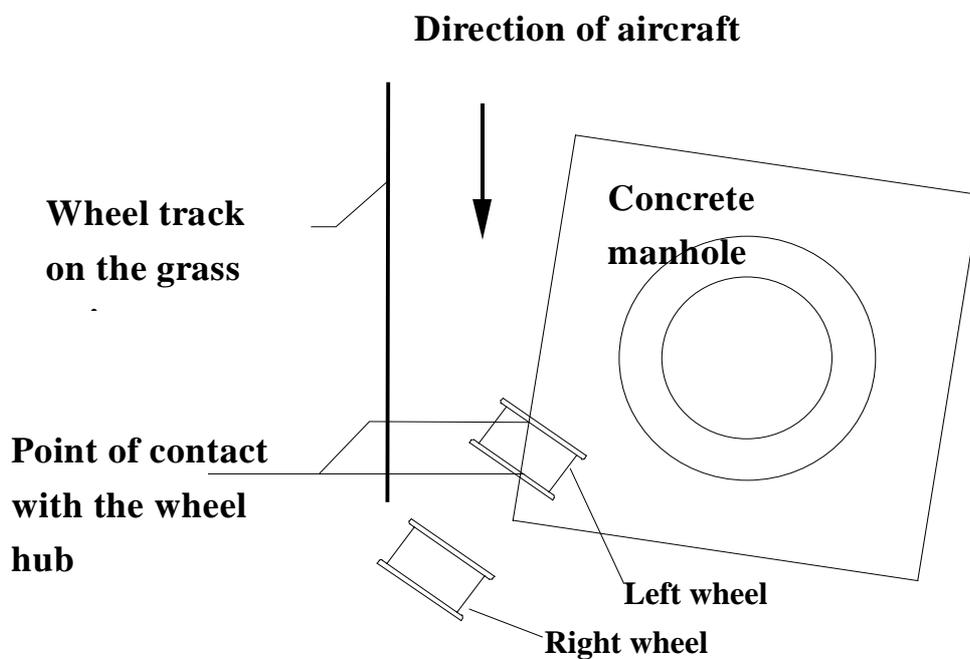
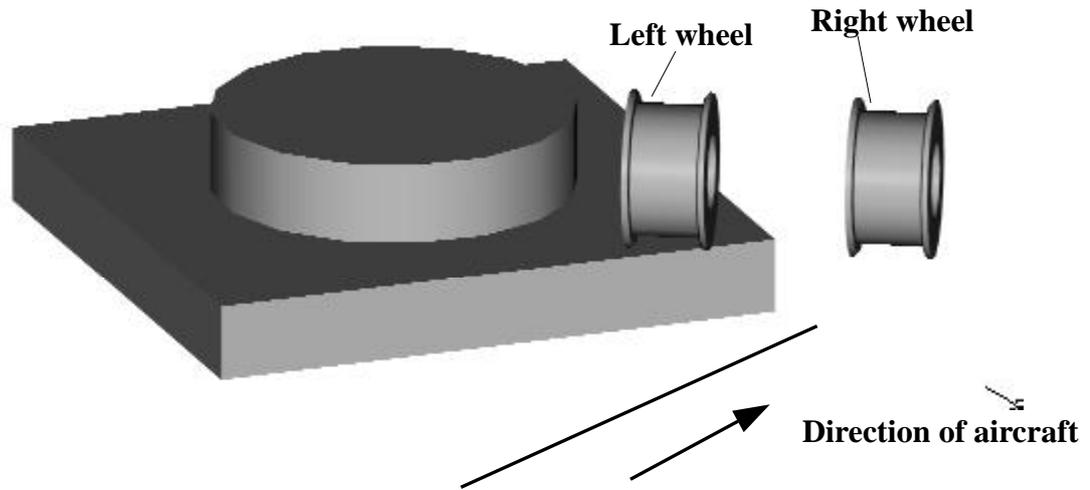
As shown in Figures 2-10 and 2-11, the height of the cement base was 29 centimeters. Since the height of the tire was 33 centimeters (according to the tire manual), the left wheel hub was supported by the right tire and did not come into contact with the cement base after the left tire had ruptured. When the right tire ruptured, the left wheel hub lowered due to the weight of the aircraft and ultimately came into collision with the cement base. This was evidenced from the dents found on the lateral

flanges of the left wheel hub, and on the broken corners found at the edge of the cement base.

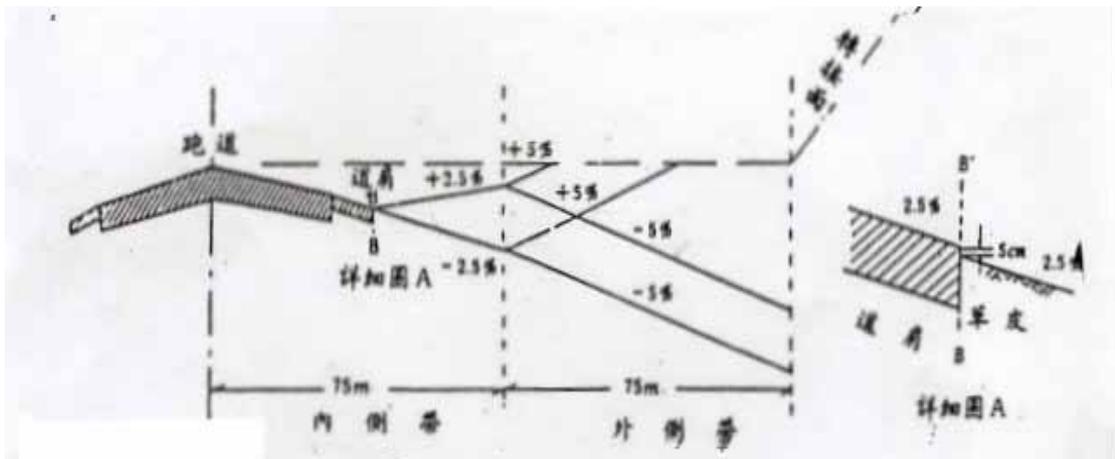
Fig. 2-14 Traverse slope of the runway strip.

The angle of elevation of the grass area as measured was -10 degrees.

The cowl of #1 engine of China Airlines B18253 came into contact with the grass surface after the aircraft ran off the runway. Thus from the physical appearance of the aircraft (Fig. 2-15) and assuming that the left wing gear ran into a grass area with the same slope, the angle of elevation of the runway's inner strip exceeded 6.9 degrees, that is, the grass areas ran over by the left and right wing gear had a difference in elevation of 134 centimeters. The traverse slope exceeded 12.1%, which does not comply with the above guideline.

Therefore, due to safety concerns, the traverse slopes of the runway strips at the CKS airport should be appropriately modified.
