Accident Investigation Report

ASC-AAR-00-11-001

MD-90-30 cabin explosion and fire

during landing roll Hua-Lien, Taiwan

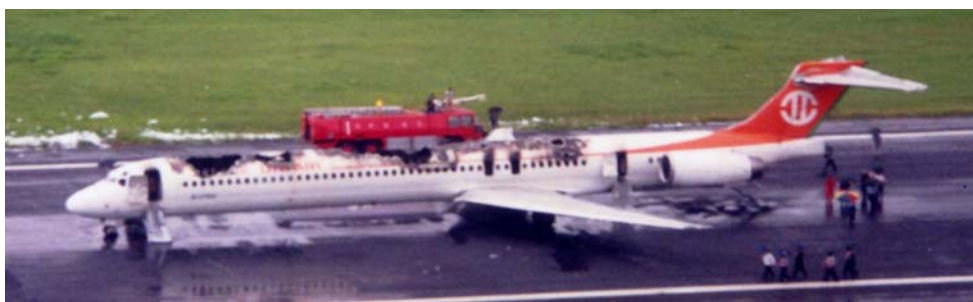
Of the 4 holes found on the fuselage, 3 were located on the left side. One was located in the front section (a large opening of 337.82cm in length), another was between rows 5~7 (a longitudinally hole of 144.78cm in length that is ripped off along the rivet line), and the third was on the rear part of the aircraft (an opening of extended space measuring 1320.80cm in length). The one hole fused out on the right side of the fuselage was found between rows 7 and 9 and above the *UNI AIR* insignia. Fragments of the keel beam, over the 7th row on the left side, were found among the debris scattered about the end of the runway. (See Pictures 1.12-1 and 1.12-2)

Fig. 1.12-1 The damaged aircraft (left side)

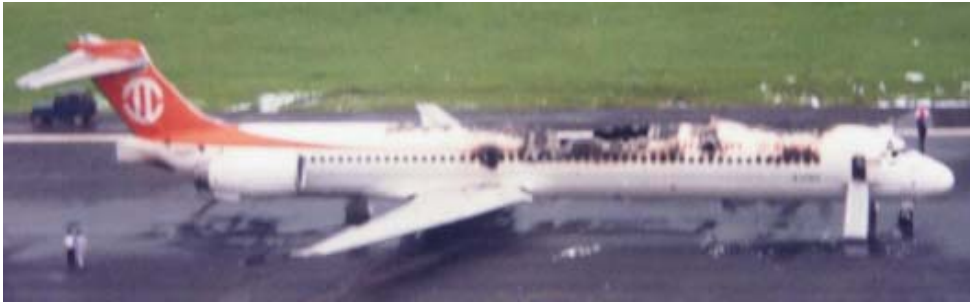
Fig. 1.12-2 The damaged aircraft (right side)

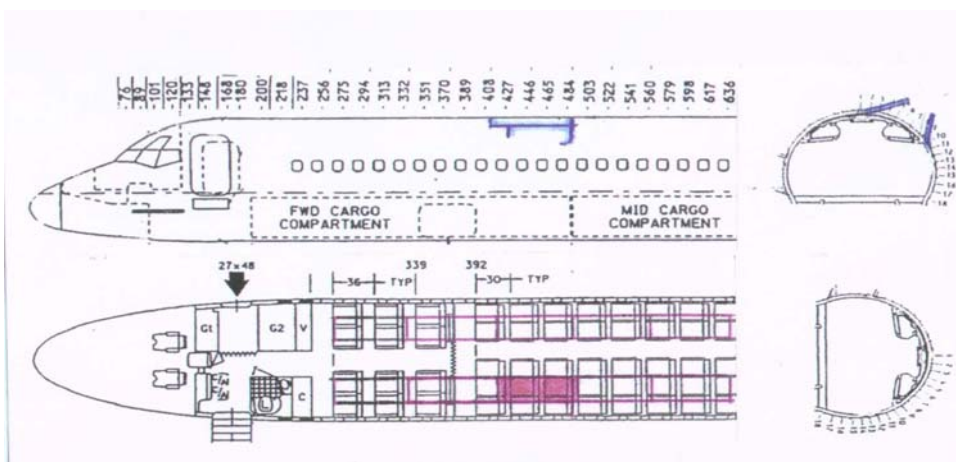
The area of the explosion is found between frameworks FS408 and FS484 of the fuselage. A sectional view shows that the explosion covered the longitudinal beams 1 through L10 on the left side, right above the carryon luggage bin over rows 5, 6 and 7 on the left side, as shown in Fig. 1.12-3.

Fig. 1.12-3 Layout of the explosion area

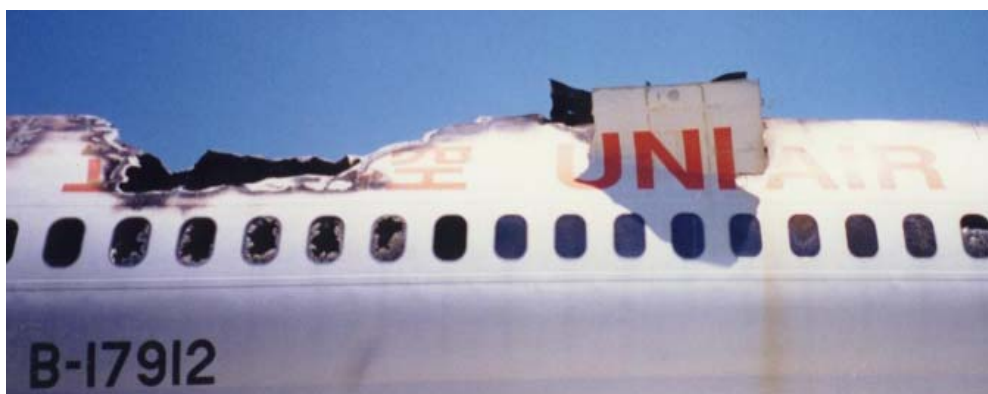
An area of ripped-off skin, within the explosion area, demonstrates an opening along the rivet perforation. Both cracks pointed upwards from the rivet perforation line, and tend to aim towards the lower left side. Also, the crack located on the left framework FS.484 stretches from L6 to L10 (some 56.9cm) and the crack on the left framework FS.427 develops from L6 through L9 (approximately 40.7cm), A part of the skin along the rivet perforation and the mid-upper section shows missing paint (indicated by the arrow, in Picture 1.12-4). The structural drawing of the aircraft shows that the ripped-off skin is located above the overhead carryon, bin above rows 6~7.

Fig. 1.12-4 The ripped-off cover

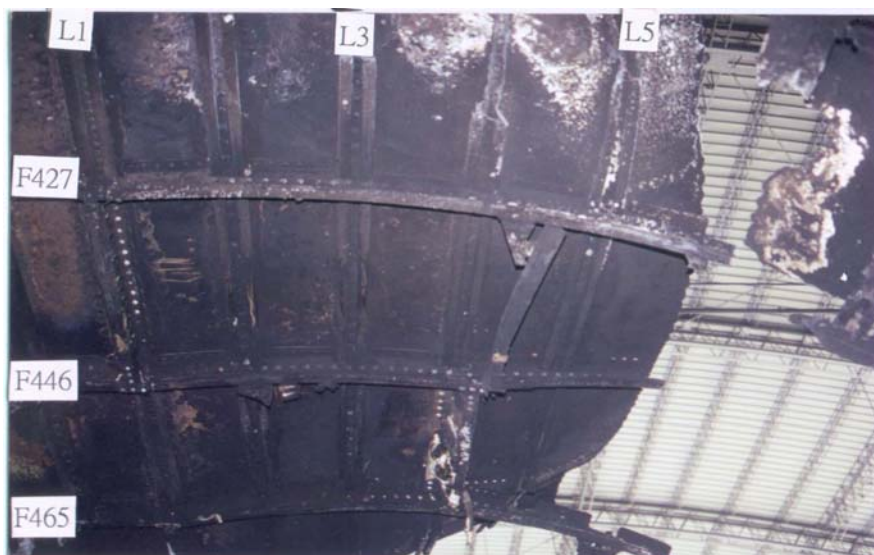
All FS.408, FS.427, FS.446, FS.465 and FS.484 frameworks of the fuselage and the 8 sections of the keel beam ranging from L1 through L8 were severely damaged by the fire. The explosion ripped off the skin along the rivet perforation of section L6 of the keel beam, with extension toward the top and the side. Section L6 of the keel beam (FS.408 through Fs.484) broke off in the explosion. The lining cover of the inner structure in the vicinity of fuselage frameworks FS.408 and FS.427 was also torn off from L6 through L13, displaying the deformed skin and the bent

section of the keel beam. Sections L4, L5 and L6 of the keel beam broke off at FS.408. (Picture 1.12-5)

Fig. 1.12-5 Ripped-off structural skin in the vicinity of the framework

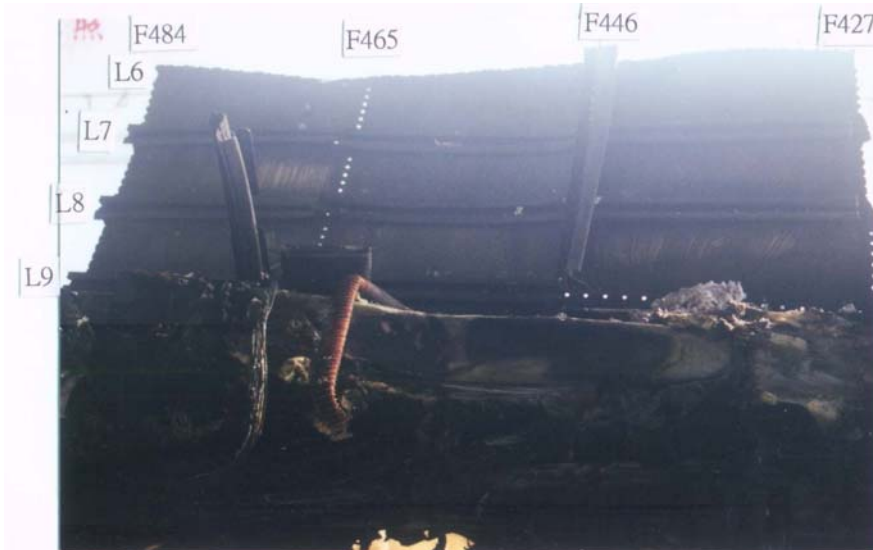
1.12-7 shows how the condition of the air duct as seen from the outside. There is a large burnt area from the bottom to the top.

Fig. 1.12-7 Damaged air duct showing burns from the bottom to the top

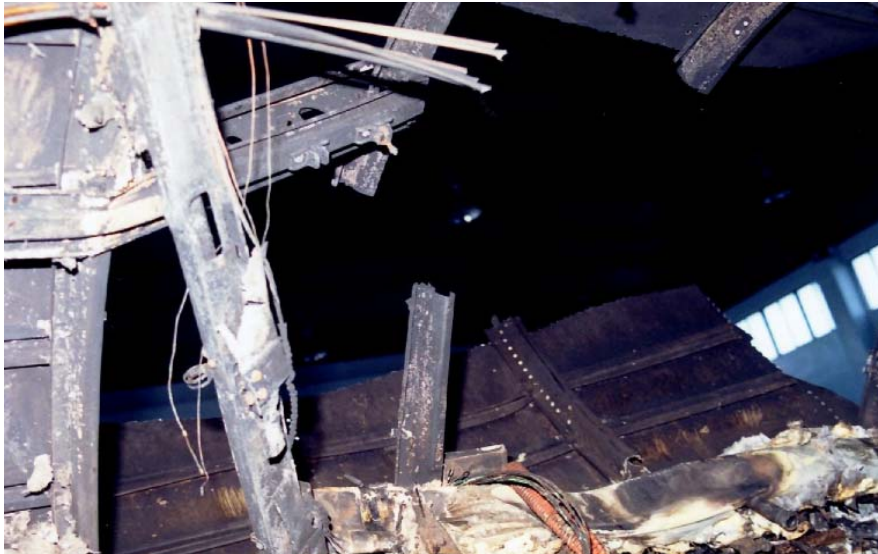
Fig. 1.12-8 Breaking point of the longitudinal beam

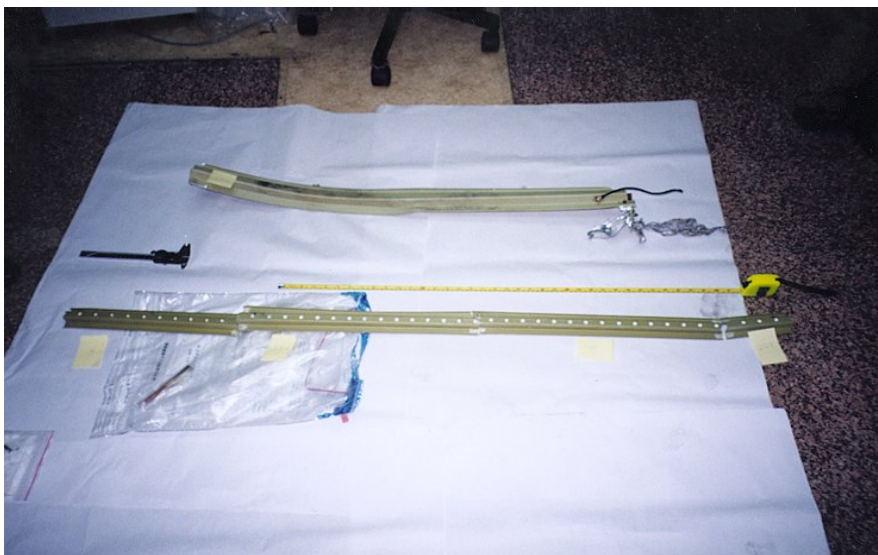
Fig. 1.12-9 Fragments of longitudinal beam and bin rail tie rod found on the runway (showing no burn signs)

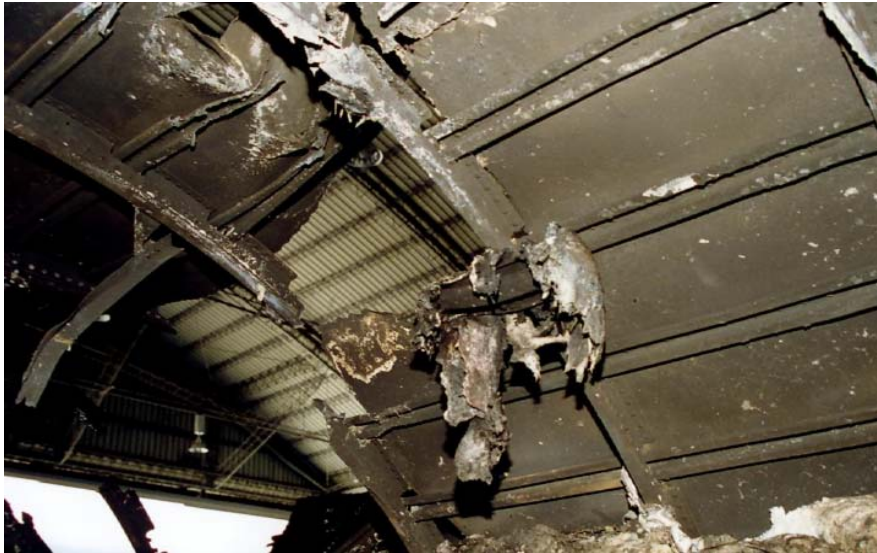
Fig. 1.12-10 Bin support and the tie rod

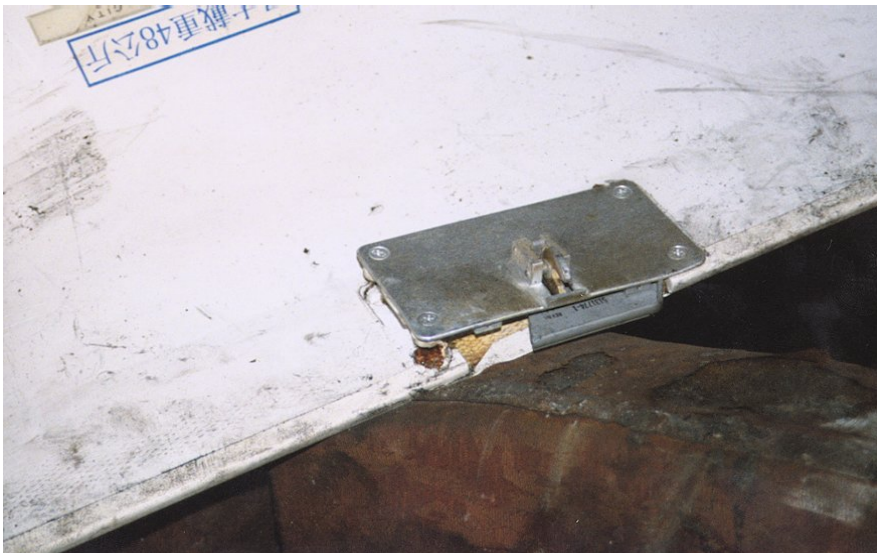
Fig. 1.12-11 The bin lid latch

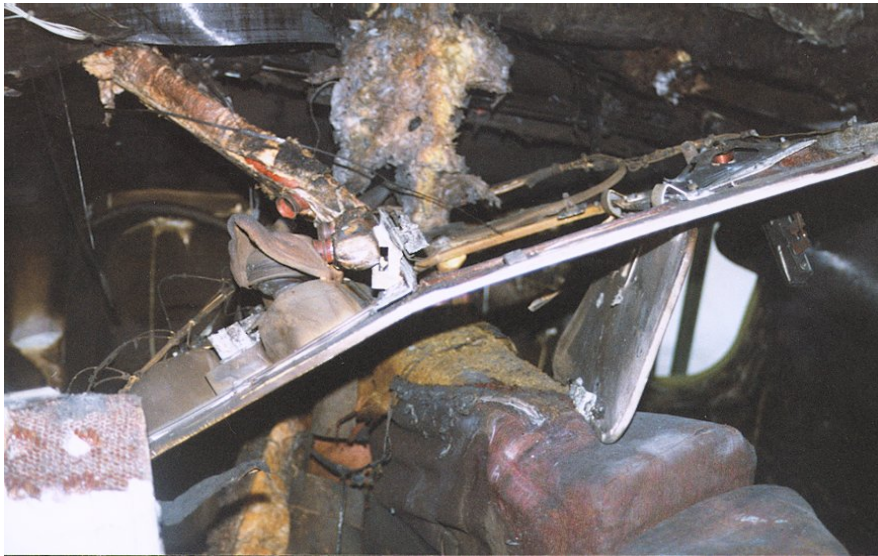
Fig. 1.12-13 Condition of the PSU

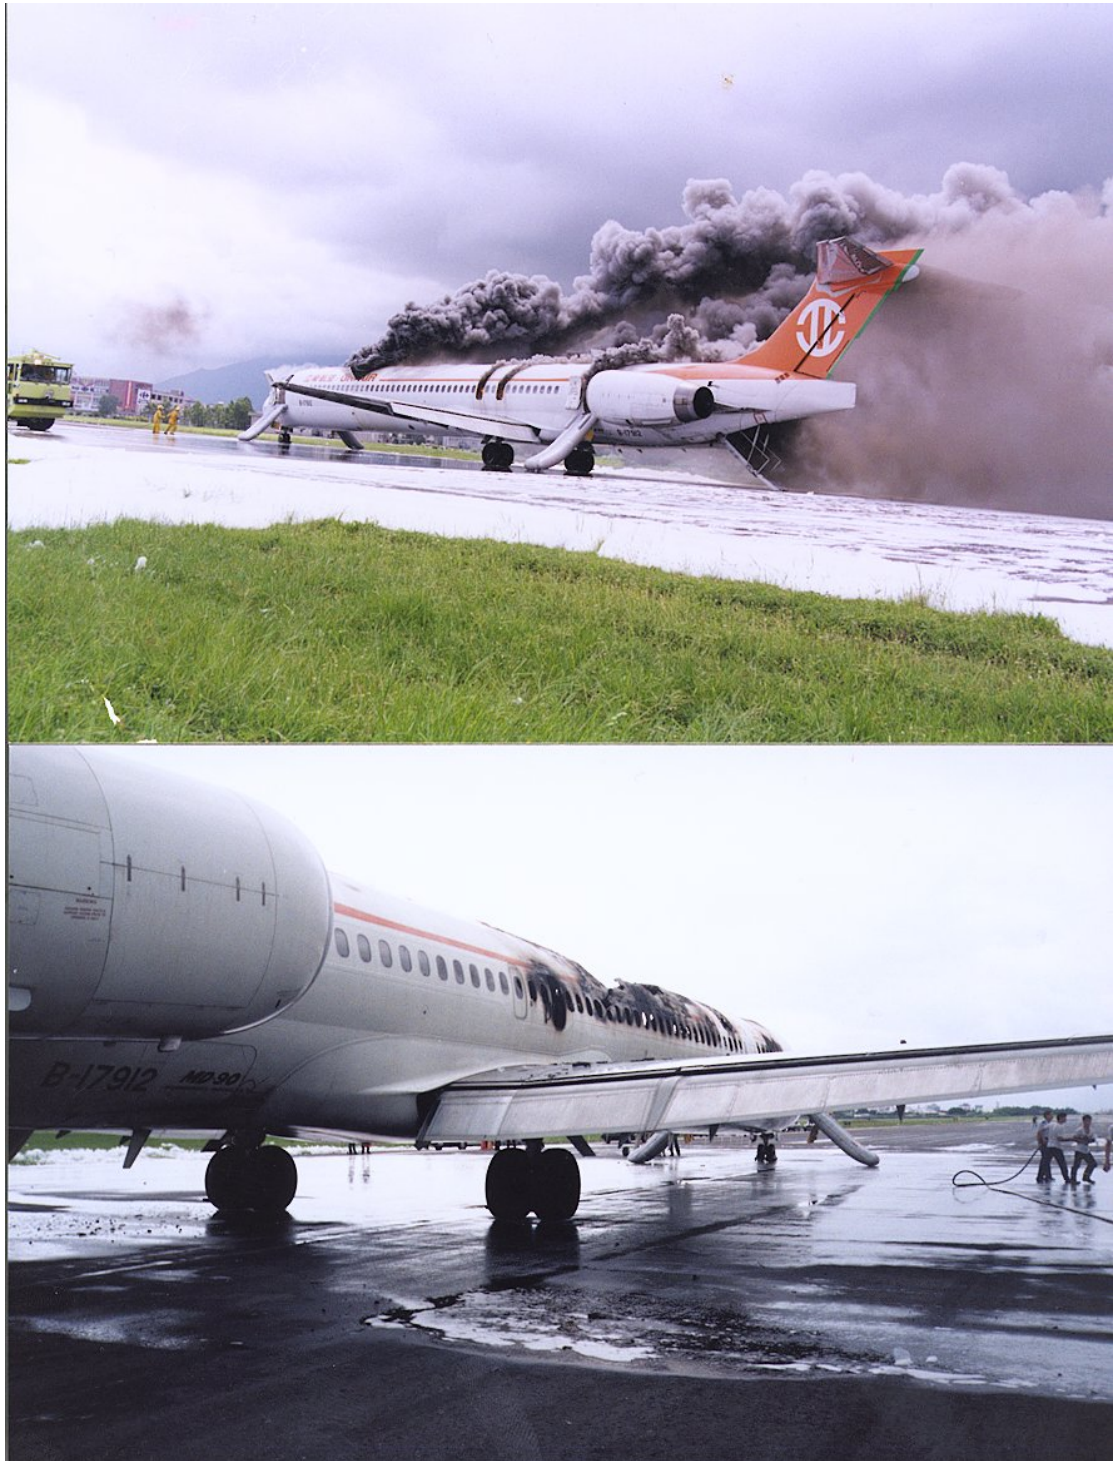
The 3 emergency exits L1, R1 and L4 remained unaffected by either smoke or fire. The 3 overwing hatches on the right side, L1, L2 and R1, were found open. Only one hatch was found on the seats inside the aircraft, while 2 others were missing. The R3 overwing hatch was not open (Fig. 1.12-14).

Fig. 1.12-14 Overwing hatches on the left and right (R3 is not open)

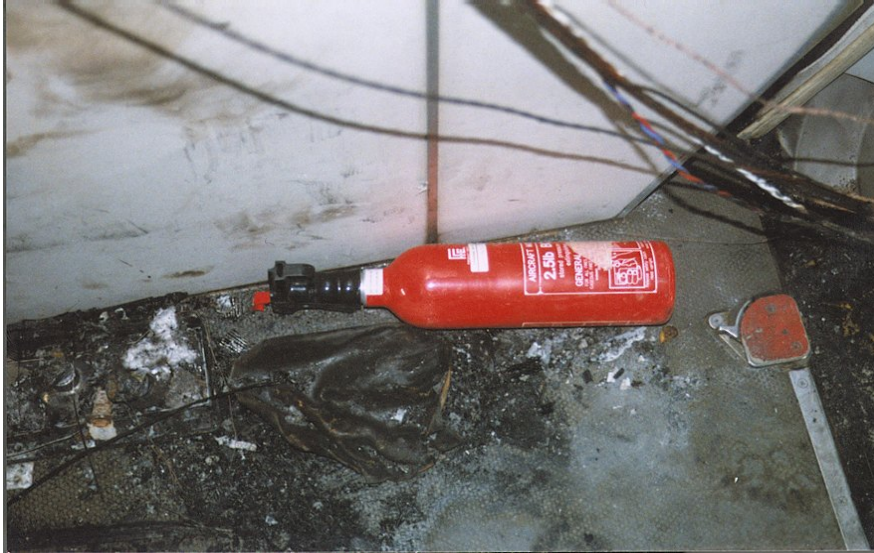
The labels on the equipment indicated that all the emergency equipment remains effective. The fire extinguisher located behind the rear of the co-pilot was found to have been used and was discovered near the L1 door (Fig. 1.12-15). The fire extinguisher in the doghouse behind row 37 was not used and was found in the aisle near the passenger seat in front of the L4 exit. The emergency equipment in all other doghouses was found in its original position, and found to have not been used. A melted speaker was found on the floor, beneath its original position. The evacuation indication light was found on the floor burned beyond recognition.

Fig. 1.12-15 A used fire extinguisher

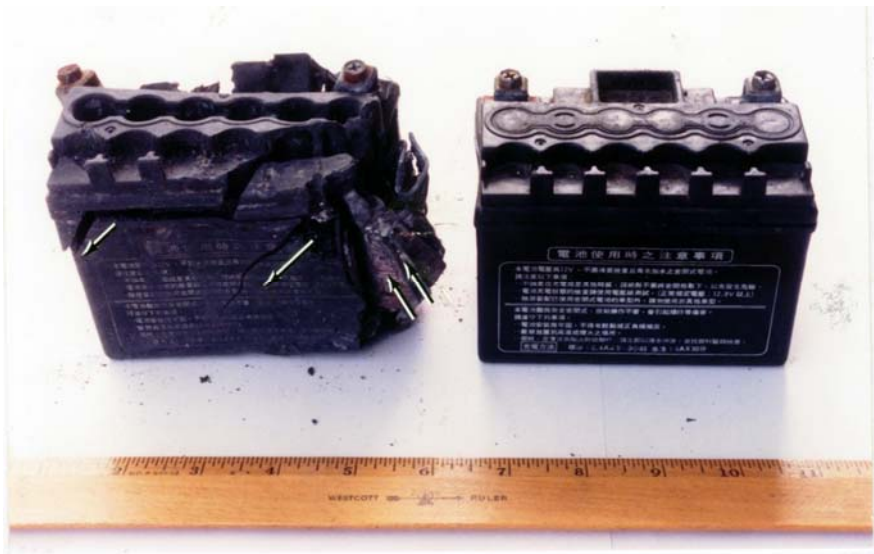
Fig. 1.14-1 On the left is the battery found under seat 5C. An intact battery of identical type is shown on the right.

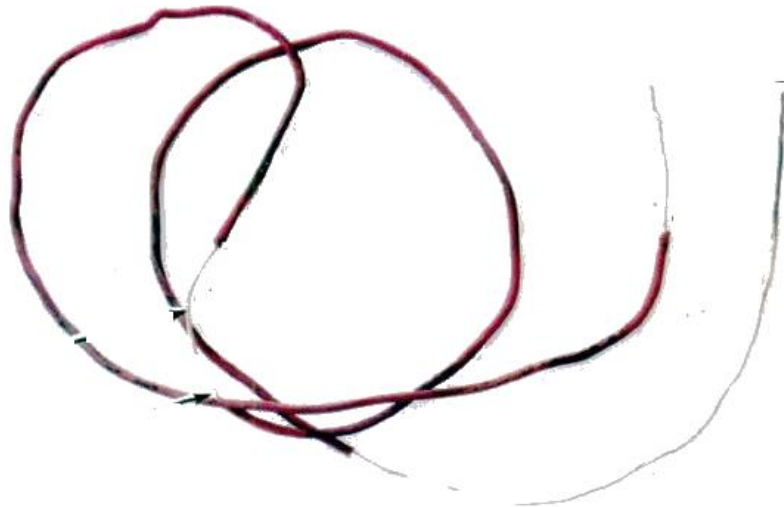
Fig. 1.14-2 The mono-core metal conductor of evidence No. 219

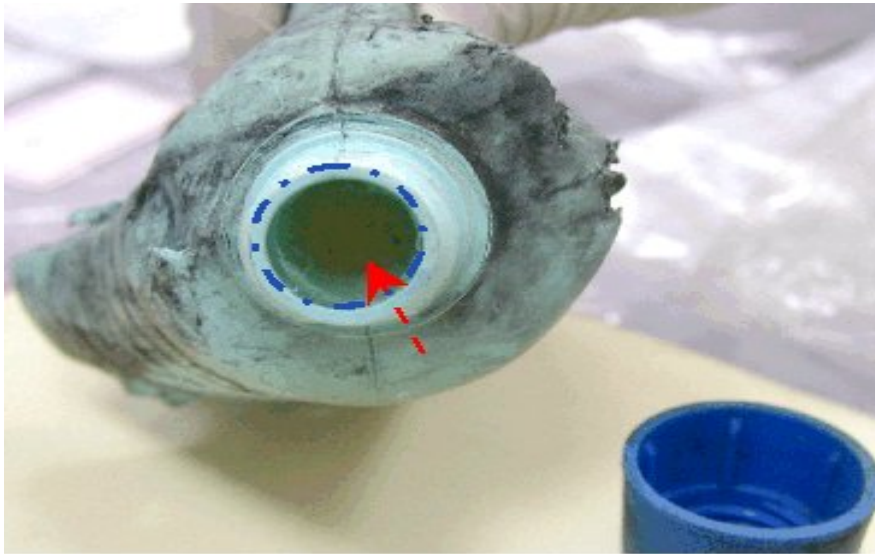
3. Evidence No. 219, found on the runway, and evidence No. 585, found on the floor under seat 7C of the main cabin, both belong to the upper part of the blue-colored bottle containing bleaching liquid. Soft and semi-transparent material is located on the inside of the bottle's neck and gasoline was detected on the inner wall (Fig. 1.14-3 and 1.14-4).

Fig. 1.14-3 A view from the mouth to the bottom of the bottle, semi-transparent material evident on the neck of evidence No. 210.

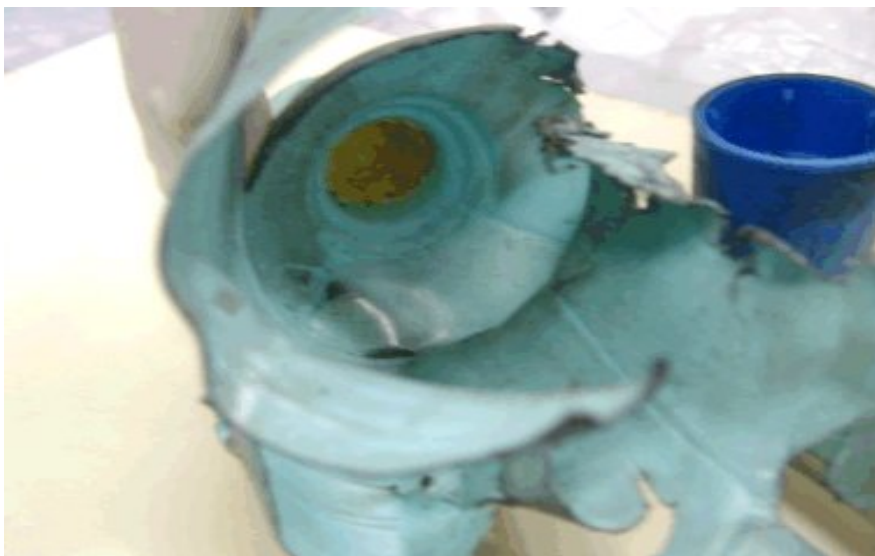
Fig. 1.14-4 A view from the fractured bottle opening, evidence No. 585 showing semi-transparent material.

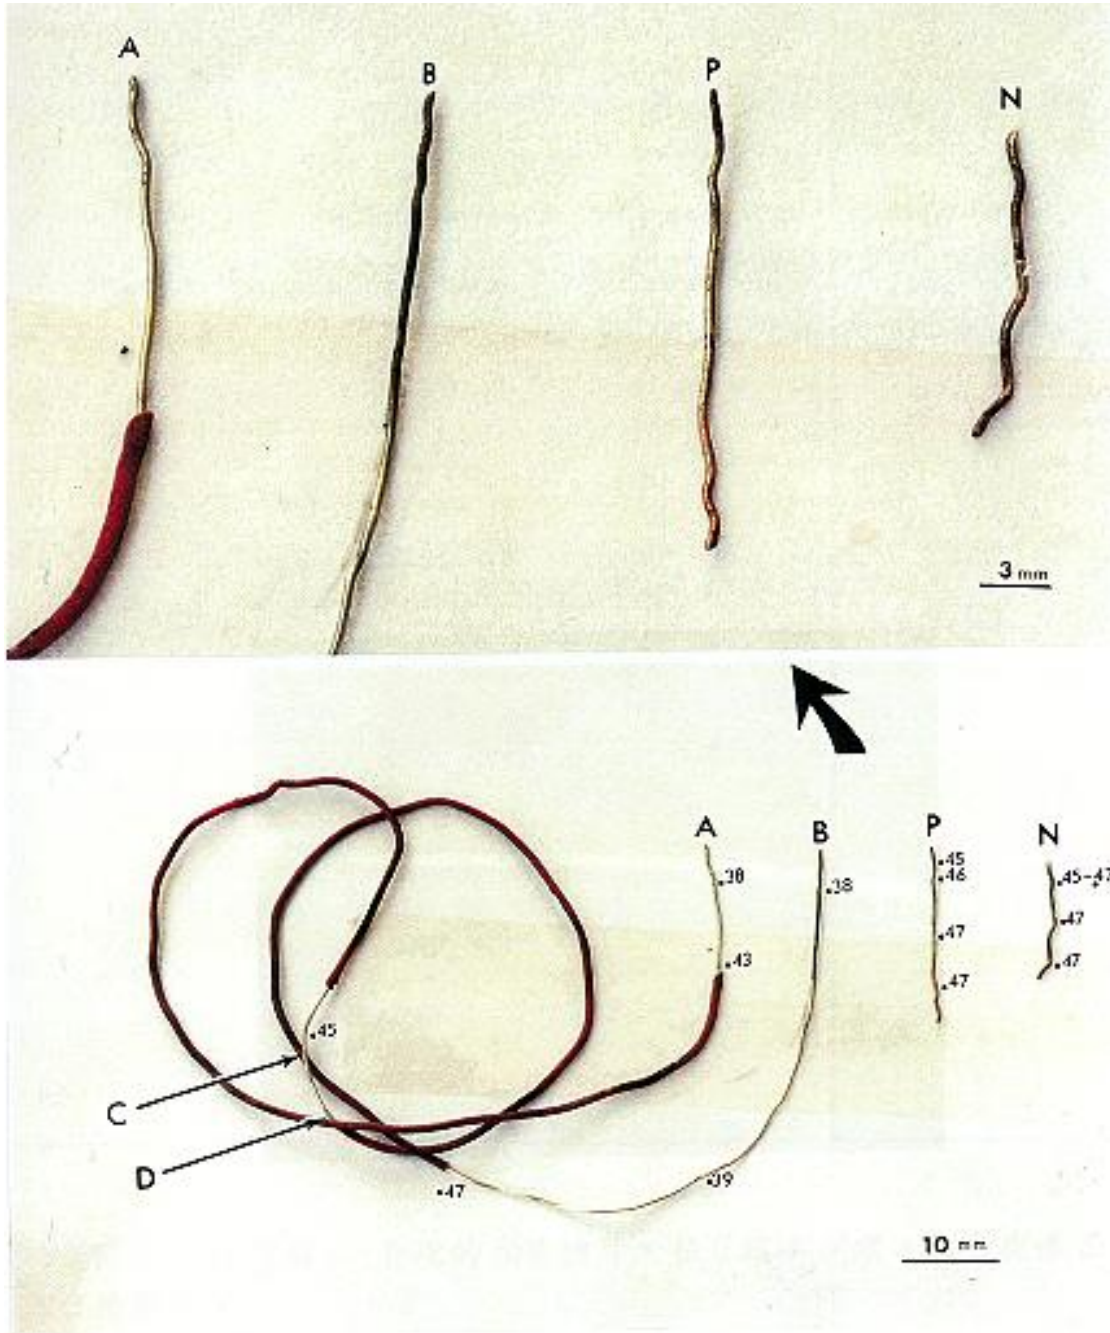
- 1) The tests demonstrate that the wire gather from the runway is the same material as the two wires connected to the positive and negative battery terminals. It is a round copper wire 0.47 mm diameter between AWG#24 and AWG#25.
- 2) The broken wire from the runway has one end that appears to be the same as that of the negative wire. The contaminated fracture surface of the negative wire is difficult to verify the both wires have identically connection.
- 3) Melting, burns and discolor at the P end of the positive wire suggests that there was a short circuit and arcing before the battery was destroyed.
- 4) The simulation demonstrated that connecting the two terminals with one copper wire would create a short circuit or arcing and melt the contact.

Figure 1. The mage of the three wires and their diameters. From left to right, there is the #1 wire gathered from the runway, the battery positive and negative wire. Most of the plastic shields of the #1 wire are red and the others are charred black. The broken end of A, B, P and N wires are a silver color and others are a red brass. The B and P ends turned dark brown.

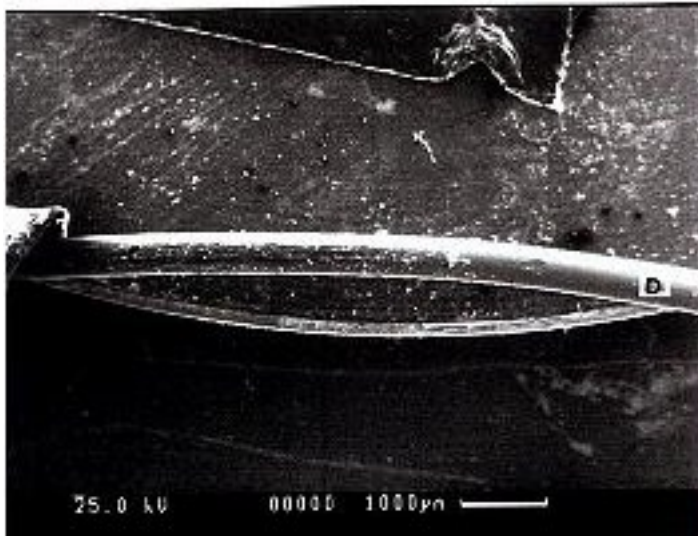
Figure 2. SEM image of segments C, D of the #1 wire. The C segment is scratch. The segment D remains unmarked.

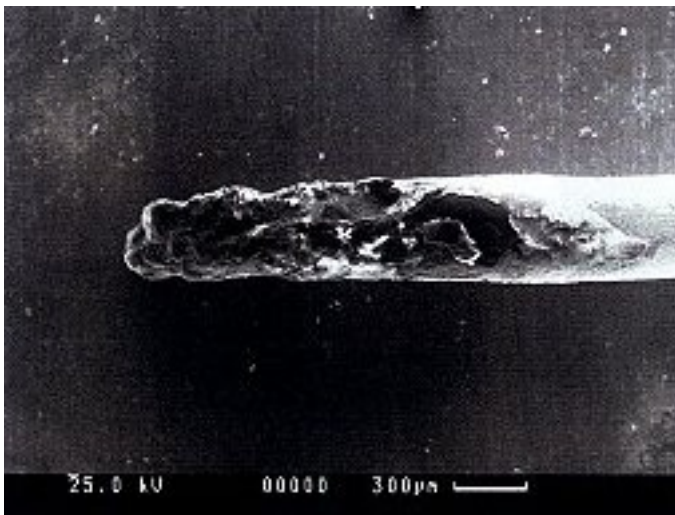
Figure 7. The SEM image shows the P of the positive wire. The lead has necking and the broken surface is a dark brown color, with broken plating and uneven on the substrate.

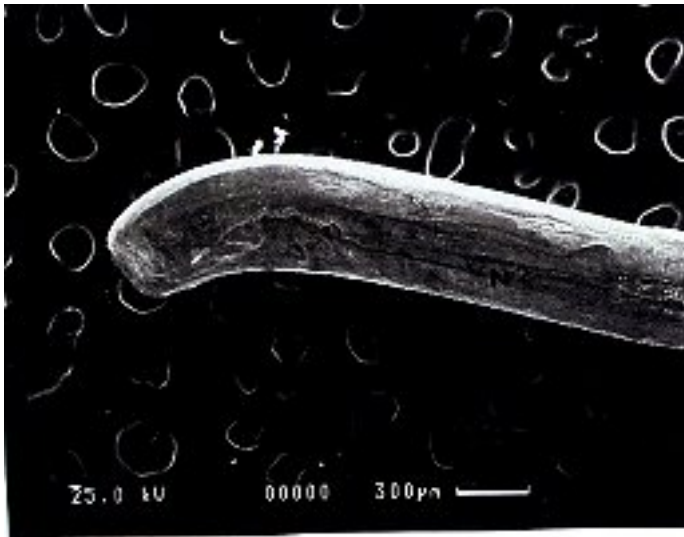
Figure 8. The SEM image shows N side of the negative wire. The broken surface shows necking and squeeze marks.

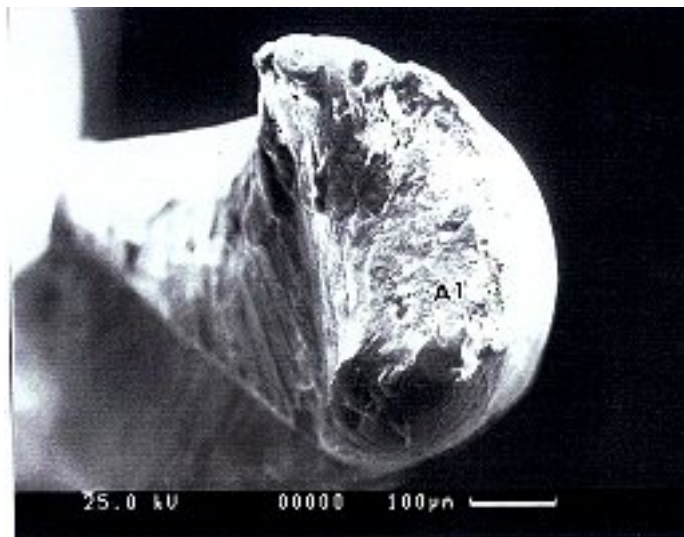
Figure 9. The SEM image shows A fracture surface of the #1 wire. The fracture surface is half-moon shaped with the left side squeezed into a spiral form.

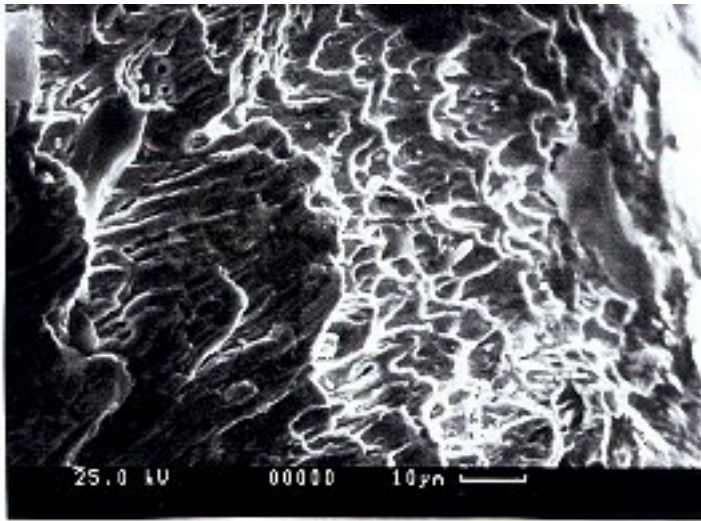
Figure 10. The SEM image shows the fracture surface of A1 in figure 9. The fracture surface is clean with sharp dimples, result by overstress.

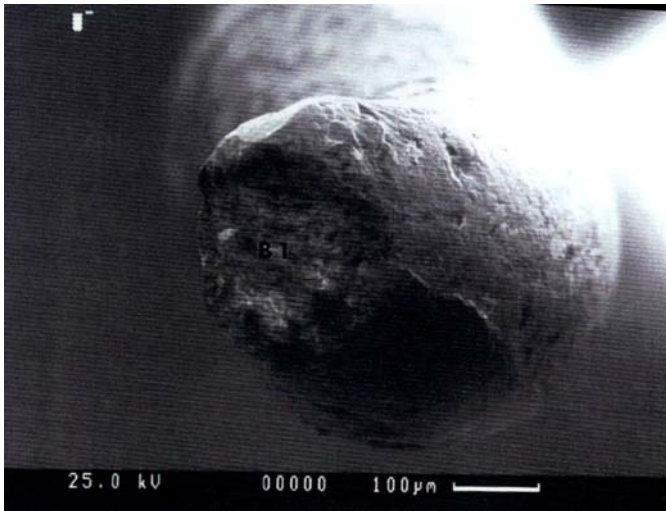
Figure 12. The SEM image shows B fracture surface of the #1 wire. The fracture surface is round and shows clear necking.

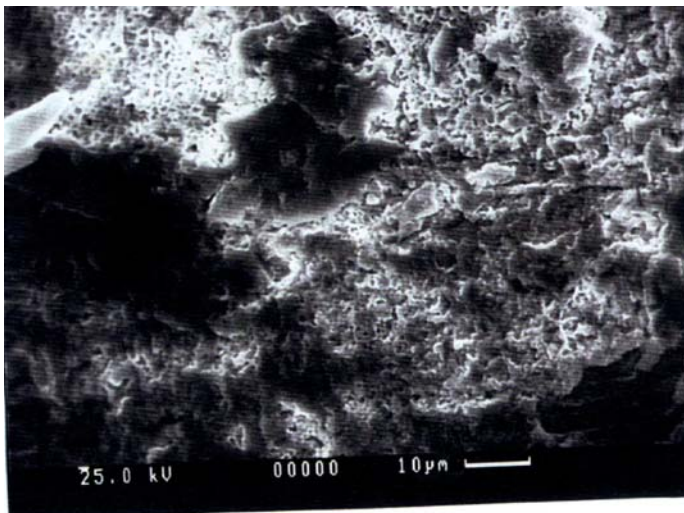
Figure 13. The SEM image shows B1 (figure 12) fracture surface of the #1 wire. The fracture surface has deposited and minor 1~3 μm diameter dimples.

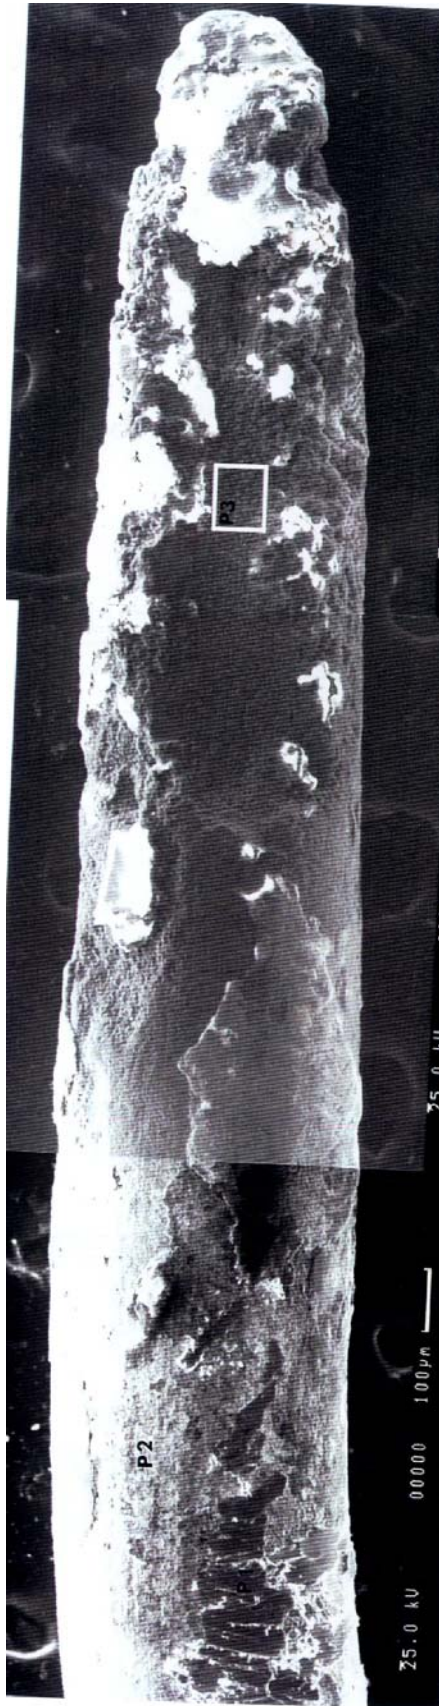
fracture surface of the #1 wire, showing necking. Within 1.7 mm from the fracture, it is dark brown with broken plating and dimples. In 1.7 mm~2.2 mm from the fracture, it is silver color with peeled plating. The fracture surface was overheated and melted, and the fracture surface deposit environment reactant and contaminants.

Figure 15. The SEM image shows P

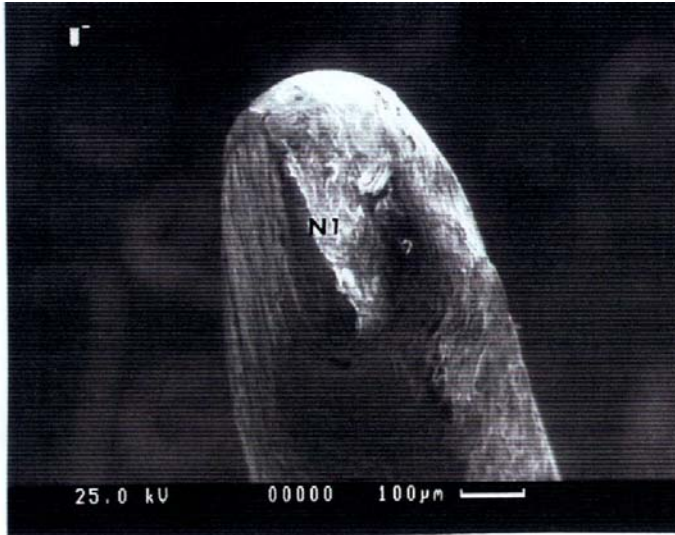
Figure 20. The SEM image shows the N fracture surface of the negative wire. The fracture surface shows it squeezed flat into an almost triangle form.

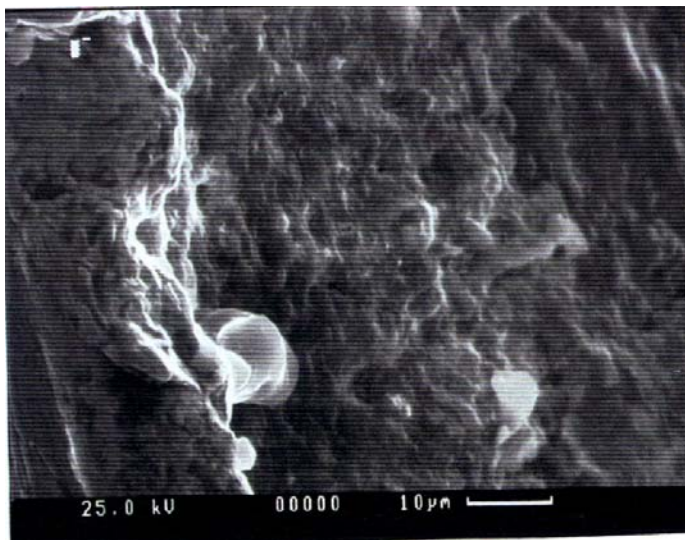
Figure 21. The SEM image shows N1 fracture surface in Figure 20. The fracture surface shows dimples, result by overstress.
