**Landed short, Boeing 747, N732PA, Renton Airport, Renton, Washington,
December 13, 1969**

AIRCRAFT INCIDENT REPORT

BOEING 747, N732PA

RENTON AIRPORT

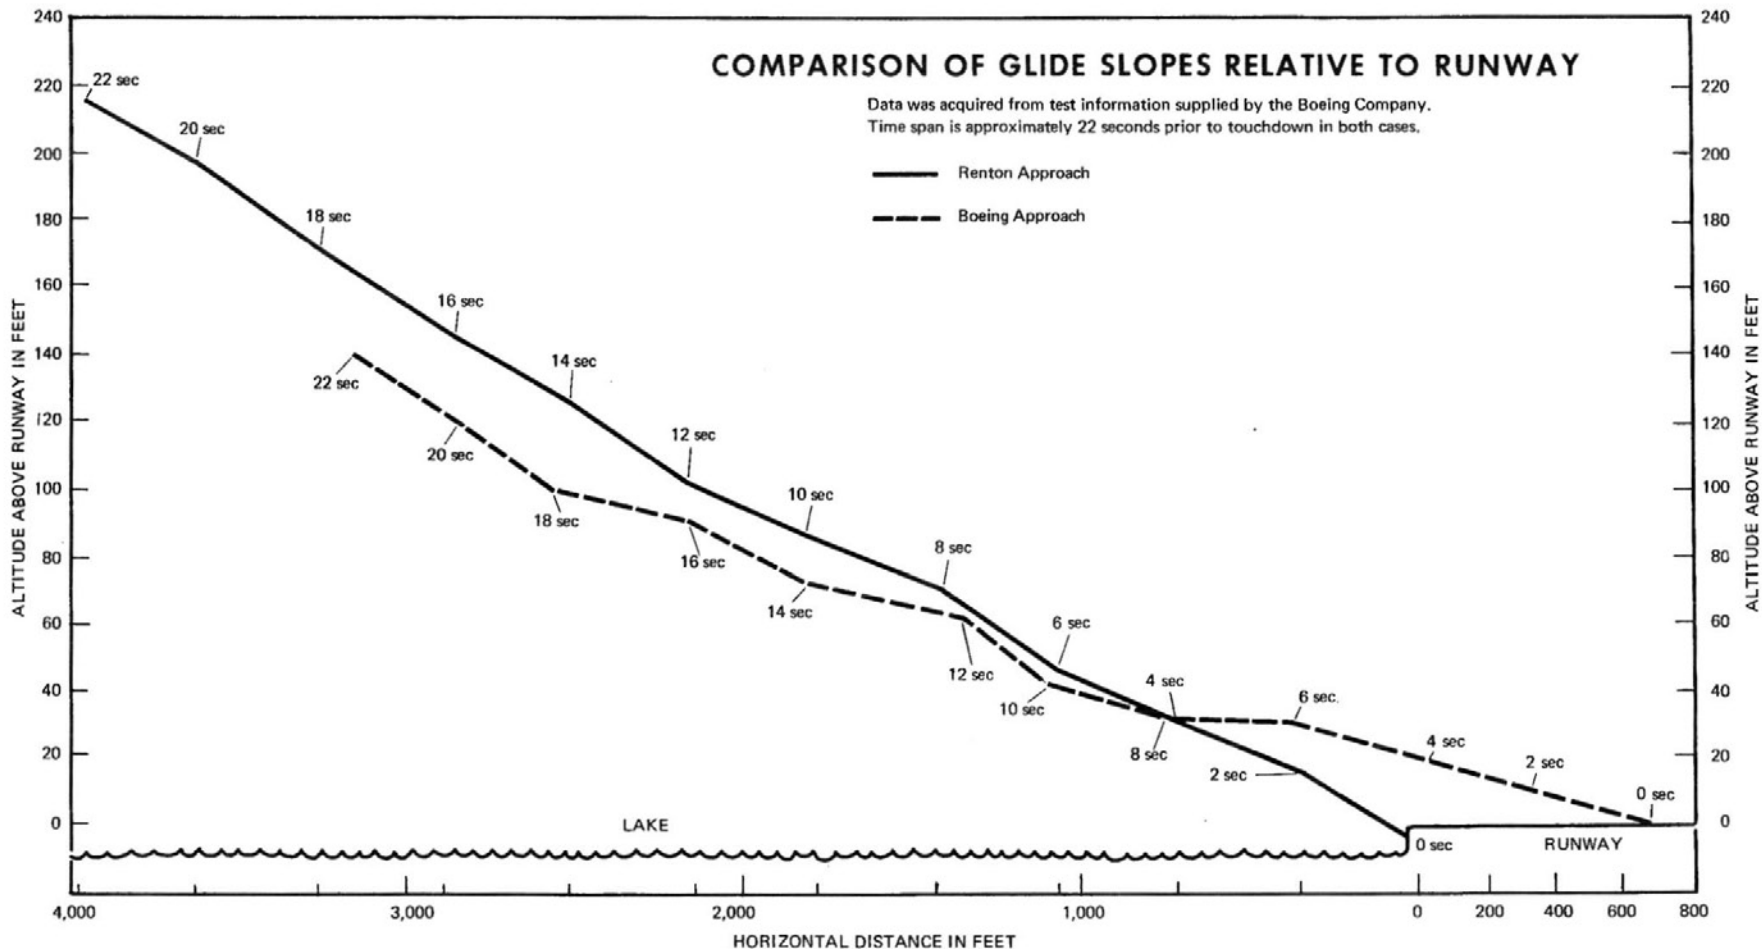
ATTACHMENT 3.

Comparison of the flight profiles from the test instrumentation data indicated that during the last 22 seconds prior to ground contact, the rate of descent was initially 700 feet per minute for the incident, decaying to 400 feet per minute for the last 4 seconds. The rates of descent for the same periods for the Boeing Field landing, typical landing, and autoland were 550 to 300, 750 to 375, and 600 to 450 feet per minute, respectively. The altitudes, 22 seconds prior to ground contact, were 235 feet for the incident landing, 140 feet for the Boeing Field landing, 235 feet for the typical landing, and 200 feet for the autoland.

Data was acquired from test information supplied by the Boeing Company.
Time span is approximately 22 seconds prior to touchdown in both cases.
