Struck trees short of runway, Texas International Airlines, Inc., Douglas DC-9, N1308T, Harlingen, Texas, January 11, 1970

AIRCRAFT ACCIDENT REPORT

Report Number: NTSB-AAR-70-28

TEXAS INTERNATIONAL AIRLINES, INC.
DOUGLAS DC-9, N1308T
HARLINGEN, TEXAS
JANUARY 11, 1970

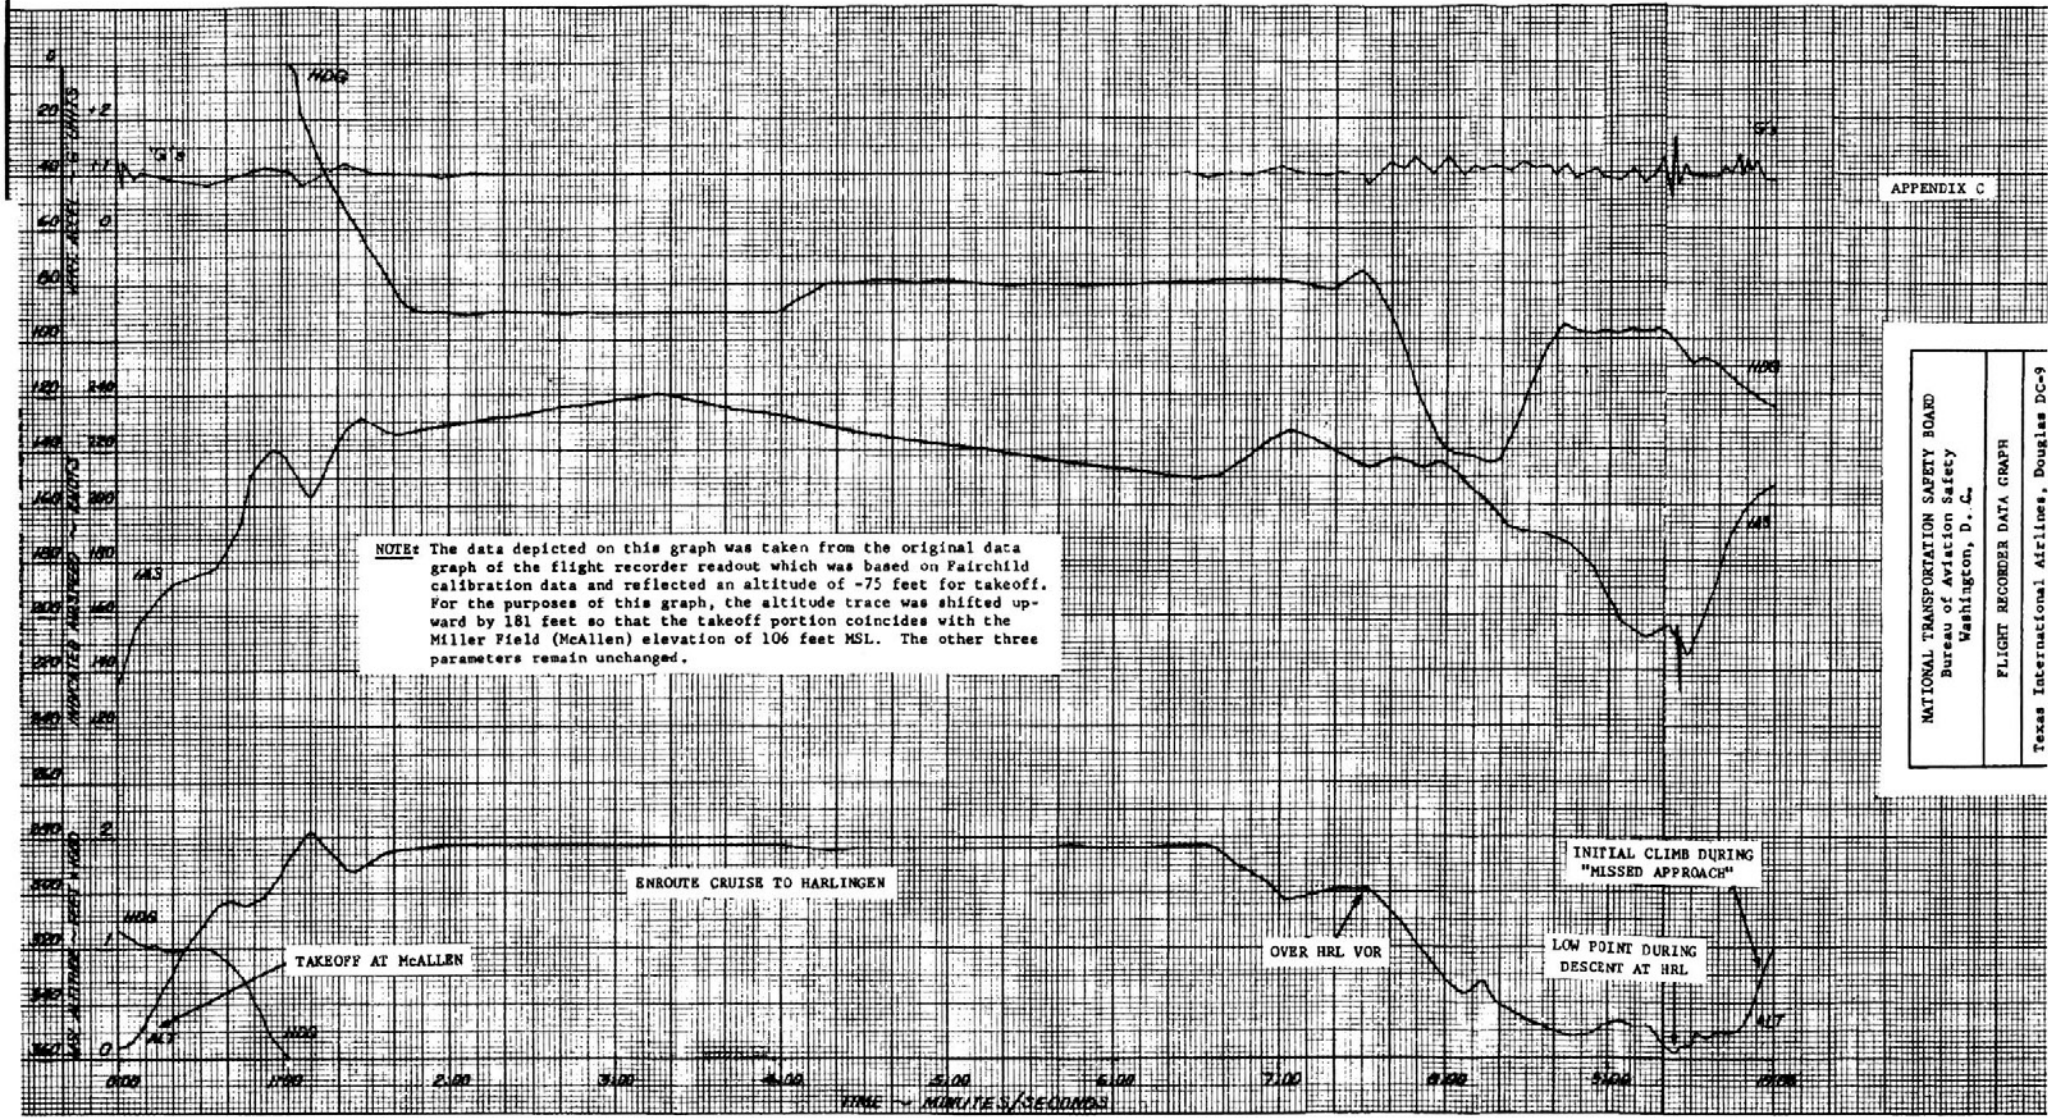
APPENDIX C

NATIONAL TRANSPORTATION SAFETY BOARD
 Bureau of Aviation Safety
 Washington, D. C.
 FLIGHT RECORDER DATA GRAPH
 Texas International Airlines, Douglas DC-9
