Crash after takeoff, United Air Lines, Inc., Boeing 737-222, N9005U, Philadelphia International Airport, Philadelphia, Pennsylvania, July 19, 1970

AIRCRAFT ACCIDENT REPORT

Boeing 737-222, N9005U

REPORT NUMBER: NTSB-AAR-72-9

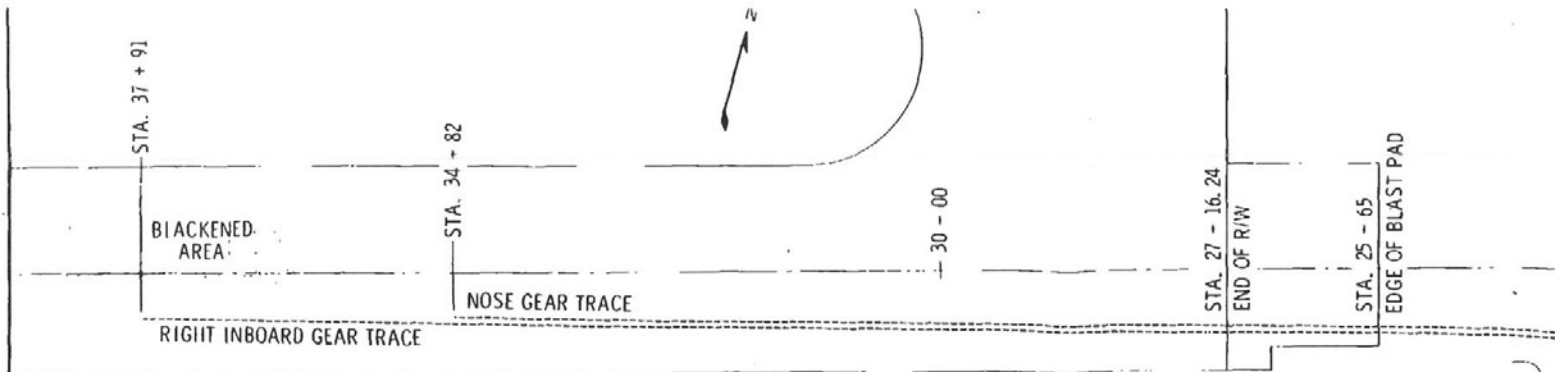
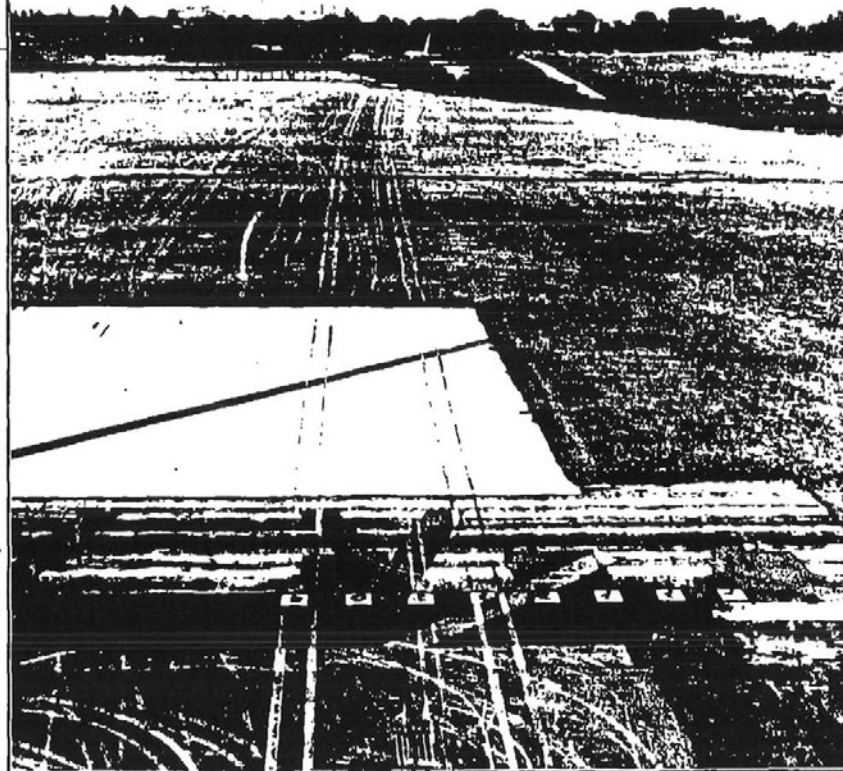
APPENDIX C

The aircraft's right main landing gear touched down approximately 1,075 feet from the end of the runway and approximately 46 feet to the right of the centerline. The nose landing gear touched down approximately 776 feet from the end of the runway and 44 feet to the right of the centerline. The blackened condition of the runway prevented the determination of the touchdown point of the left main landing gear. However, the track of the left main landing gear was visible after it came out of the blackened area. It was also evident that the nose gear wheels tracked toward the right main gearwheel tracks throughout the landing and overrun. The aircraft came to rest 1,634 feet beyond the end of the runway beside a pond on a heading of 070° magnetic. During the overrun, the aircraft had passed over three runway threshold lights, through a chain link fence topped with barbed wire, and then impacted two mounds of earth and rubble before it came to rest. (See Appendix C.)

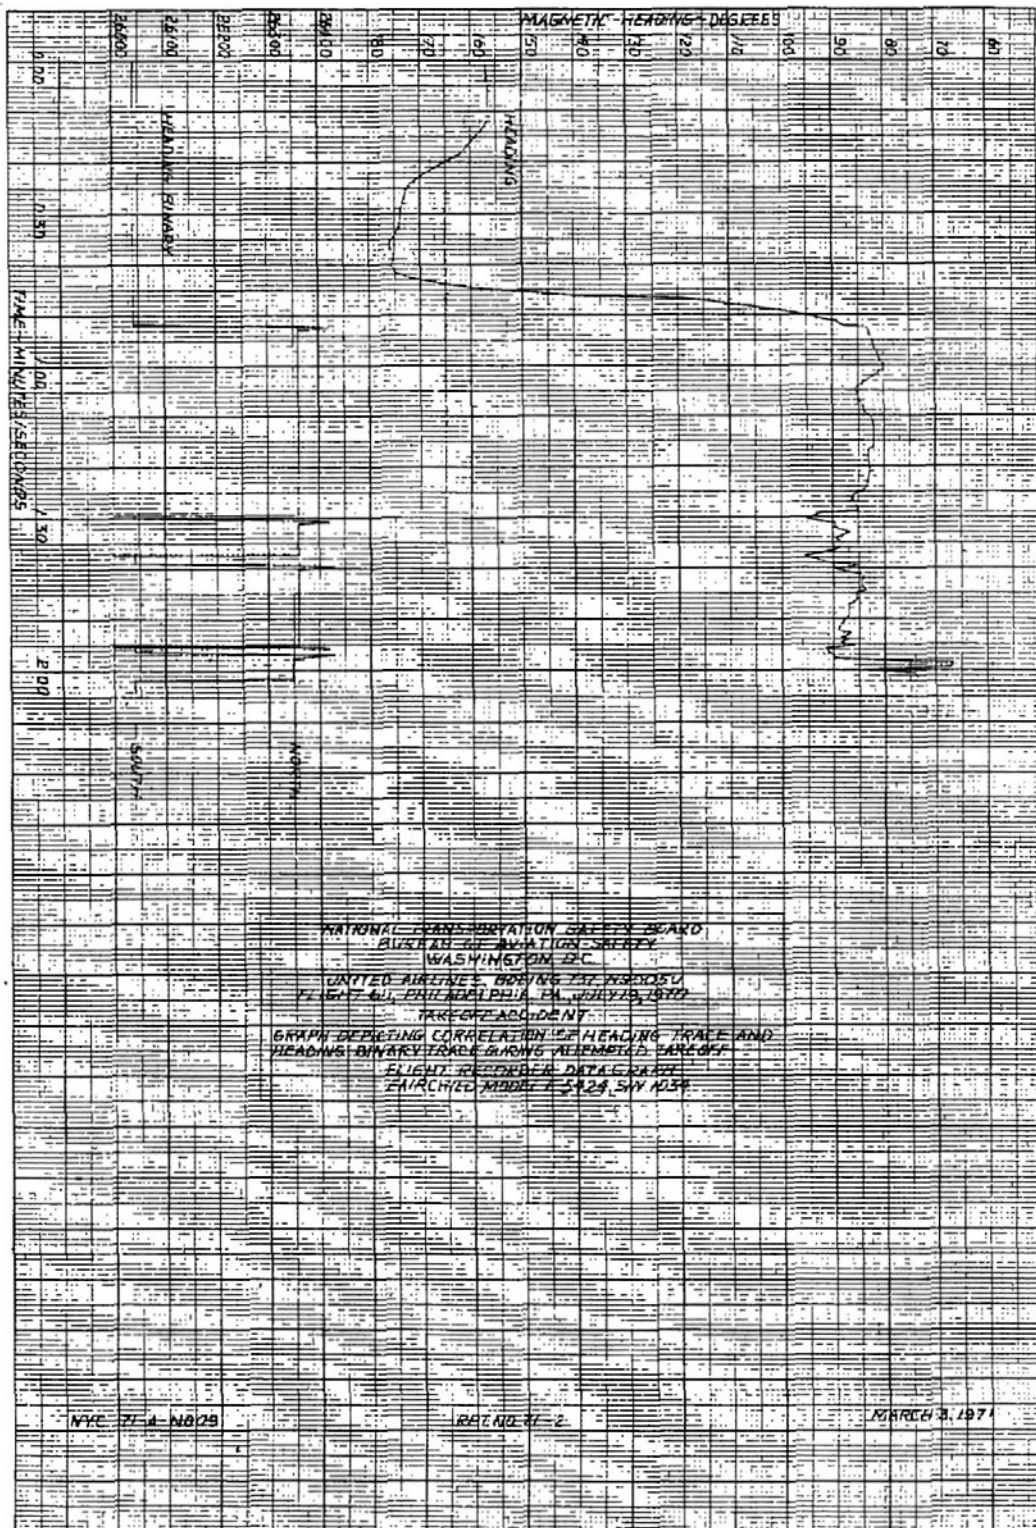
APPENDIX D

tested and found to operate properly. A further indication that the engine and reverser were operating was the evidence that during the runway and off-runway roll the nose gearwheels tracked toward the right main landing gearwheel track. (Appendix D.)

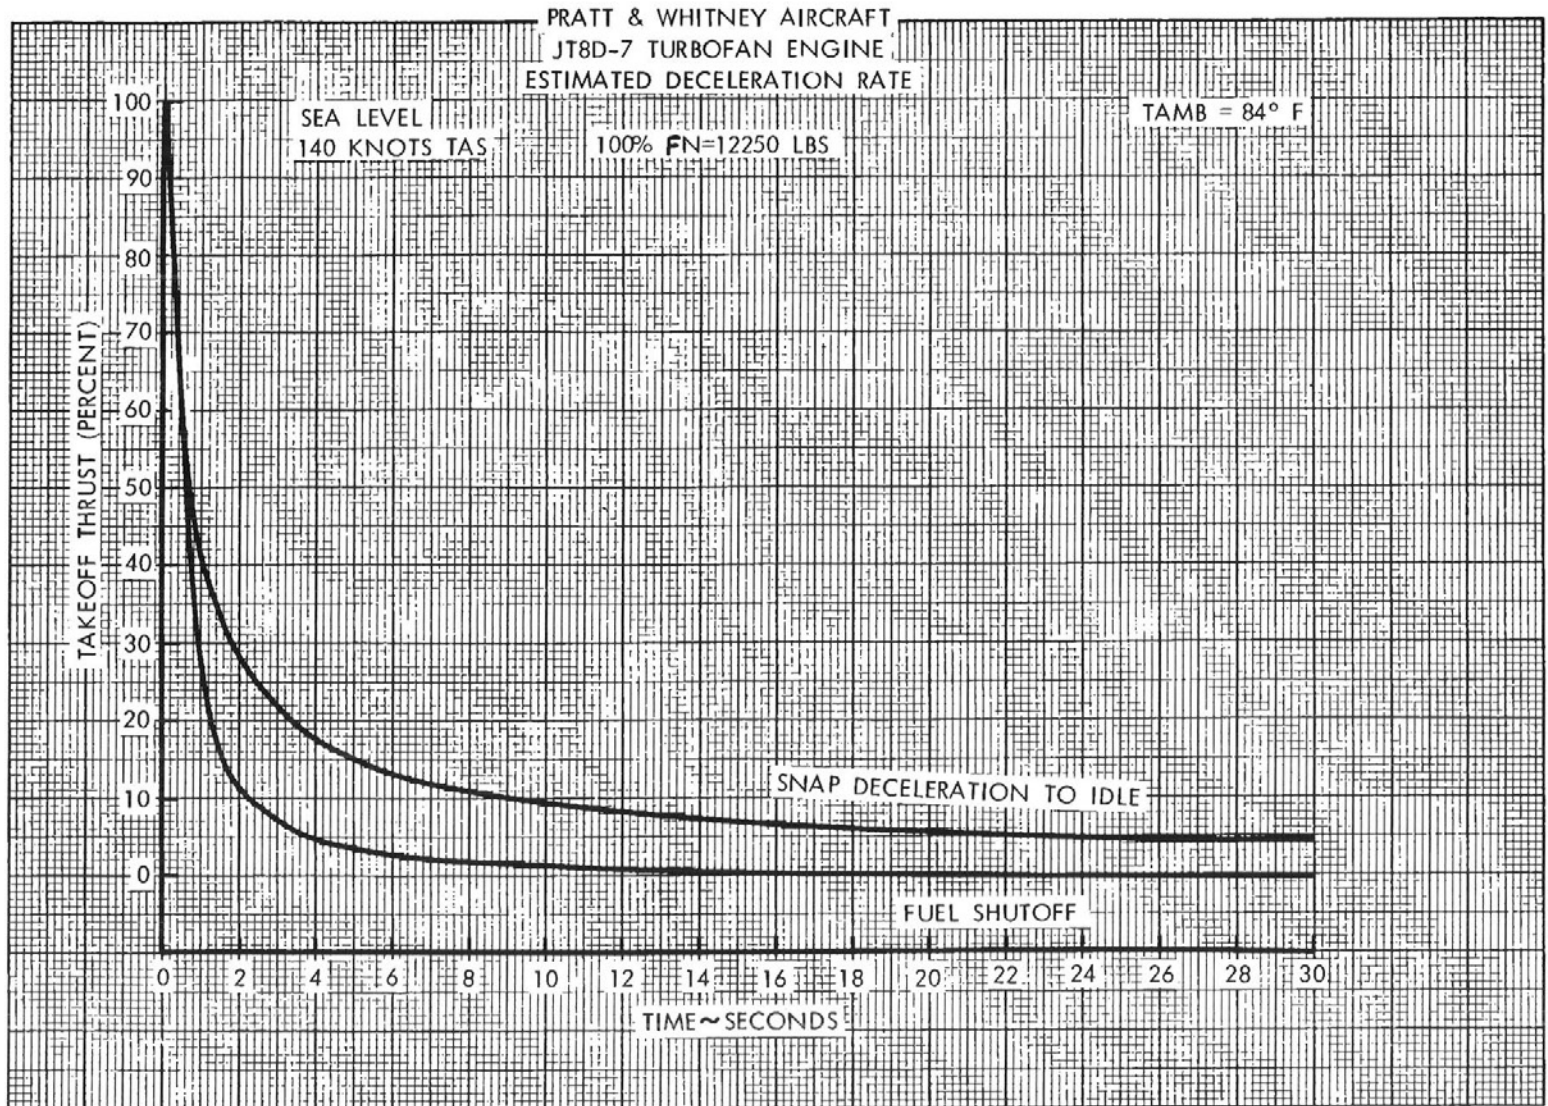
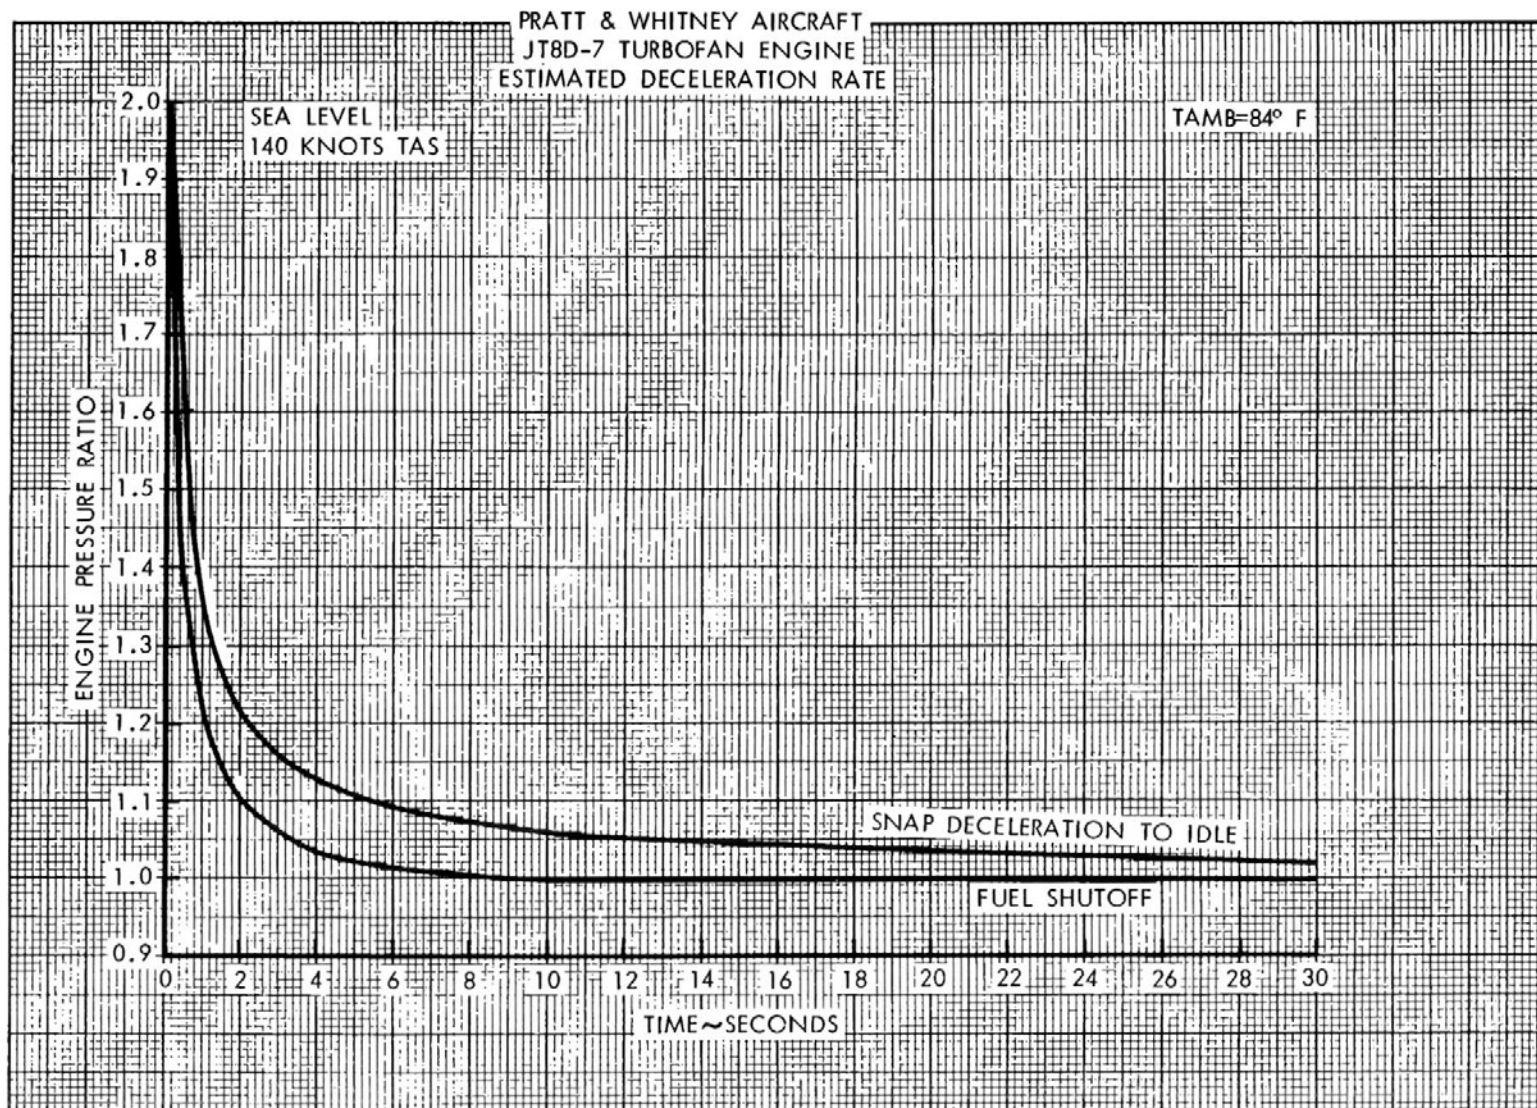
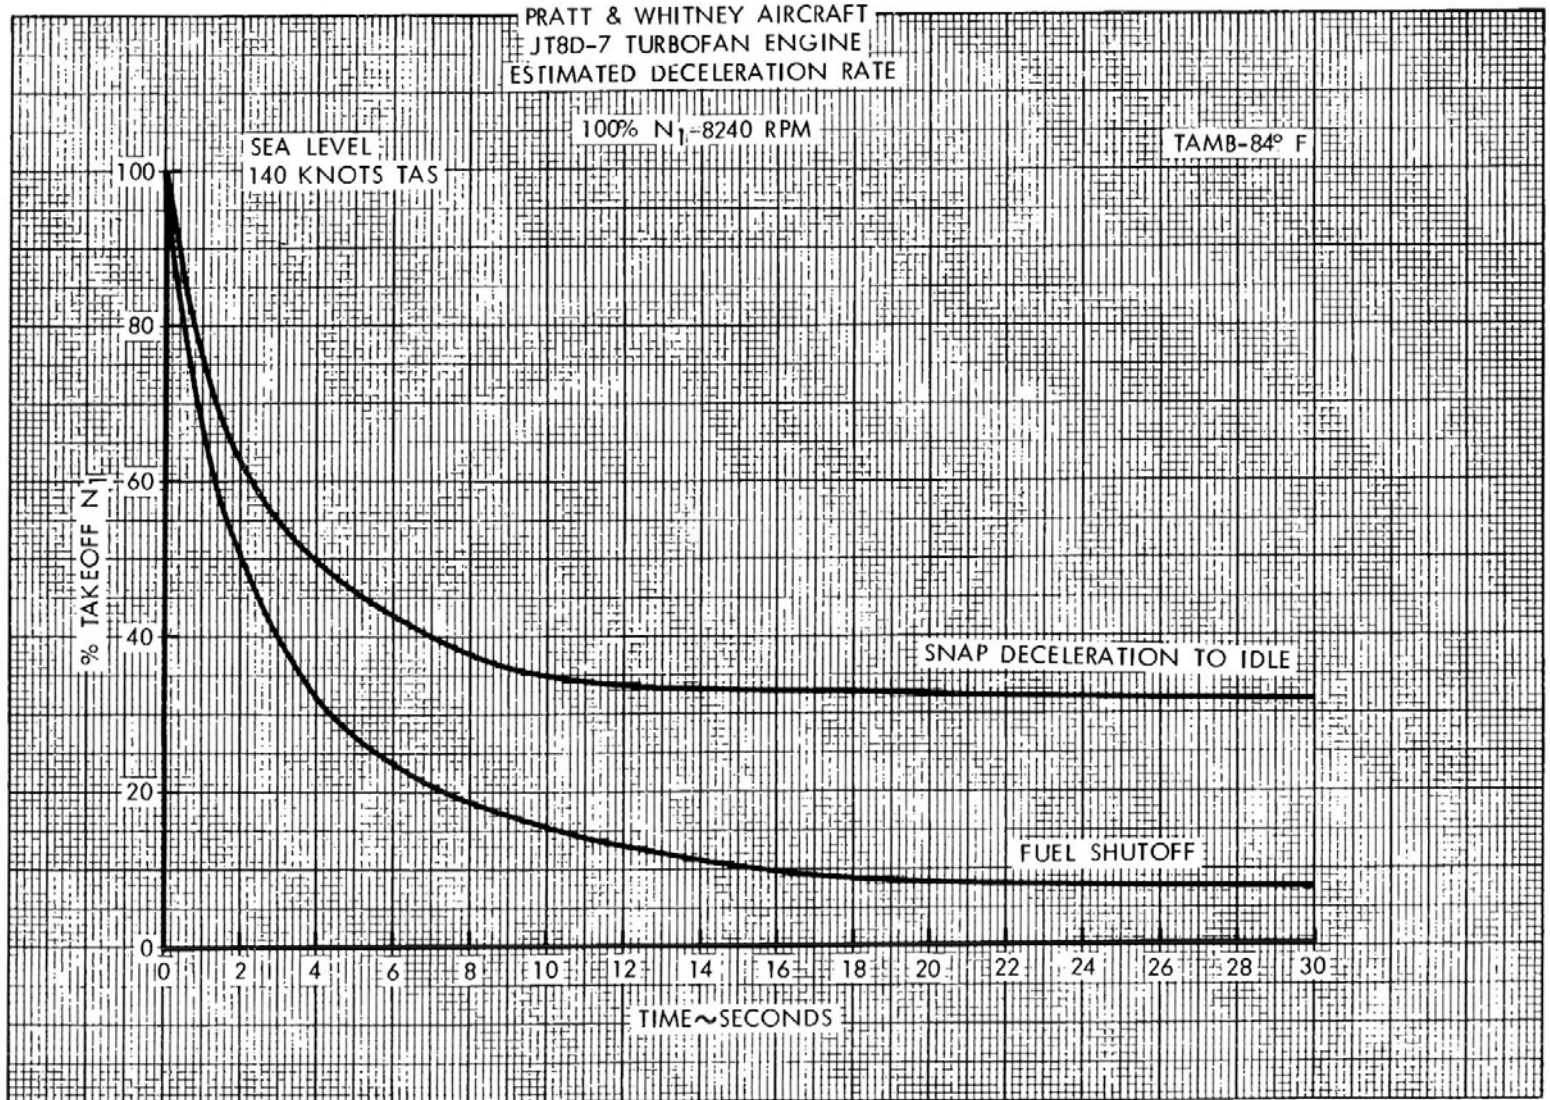
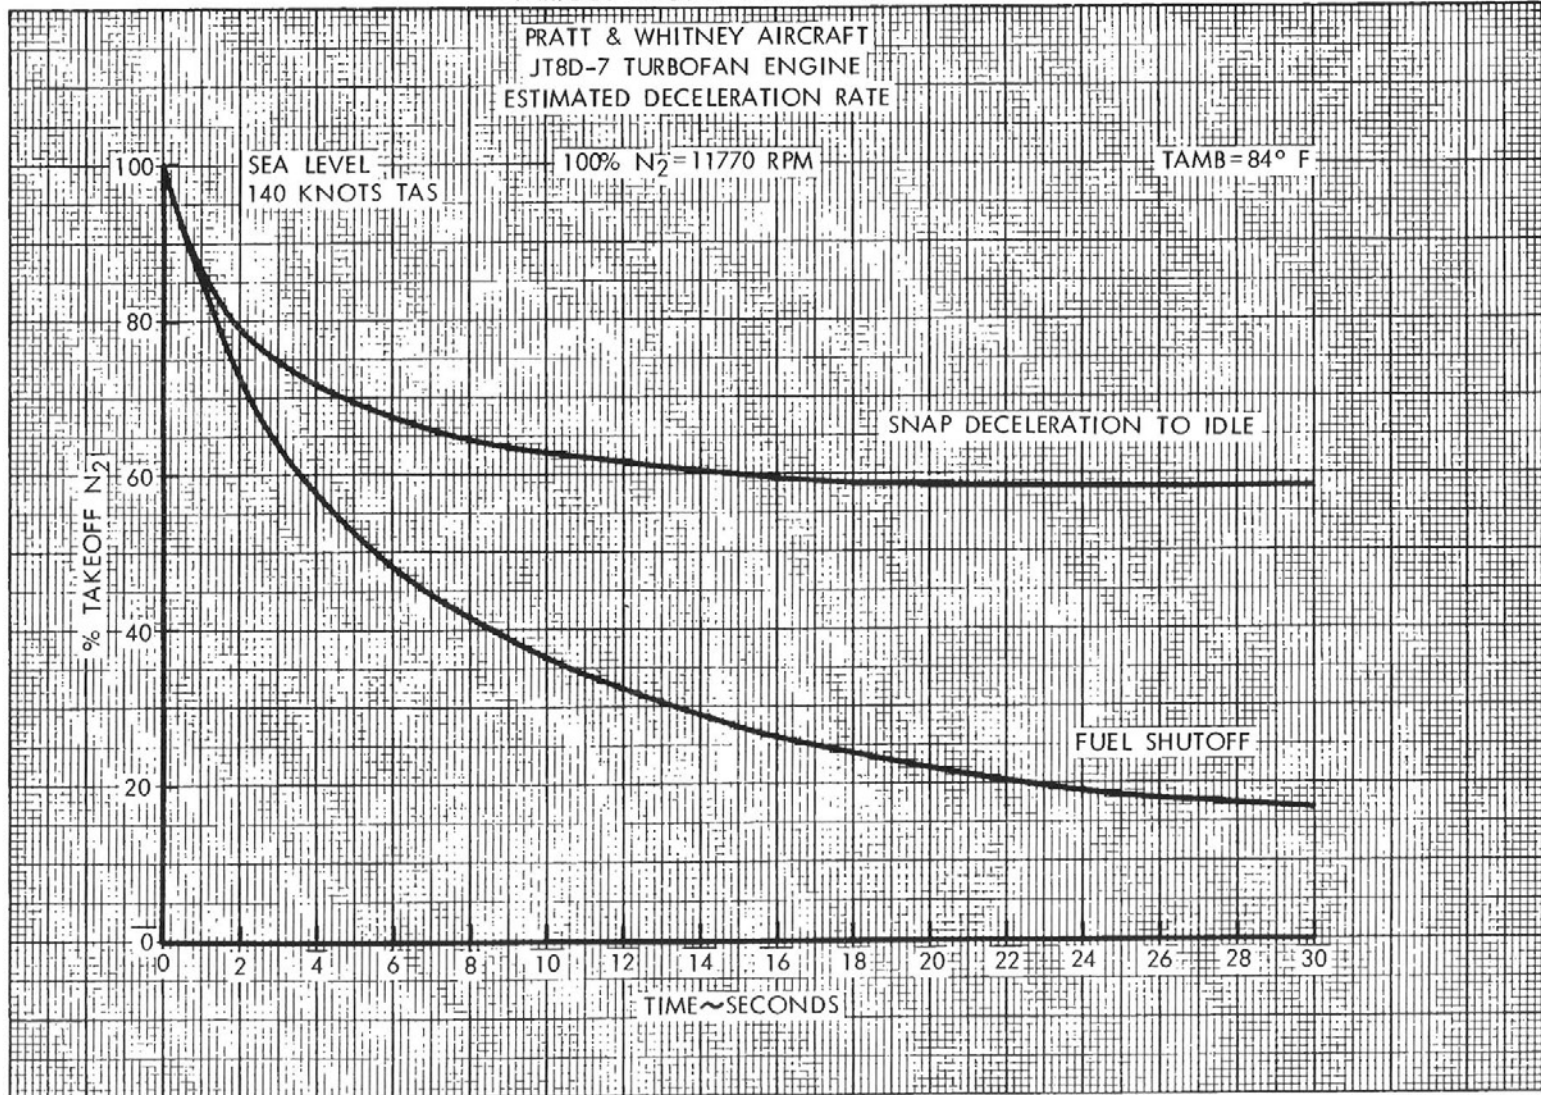
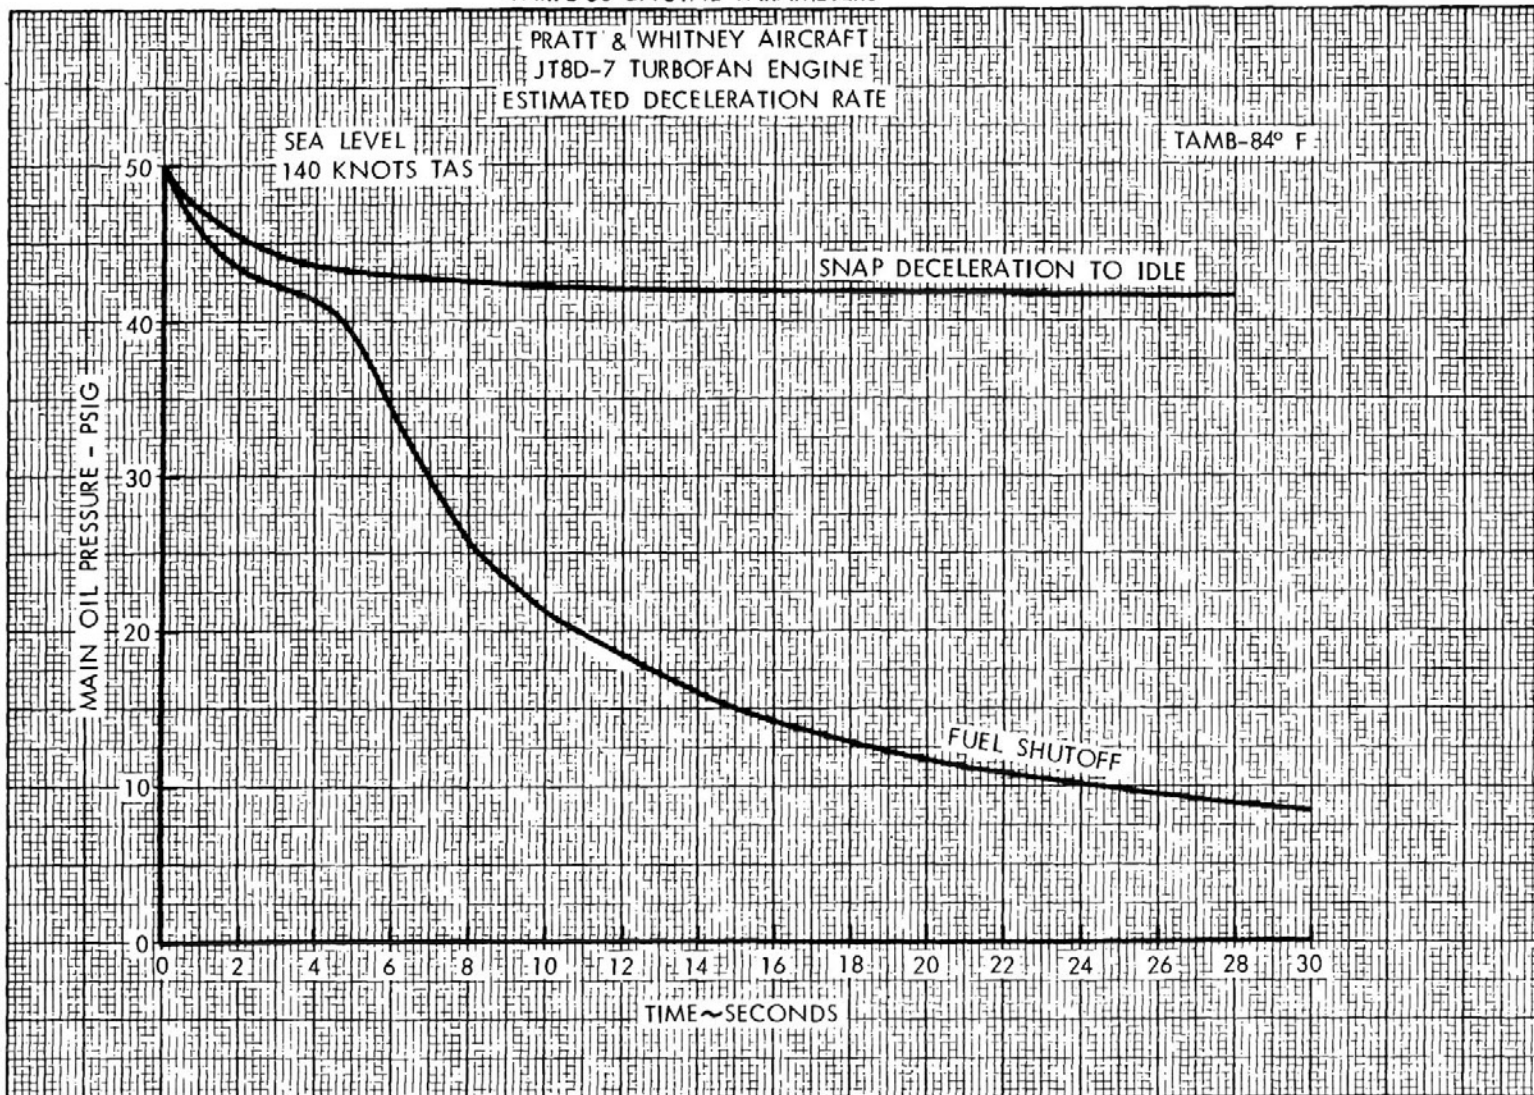
APPENDIX F
VARIOUS ENGINE PARAMETERS

The graph showing percent of takeoff thrust decay at time of fuel shutoff disclosed that thrust decayed from 100 percent to 25 percent in 1 second and continued to decline to 11 percent in 2 seconds. In a snap deceleration to idle, the thrust decayed from 100 percent to 28 percent in 2 seconds (See Appendix F)

The graph showing percentage of takeoff N₂ rotor speed showed that an initial decay from 100 percent to 72 percent occurred in 2 seconds, and continued to decay to 58 percent in 4 seconds and to 40 percent in 8 seconds.

The turbine inlet temperature decay graph shows at fuel shutoff the temperature will drop from 1,800°F. to 900°F. in 1 second and down to 600°F. in 2 seconds.

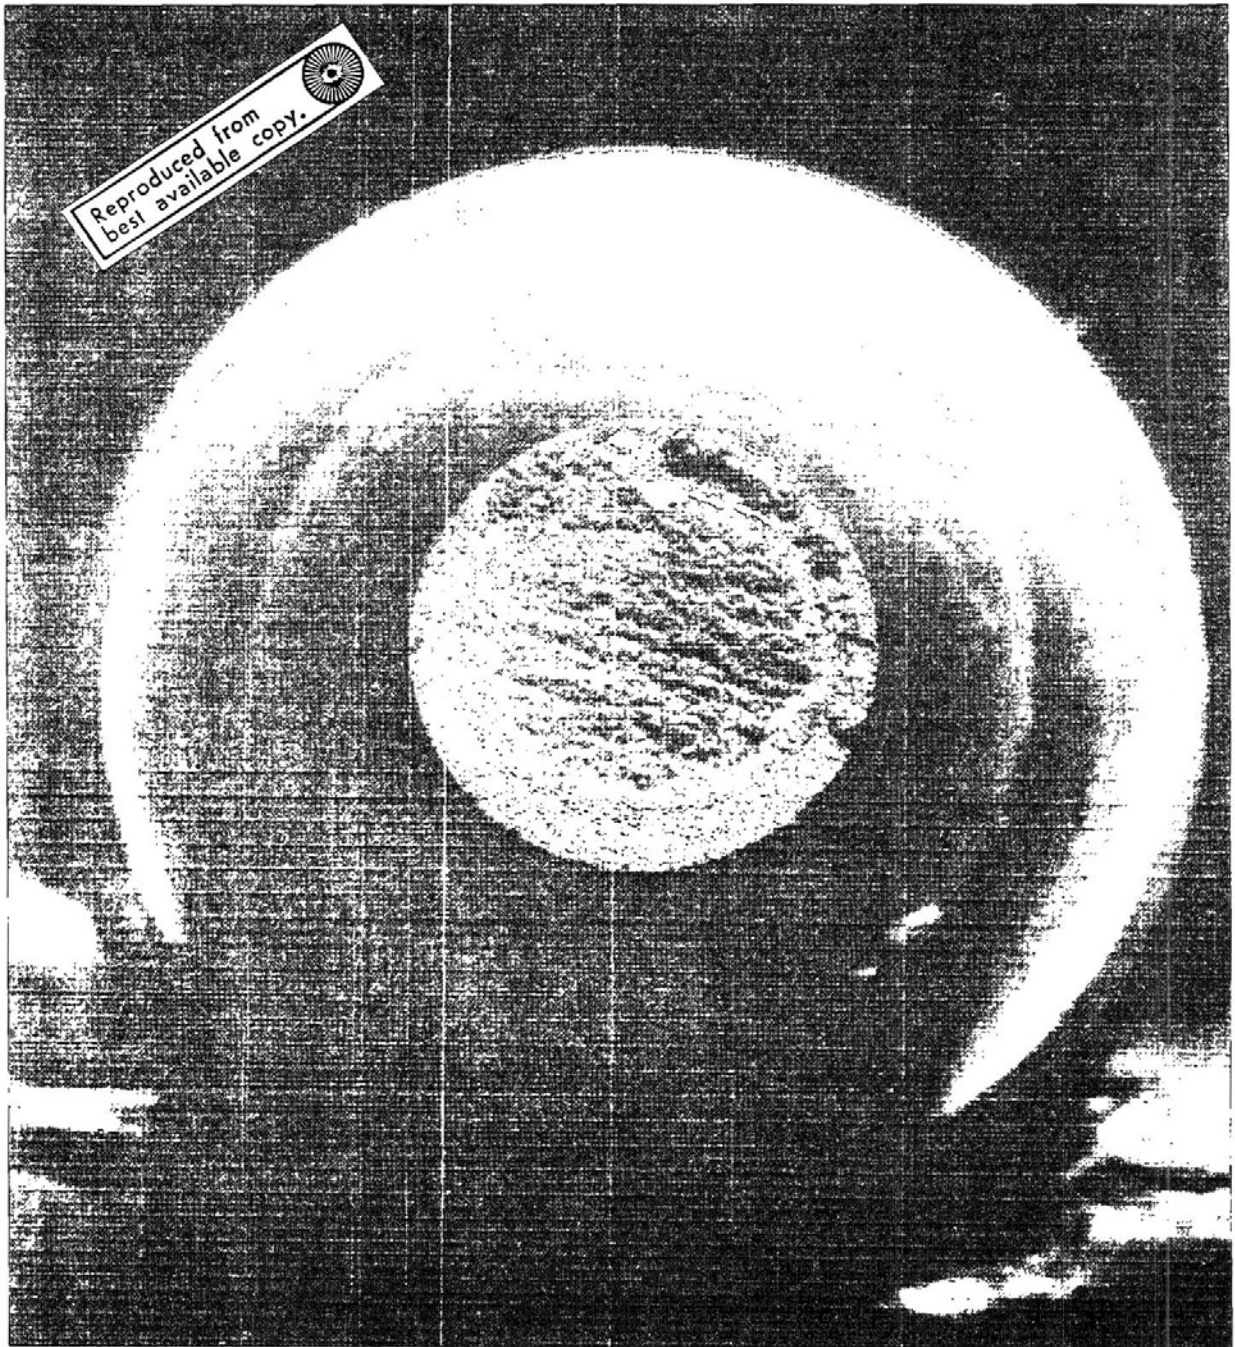
In view of the evidence found during the investigation concerning the fracture of the No. 2 engine fuel pump drive shaft P/N 208235, a visual metallurgical examination of this part was conducted by the Safety Board. This examination revealed that there was a complete transverse fracture in the shaft in a 3/8-inch diameter reduced section about 1-7/8 inches from the larger (7/8-inch major diameter) splined end. The appearance of the mating fracture faces, as viewed through a binocular microscope, indicated that the fracture resulted from the propagation of fatigue cracks from the surface of the reduced section of the shaft.

Pratt & Whitney reported that a laboratory examination of the broken fuel pump drive shaft indicated that the fracture was caused by fatigue, which resulted from a rotating beam-type loading.

An extrapolation of the above cited rig test and fatigue origin data, coupled with a comparison of the similarity between the fracture surface of the broken fuel pump drive shaft (Appendix G) and the test specimen that was subjected to a stress range of 160,000 to 165,000 p.s.i. (Appendix H), led to the estimation by Pratt & Whitney that a stress in excess of 180,000 p.s.i. was required to fail the broken fuel pump drive shaft.

The manufacturer indicated that it was not possible to determine the specific number of cycles from the initiation of the fatigue crack to the final failure since the stress level or time exposure to the stress necessary to initiate the crack is not known. However, based on the aforesaid rig test, there is an indication that the failure could have occurred in fewer than 2,000 cycles from initiation of a crack. This is evidenced by the similarity between the rig failed shaft and engine failed shaft in that the rig failure had at least 40 fatigue origins. These origins were very similar in appearance.

The fuel pump drive shaft splines bore evidence of normal as well as abnormal wear. The normal wear was obvious, due to its pattern and axial location, on the driven side of the spline. The abnormal wear was particularly evidenced by the wear on the nondriven side. This degree of abnormal wear further substantiated a high

Results of examination and testing of the fuel pump drive shaft showed that the fracture was caused by fatigue resulting from a rotating beam type loading.

The loading induced on this shaft was due to an extreme misalignment between the fuel pump and the spur gear drive shaft. It was estimated that the misalignment created a bending stress in excess of 180,000 p.s.i. in the fuel pump drive shaft. Such a high bending stress results in ratchet marks, indicating multiple fatigue origins, which increase in number with the degree of stress concentration and stress level. The number of cycles to failure is primarily dependent on the level of this bending stress. In this case, the number of cycles is assumed to have been low. Inspection of the fuel pump drive shaft fracture surfaces revealed an extremely high number (at least 50) of fatigue origins.

Failed Fuel Pump Drive Shaft P/N 208235 from UAL Engine 656059 Involved in Philadelphia Incident. . .Boeing 737 N900 5U, Flight 611, No. 2 Position, 7/19/70. Viewed Toward Gearbox.

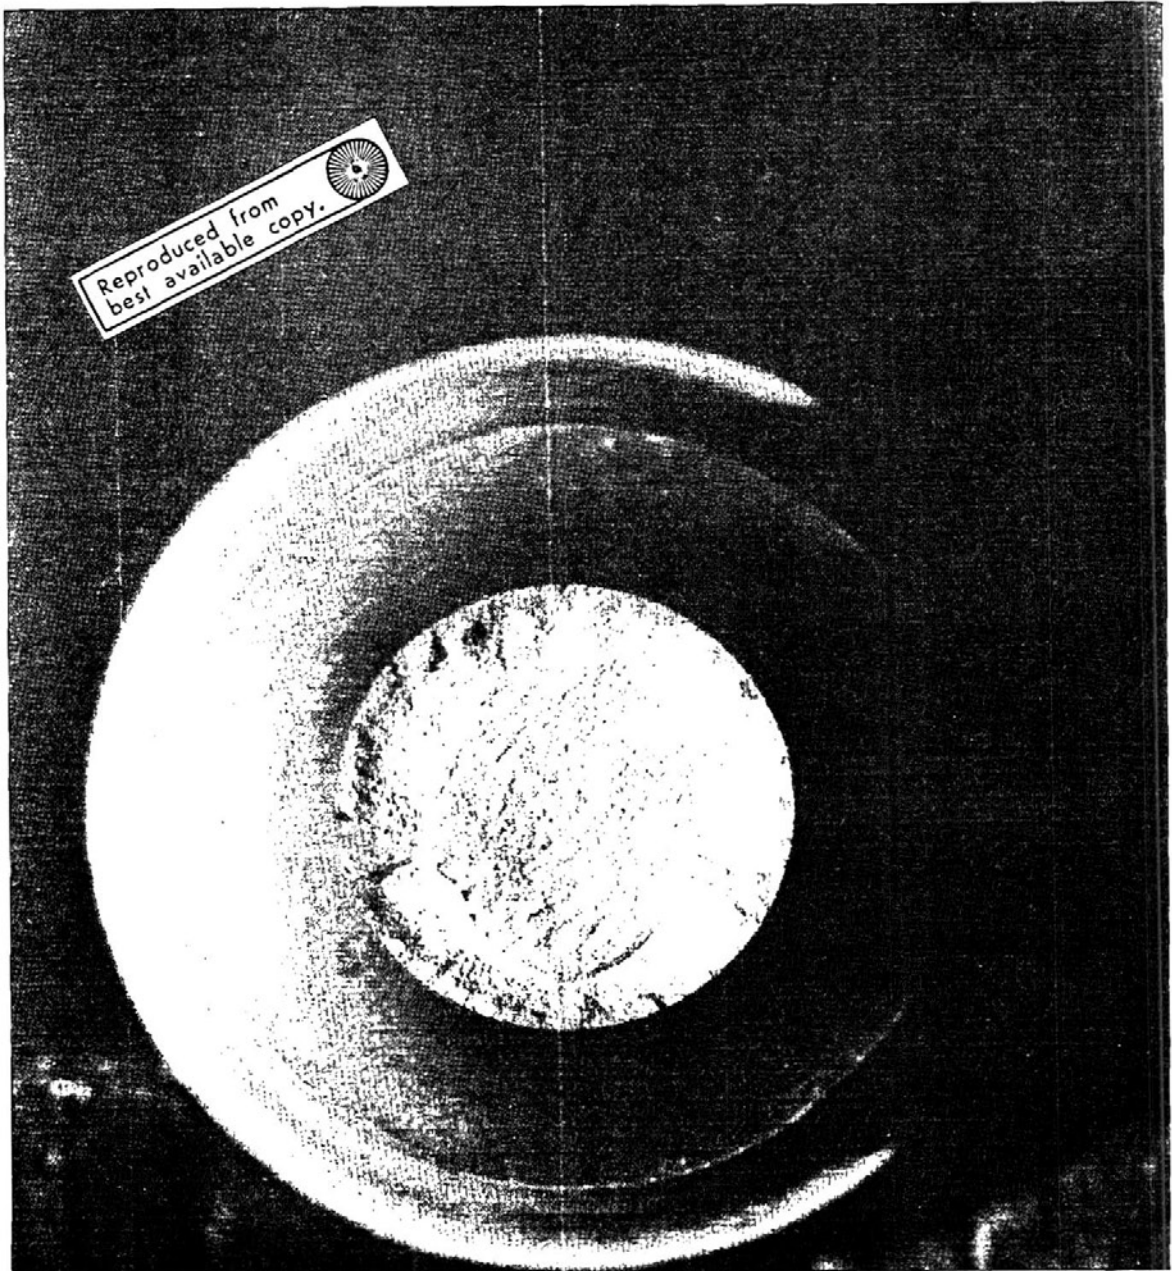
In order to study the effects of this misalignment, Pratt & Whitney performed a simplified rig test wherein test specimens were subjected to a known stress range and the number of rotational cycles to failure were counted.

Fuel Pump Shaft Test Simulation – Bending Stress 160,000-165,000 PSI – 3500 Cycles
