Uncontained engine failure, Air France, Boeing 747-128, F-BPVD, St. Jean, P.Q., Canada, August 17, 1970

AIRCRAFT INCIDENT REPORT

**AIR FRANCE
BOEING 747-128, F-BPVD
ST. JEAN, P.Q., CANADA
AUGUST 17, 1970**

**NATIONAL TRANSPORTATION SAFETY BOARD
Bureau of Aviation Safety
Washington, D. C. 20591**

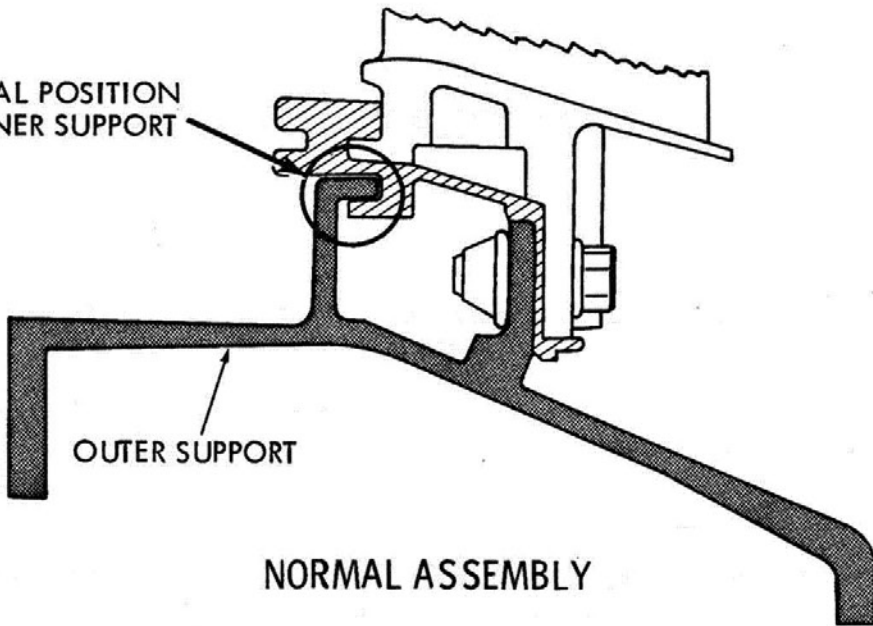
NORMAL ASSEMBLY

NORMAL POSITION
OF INNER SUPPORT

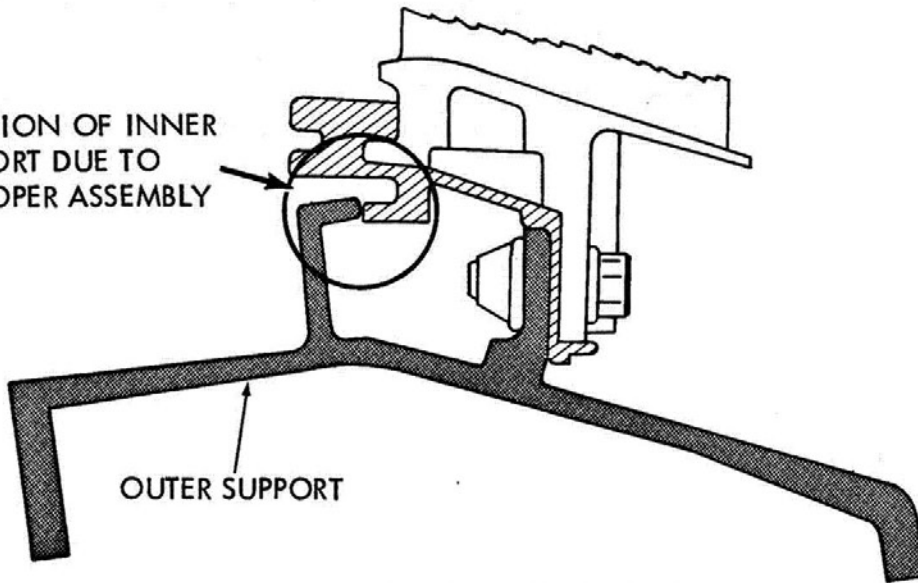
INCORRECT ASSEMBLY

installed in this engine, was not correctly assembled. The result was a transient condition of second-stage turbine disk rub against the second-stage turbine vanes, causing grooving of the disk in the rim area. This occurred during application of takeoff thrust when maximum gas velocities in a rearward direction existed. Progressive weakening of the disk around its periphery resulted in separation of the disk rim, and fragments of the rim penetrated the high-pressure turbine case and caused varied degrees of secondary damage and localized fire.

Mr. Frank Taylor. The cause of the disc failure was reported by P&WA at this meeting. It was established that incorrect installation of the second-stage turbine stator vane outer support permitted the stator ring and seal to deflect and contact the second-stage turbine disc at takeoff power output, causing eventual failure of the disc. This engine had been operated 267 hours and had 58 operating cycles. P&WA was directed to review assembly tolerances, fits, and procedures with the FAA for adequacy for both production and field use. P&WA will revise assembly procedures and instructions as found necessary by this review.

POSITION OF INNER
SUPPORT DUE TO
IMPROPER ASSEMBLY

As a result of this incident and identification of the failure mechanism, the manufacturer's assembly and inspection procedures were revised to provide for sequence torquing of the 90 bolts securing the second-stage nozzle guide vanes and a measurement of critical axial dimension to ascertain correct assembly and fits.
