**Loss of control, Trans International Airlines Corp., Ferry Flight 863,
Douglas DC-8-63F, N4863T, J. F. Kennedy International Airport, New York,
September 8, 1970**

AIRCRAFT ACCIDENT REPORT

FERRY FLIGHT 863, DOUGLAS DC-8-63F, N4863T

REPORT NUMBER: NTSB-AAR-71-12

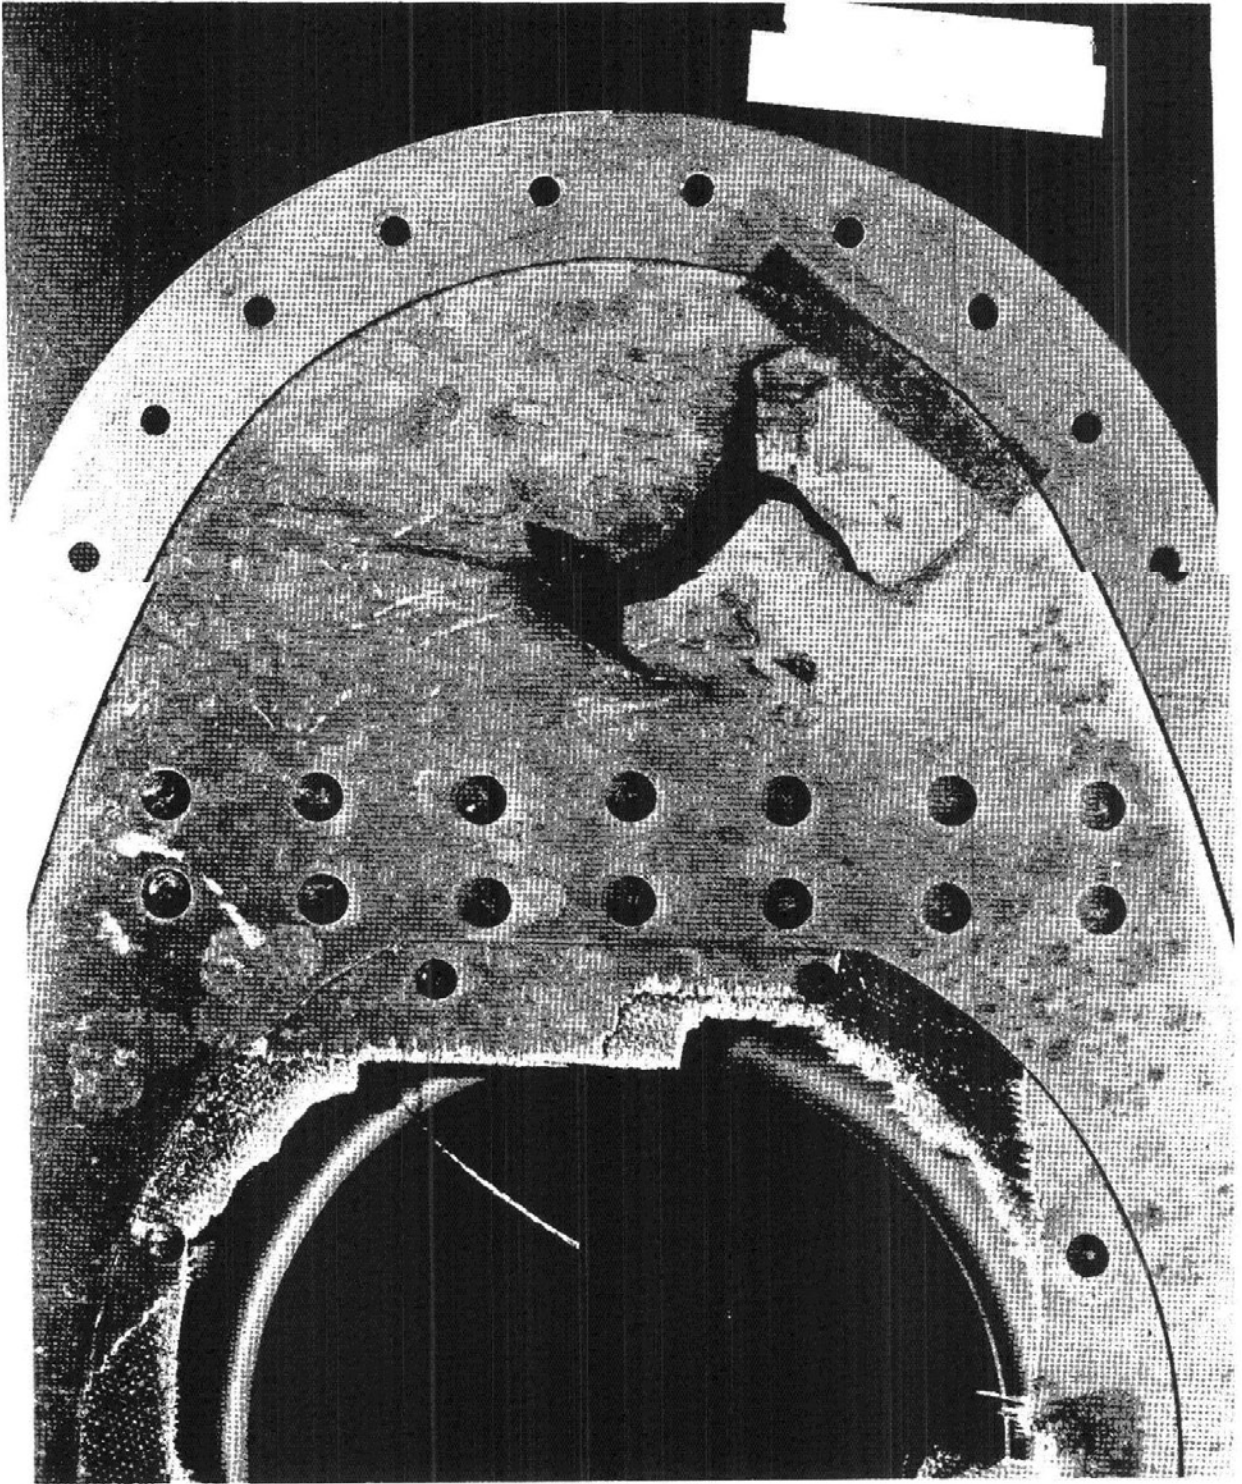
During the examination of the right horizontal stabilizer, a hole was found in a rear spar web access door at approximately stabilizer Station 32. This hole appeared to have been punched in the access door by a foreign object. On that portion of the leading edge of the right elevator that faced the hole, an area of scratches and gouges was found. There were scratches adjacent to and below the hole in the access door and a smear of asphaltic material adhered to the metal near the hole. (See Attachment No. 2.)

Examination of the leading edge of the right elevator and the trailing face of the right stabilizer indicated that an irregular shaped, asphalt-covered, hard object was lodged between the two surfaces. Calculations based on the fresh scars and marks in this area indicated that the elevator was approximately 12° trailing edge up when sufficient force was applied to cause the foreign object to scar and pit the metal. Scrape marks on the access door indicated that the object skidded or slid, under pressure, up the face of the door. Finally, the object punched an irregular hole in the door and then fell free, probably upon impact. (See Attachment 2.)
