Hard landing, Alitalia Airlines, McDonnell-Douglas DC-8-62, I-DIWZ (Italian Registry), John F. Kennedy International Airport, Jamaica, New York, September 15, 1970

AIRCRAFT ACCIDENT REPORT

MCDONNELL-DOUGLAS DC-8-62, I-DIWZ

REPORT NUMBER: NTSB AAR-71-9

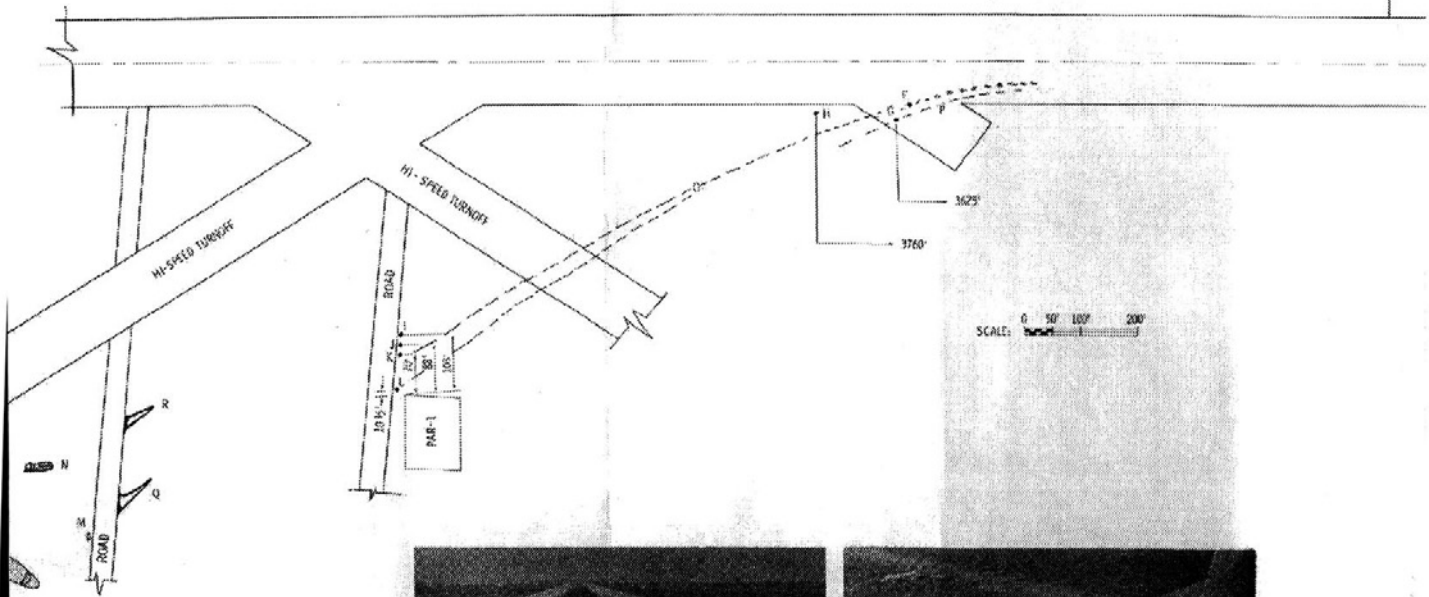
WRECKAGE DISTRIBUTION CHART
ALITALIA DOUGLAS DC-8, I-DIWZ
J.F. KENNEDY INTERNATIONAL AIRPORT, N.Y.
September 15, 1970

The first indication of a touchdown on the runway surface was a sharply defined score beginning 1,590 feet beyond the threshold of Runway 4R. This score was approximately one-half inch wide and varied in depth to three-

quarters of an inch. The score was located 9 inches to the left of the runway centerline. (See Appendix D for wreckage distribution chart and location of scoring marks on the runway.)
