**Hard landing, Eastern Air Lines, Inc., DC-9-31, N8961E, Fort Lauderdale, Florida, May 18, 1972**

**AIRCRAFT ACCIDENT REPORT**

**DC-9-31, N8961E**

Report Number: **NTSB-AAR-72-31**

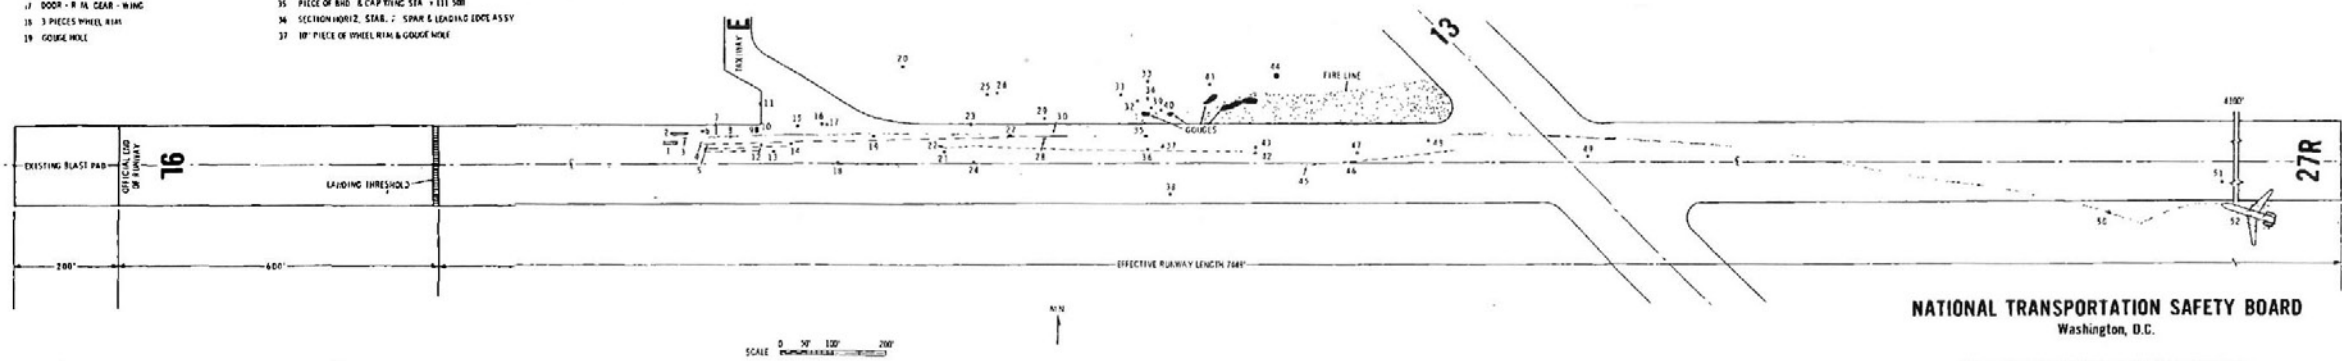
**WRECKAGE DISTRIBUTION CHART**  
 EASTERN AIRLINES, INC. DOUGLAS DC-9-31, N8961E  
 FORT LAUDERDALE - HOLLYWOOD INTERNATIONAL AIRPORT  
 Fort Lauderdale, Florida  
 May 18, 1972

The right main landing gear with a section of the rear spar web separated from the aircraft at impact. The left main landing gear was pushed up and to the rear but remained attached to the left wing. The nose gear was found in the down and locked position. The wing-leading edge slats were fully extended. The exact position of the trailing edge flaps could not be determined because of the damage caused by the collapse of the main landing gear. All spoiler panels were found in the retracted position. All flight control surfaces were accounted for, and no discrepancies were found in any flight control system. The stabilizer was positioned at 2.5°, aircraft nose up.
