Loss of control, Delta Air Lines, Inc., McDonnell Douglas DC-9-14, N3305L, Greater Southwest International Airport, Fort Worth, Texas, May 30, 1972

AIRCRAFT ACCIDENT REPORT

MCDONNELL DOUGLAS DC-9-14, N3305L

REPORT NUMBER: NTSB-AAR-73-3

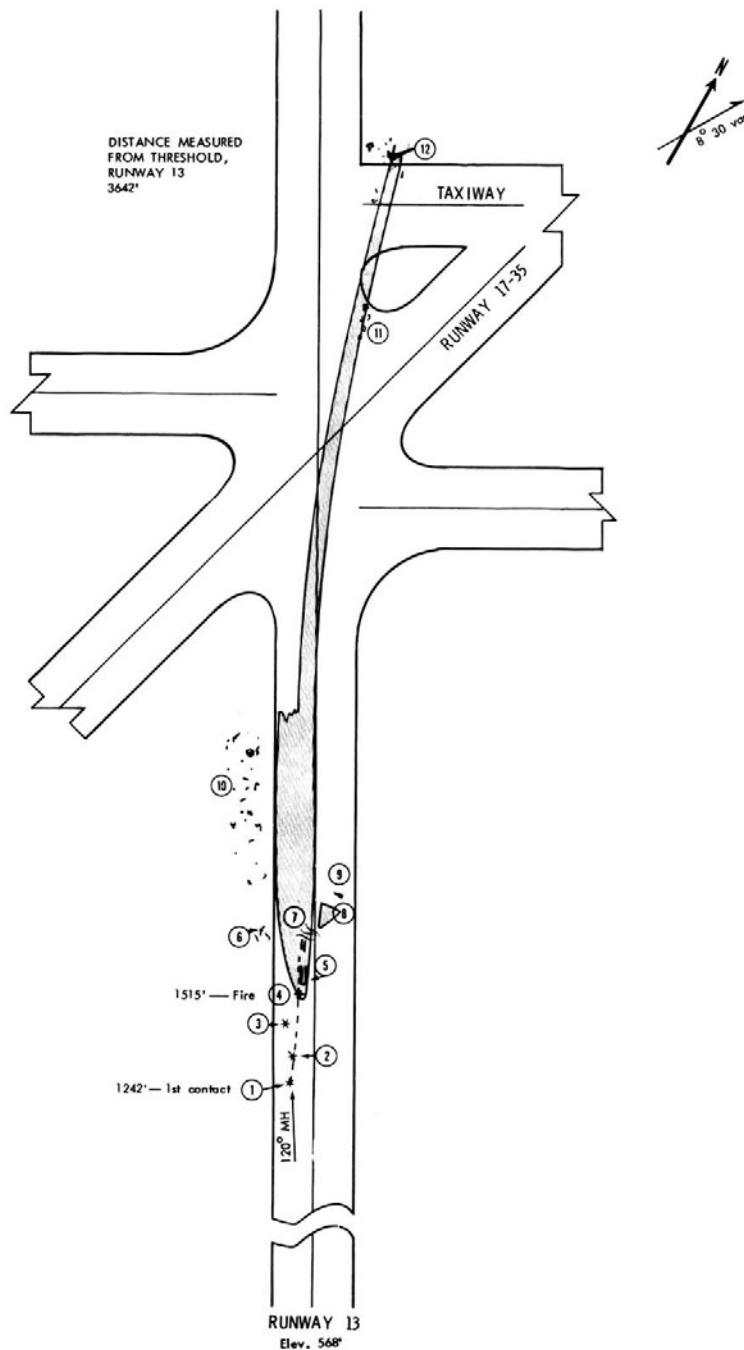
The initial marks on the runway continued in a slight curve to the right for approximately 340 feet down the left side of the runway. A fuel stain on the runway originated 84 feet from the initial impact mark, and ground fire originated 273 feet beyond the point of initial contact.

A continuous trail, made by fire, extended from that point to the main wreckage site. The parts of the airplane, including right wing fuel system components, outside of this trail were neither burned nor sooted. (See Wreckage Distribution Chart, Appendix F.)

1. First contact - score in runway surface.
2. Unburned fuel on runway surface.
3. Green material from right navigation light.
4. Ground fire area.
5. Mark on runway with paint smears similar to paint scheme on the sides on the fuselage nose section.
6. Pieces of right wing tip and adjacent structure.
7. Gouges and scores in runway surface which approximate the geometry of the inverted empennage.
8. Spray of red and clear material from left navigation light.
9. Window trim panel from cabin interior.
10. Scattered parts from outer portion of right wing.
11. Pieces of radome, cabin interior trim and fuselage structure.
12. Main wreckage.
