Midair collision, North Central Airlines, Inc., Allison Convair 340/440, (CV-580) N90858, And Air Wisconsin Incorporated, DHC-6, N4043B, near Appleton, Wisconsin, June 29, 1972

NATIONAL TRANSPORTATION SAFETY BOARD
Washington, D.C. 20591
REPORT NUMBER: NTSB-AAR-73-9

NORTH CENTRAL AIRLINES, INC., ALLISON CONVAIR 340/440, (CV-580) N90858
 AND
 AIR WISCONSIN INCORPORATED, DHC-6, N4043B
 NEAR APPLETON, WISCONSIN
 JUNE 29, 1972

SYNOPSIS

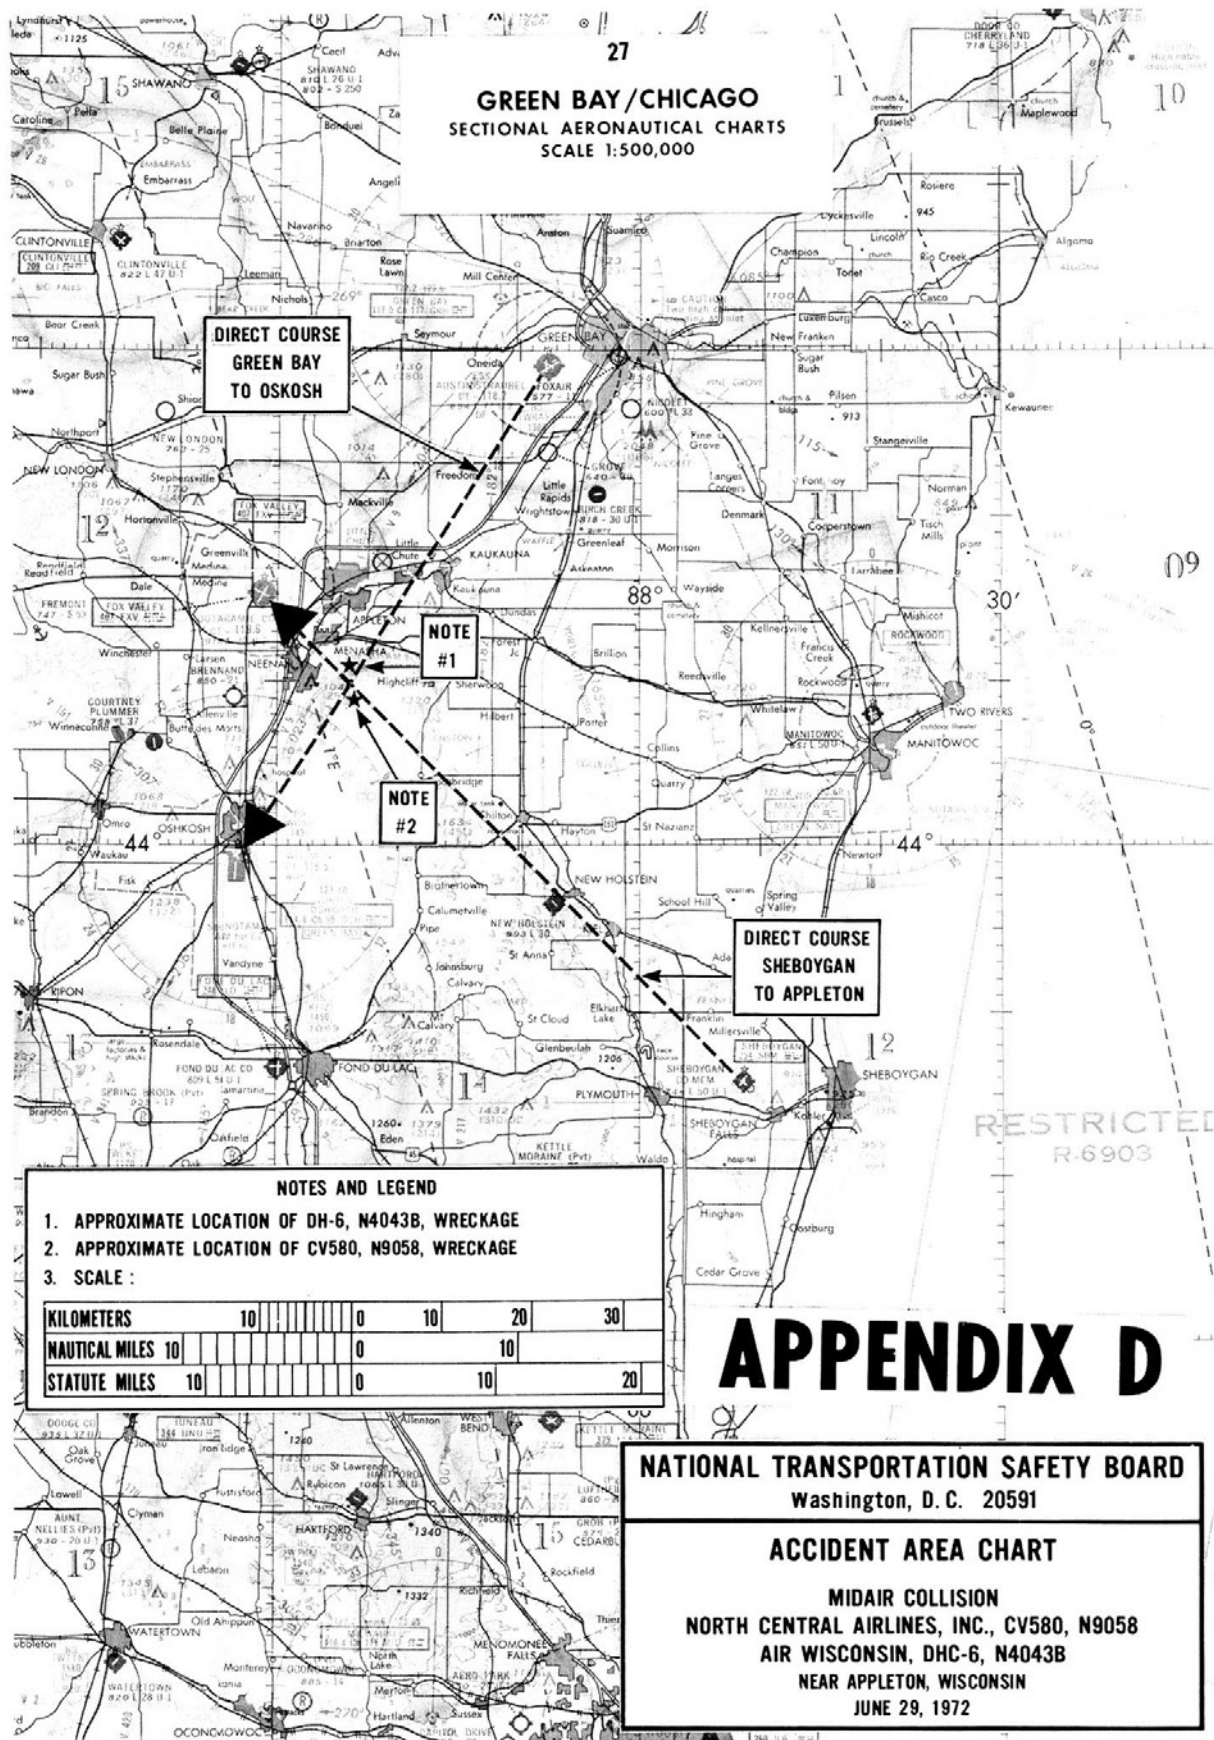
GREEN BAY/CHICAGO
SECTIONAL AERONAUTICAL CHARTS
SCALE 1:500,000

Straight line courses drawn from each flight's departure point to its respective destination intersect approximately at the collision point. (See Appendix D.)

**DIRECT COURSE
GREEN BAY
TO OSKOSH**

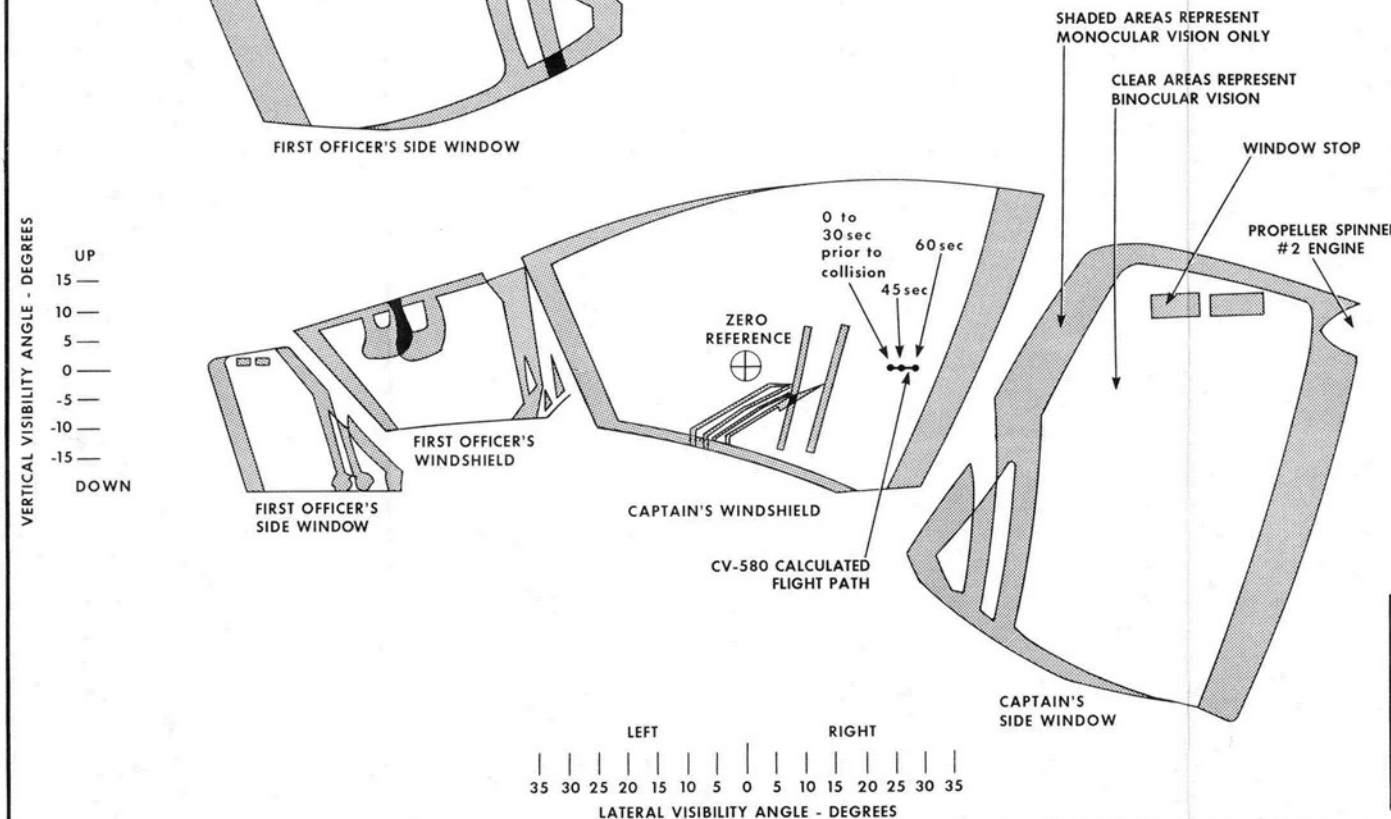
DHC-6 RIGHT SEAT
 VISIBILITY FROM CAPTAIN'S PROBABLE
 EYE REFERENCE POINT
 CAPTAIN OCCUPIED RIGHT SEAT

the right of the captain's and first officer's zero reference points for the final 30 seconds of flight. Sun position would have resulted in better illumination of the CV-580 as a target, and, at the low closure rates involved, the CV-580 should have had a higher probability of detection. However, the mitigating conditions described that reduced the fidelity of the DHC-6 target would similarly affect the fidelity of the target presented by the CV-580. The fixed bearing for the last 30 seconds would have severely limited the DHC-6 crew's ability to perceive target motion, speed, altitude and rate of closure. If the target were sighted during these 30 seconds, the fixed bearing should have alerted the DHC-6 crew that a collision threat existed.

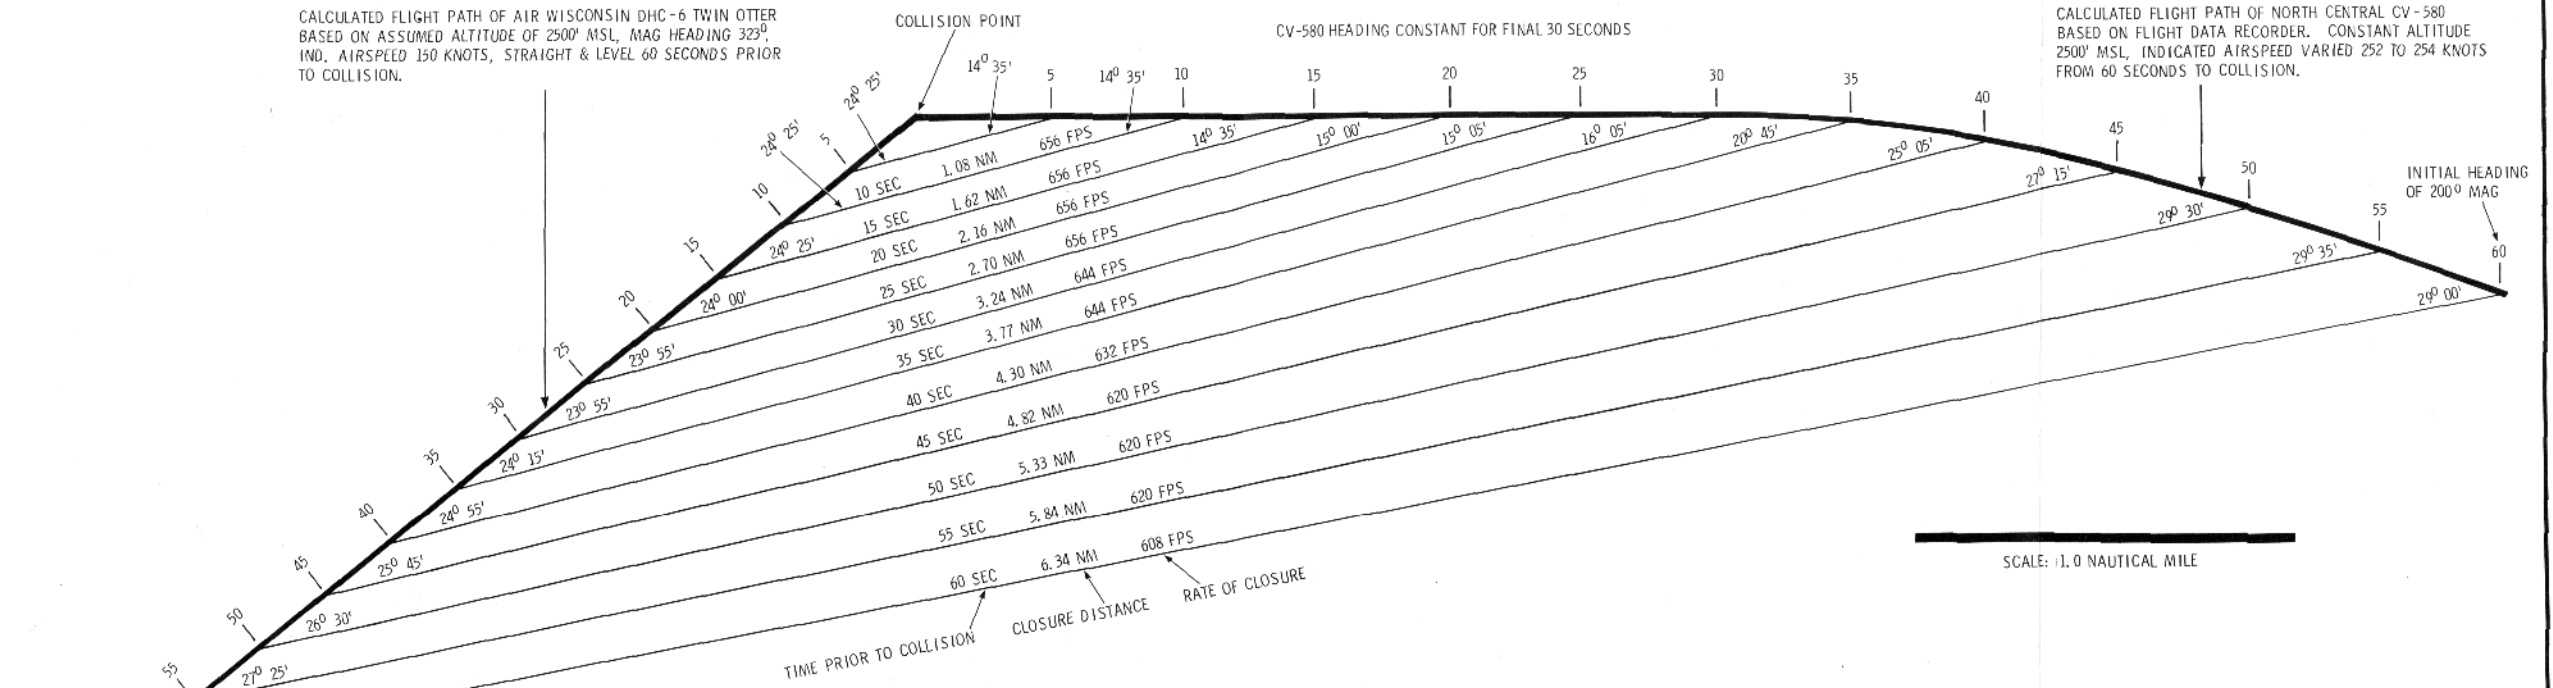
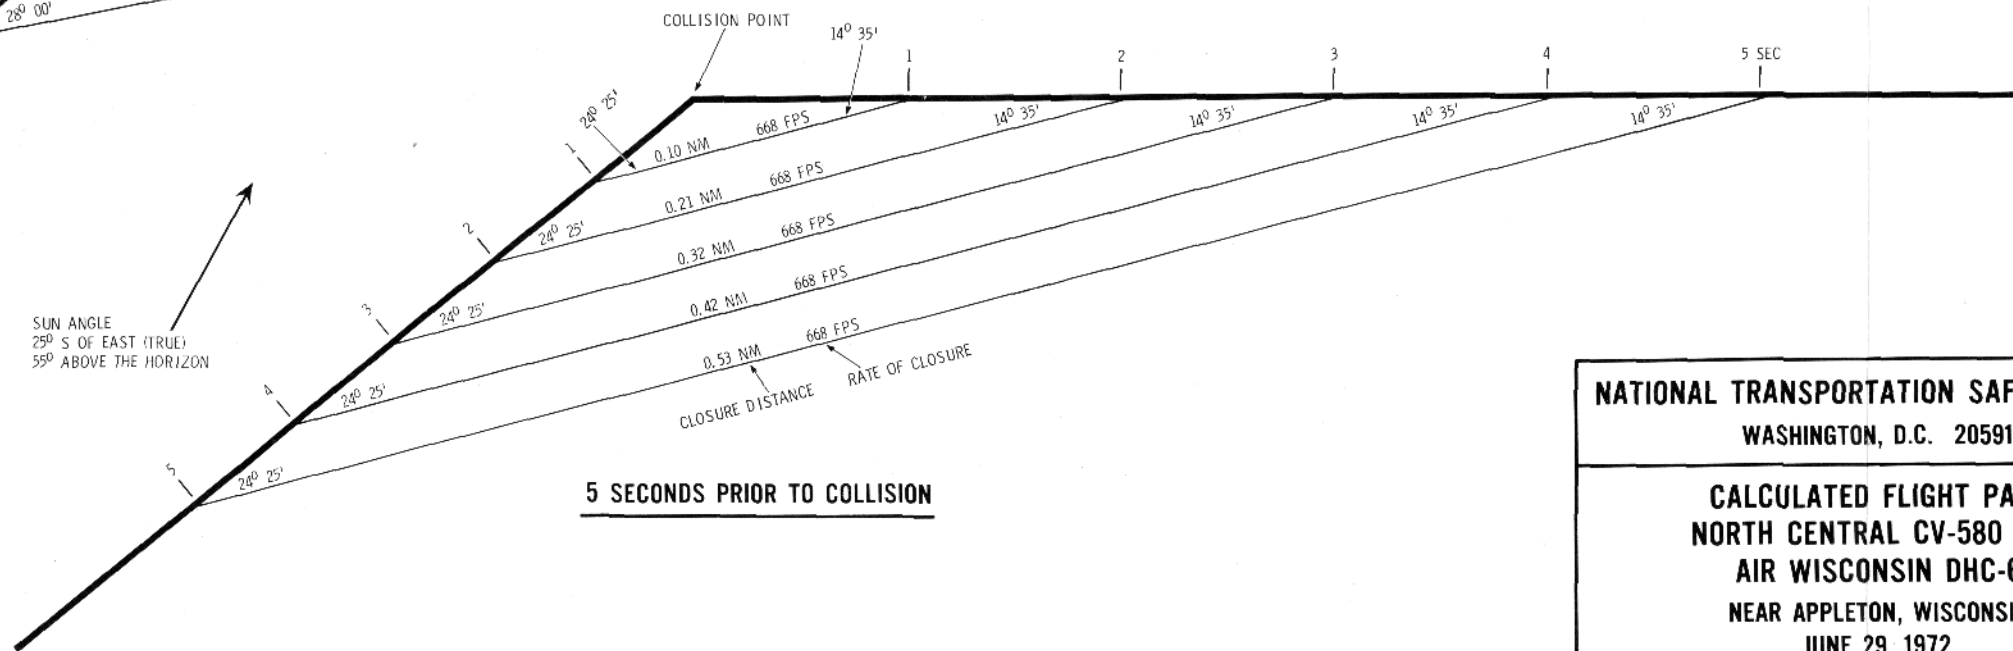
CALCULATED FLIGHT PATH
NORTH CENTRAL CV-580 AND
AIR WISCONSIN DHC-6
NEAR APPLETON, WISCONSIN
JUNE 29, 1972

CV-580 HEADING CONSTANT FOR FINAL 30 SECONDS

CALCULATED FLIGHT PATH OF NORTH CENTRAL CV-580
BASED ON FLIGHT DATA RECORDER. CONSTANT ALTITUDE
2500' MSL, INDICATED AIRSPEED VARIED 252 TO 254 KNOTS
FROM 60 SECONDS TO COLLISION.

SUN ANGLE
25° S OF EAST (TRUE)
55° ABOVE THE HORIZON

5 SECONDS PRIOR TO COLLISION
