Descent and crash into Everglades, Eastern Air Lines, Inc., L-1011, N310EA, Miami, Florida, December 29, 1972

AIRCRAFT ACCIDENT REPORT

EASTERN AIR LINES, INC.
L-1011, N310EA
MIAMI, FLORIDA
DECEMBER 29, 1972

NATIONAL TRANSPORTATION SAFETY BOARD
Washington, D.C. 20591
REPORT NUMBER: NTSB-AAR-73-14

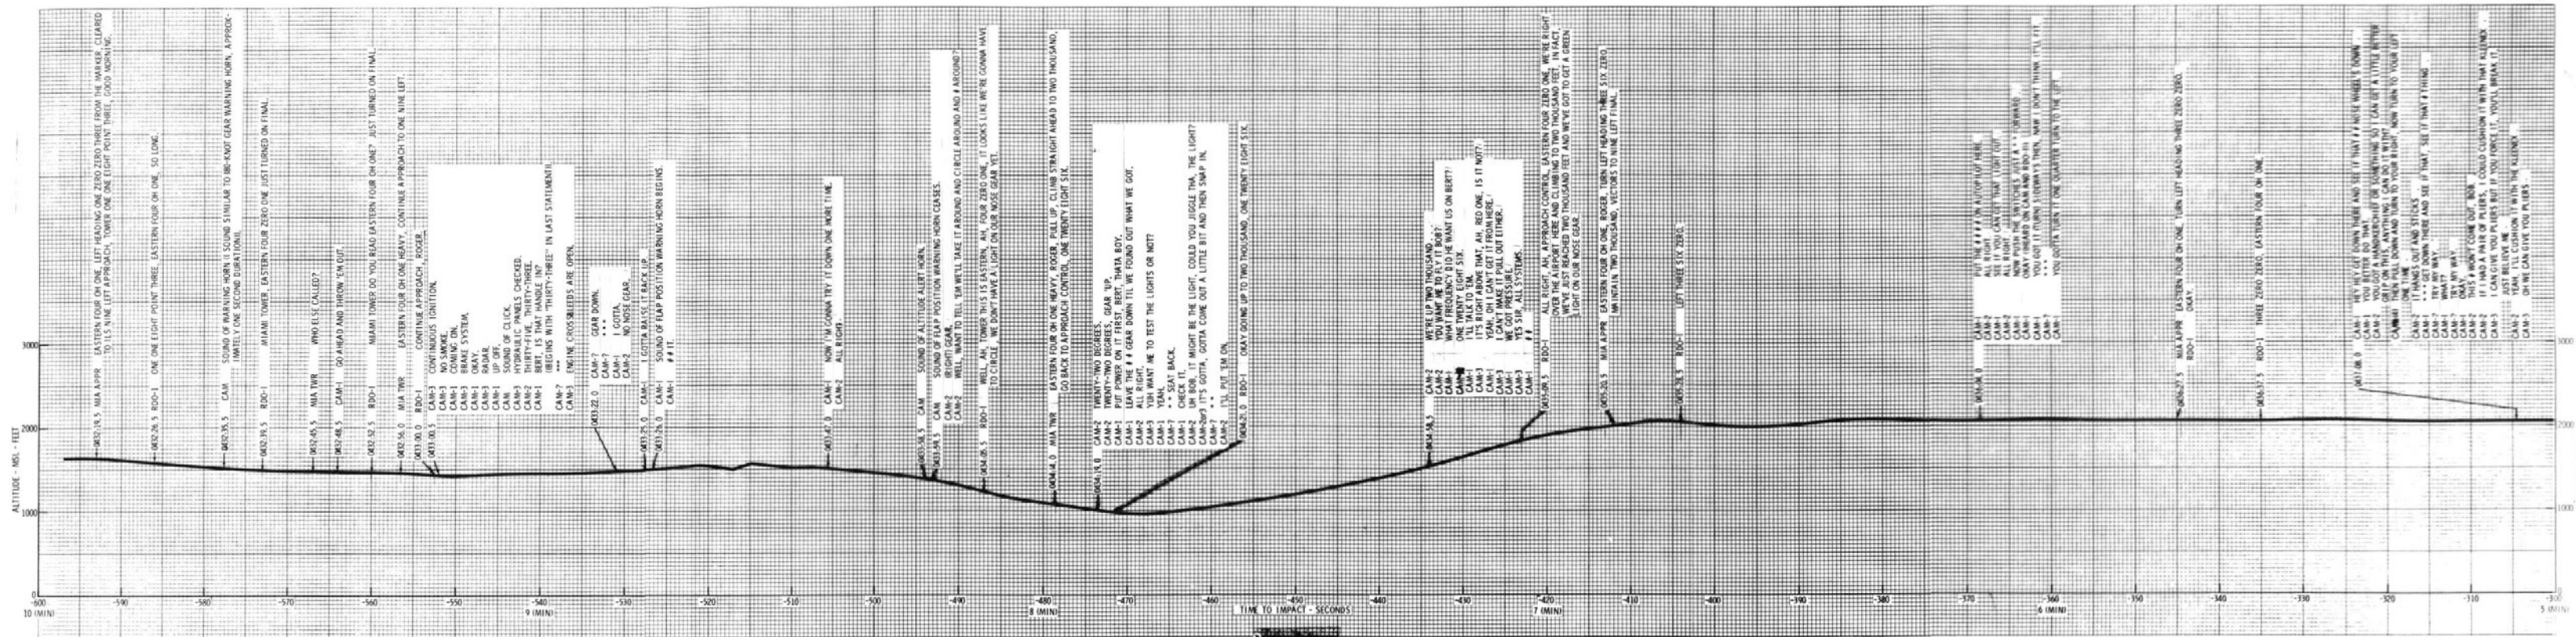
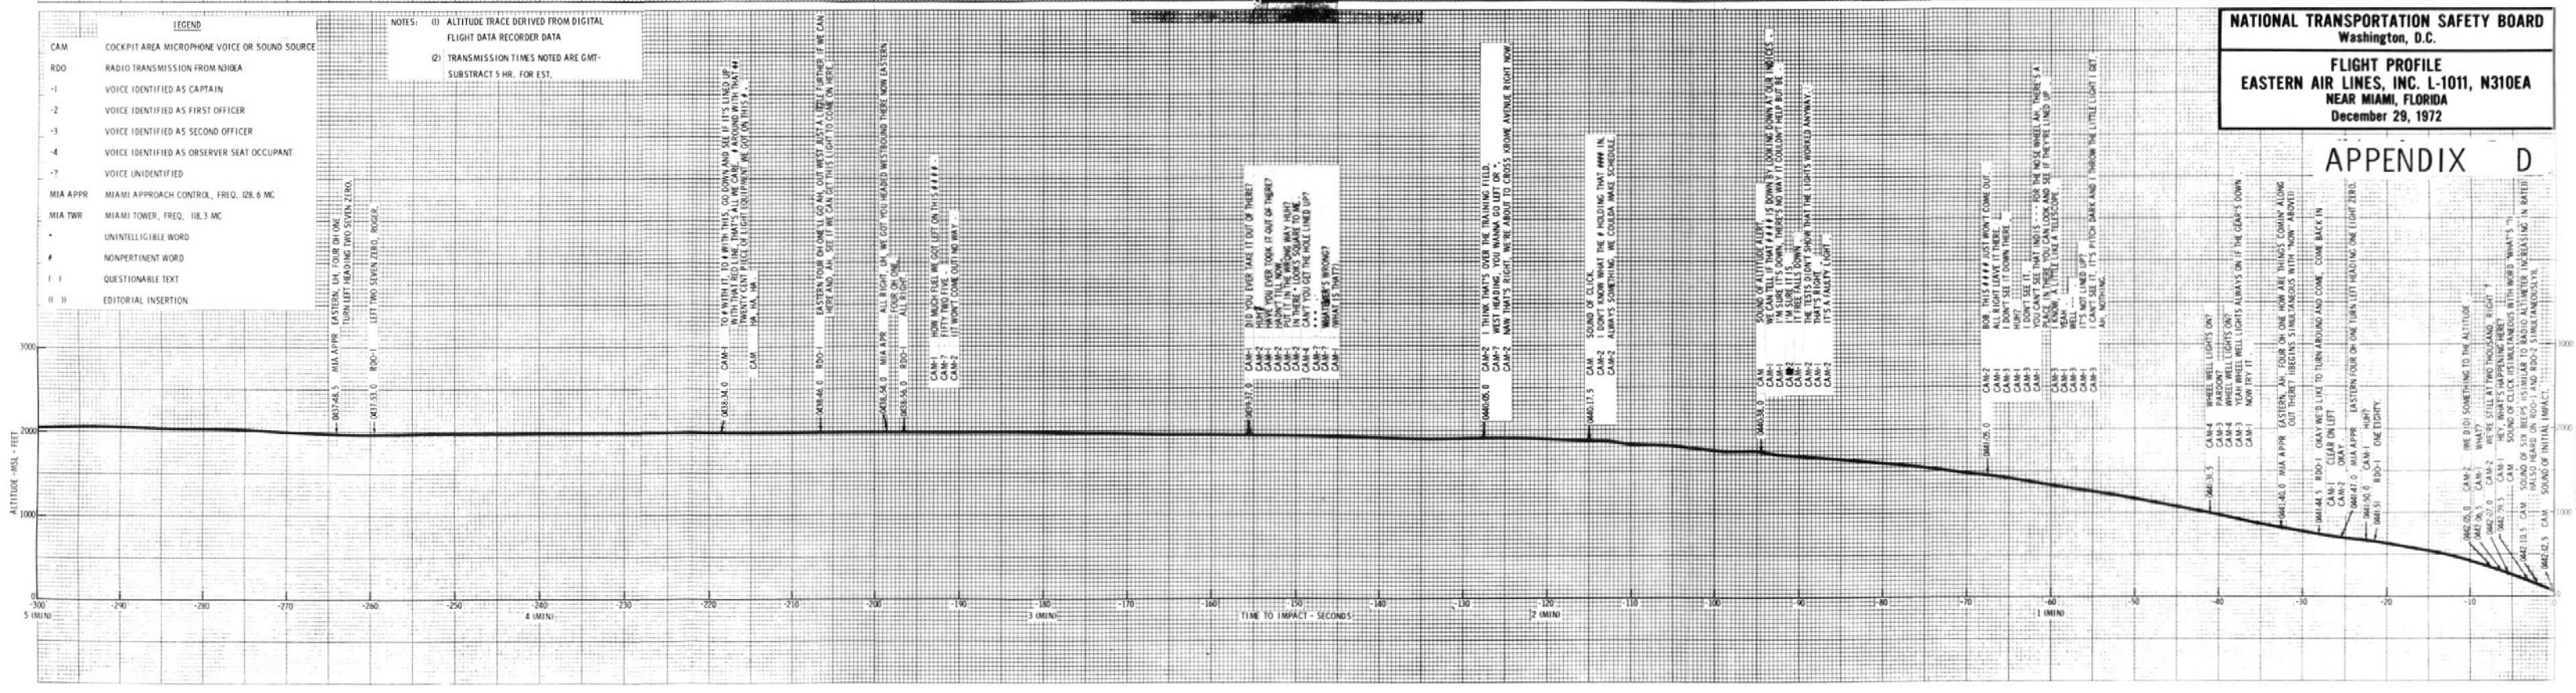
FLIGHT PROFILE
EASTERN AIR LINES, INC. L-1011, N310EA
NEAR MIAMI, FLORIDA
December 29, 1972

At approximately 2337, some 288 seconds prior to impact, the DFDR readout indicates a vertical acceleration transient of 0.04 g causing a 200-f.p.m. rate of descent. For a pilot to induce such a transient, he would have to intentionally or inadvertently disengage the altitude hold function. It is conceivable that such a transient could have been produced by an inadvertent action on the part of the pilot which caused a force to be applied to the control column. Such a force would have been sufficient to disengage the altitude hold mode. It was noted that the pitch transient occurred at the same time the captain commented to the second officer to "Get down there and see if the ... nose wheel's down." If the captain had applied a force to the control wheel while turning to talk to the second officer, the altitude hold function might have been accidentally disengaged. Such an occurrence could have been evident to both the captain and first officer by the change on the annunciator panel and the extinguishing of the altitude mode select light. If autopilot system "A" were engaged, however, the discrepancy in the disengage force comparators, i. e.,

Reference to the DFDR shows that power on the No. 3 engine was increased slightly, 1 minute before reduction of power on the Nos. 2 and 3 engines (the initiation of the descent profile). This is a normal manual adjustment typically made by a pilot, and cannot be accomplished by the autothrottle system. Additionally, the speed found set on the autothrottle selector dial was 160 knots, a speed well below that attained or maintained during the last 4 minutes of flight.

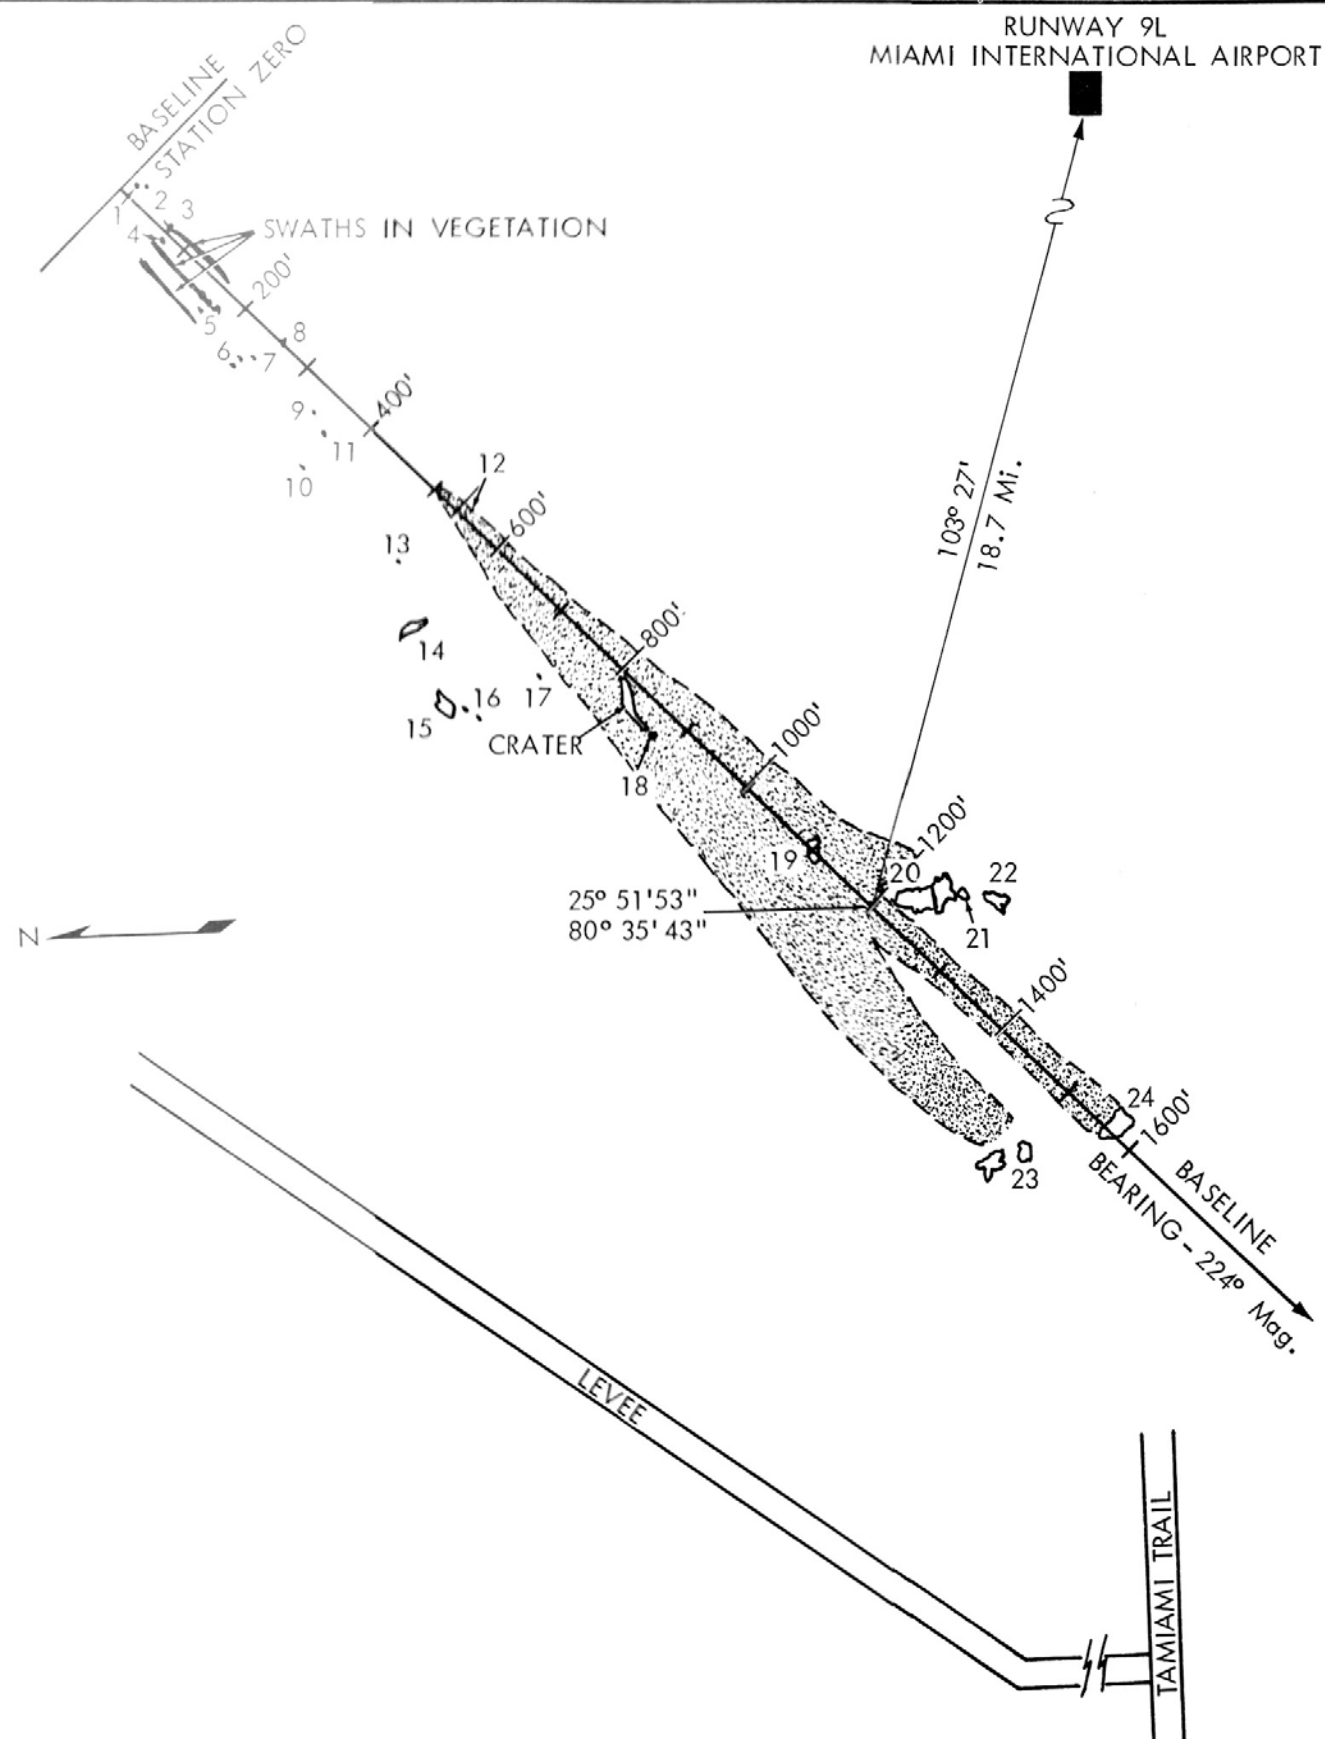
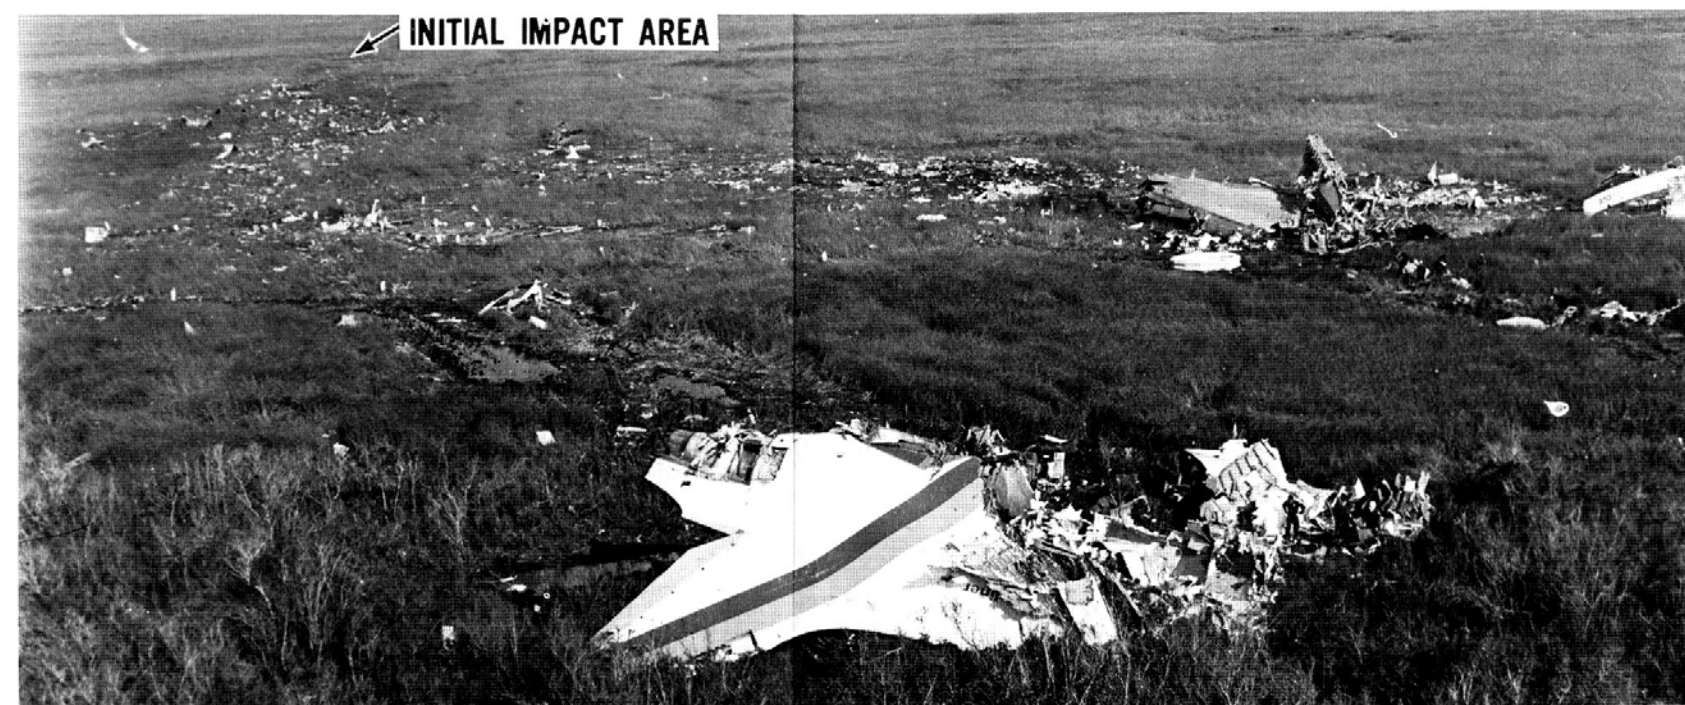
WRECKAGE DISTRIBUTION CHART
EASTERN AIRLINES, INC. L-1011, N 310EA
NEAR MIAMI, FLORIDA
December 29, 1972

The left outer wing structure impacted the ground first; the No. 1 engine, and then the left main landing gear, followed immediately. The aircraft disintegrated, scattering wreckage over an area approximately 1,600 feet long and 300 feet wide. No complete circumferential cross-section remained of the passenger compartment of the fuselage, which was broken into four main sections and numerous small pieces. The entire left wing and left stabilizer were demolished. No evidence of in-flight structural failure, fire, or explosion was found.

- 1-4. Small pieces of left-hand Wing, outer structure.
5. Small Engine parts-2 fan blades, Oil cooler.
6. Engine mount frame, part of No. 1 fan case, oil scavenge filter.
