## Pitch oscillation, Trans World Airlines, Inc., Boeing 707-331B, N8705T, Los Angeles, California, August 28, 1973

TRANS WORLD AIRLINES, INC.  
BOEING 707-331B, N8705T  
LOS ANGELES, CALIFORNIA  
AUGUST 28, 1973

NATIONAL TRANSPORTATION SAFETY BOARD  
Washington, D.C. 20591  
REPORT NUMBER: NTSB-AAR-74-8

Adopted: July 10, 1974

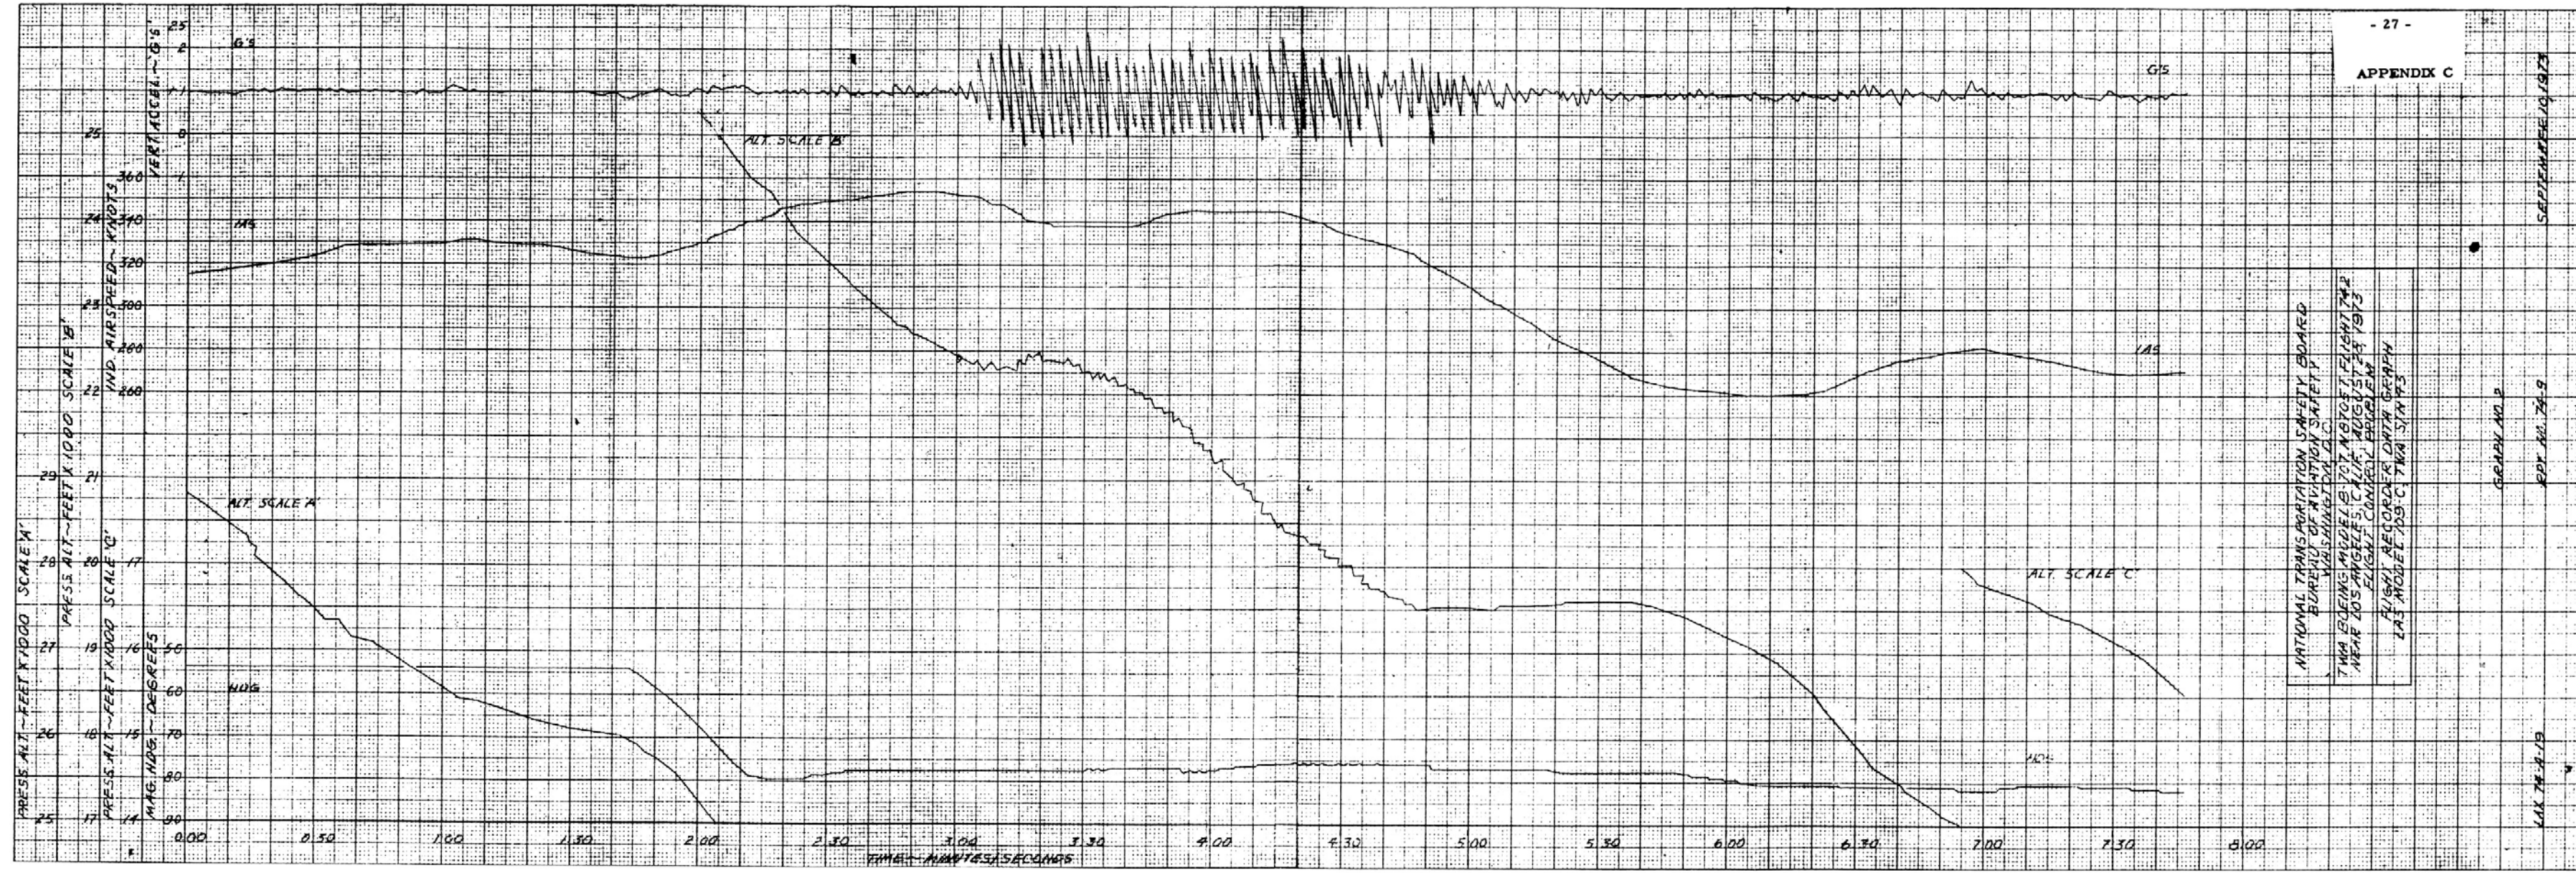
APPENDIX C

The FDR metal foil was removed and examined. (See Appendix C.) The porpoising was evident on the vertical acceleration trace as approximately 55 cycles occurring during a 2-minute period. The indicated airspeed and pressure altitude traces showed that the aircraft was descending about 2,100 feet per minute and was passing through 22,400 feet altitude at 352 kn. when the first significant vertical acceleration peak occurred. The airspeed reduced to 340 kn. during the next 20 seconds and remained between 340 to 345 kn. for about 1 minute. The airspeed then decayed to 300 kn. where the vertical acceleration excursions converged. The altitude remained constant at 22,400 feet for about 25 seconds, after which the aircraft descended. The aircraft was leveled at 19,500 feet as the pitching oscillations ceased.

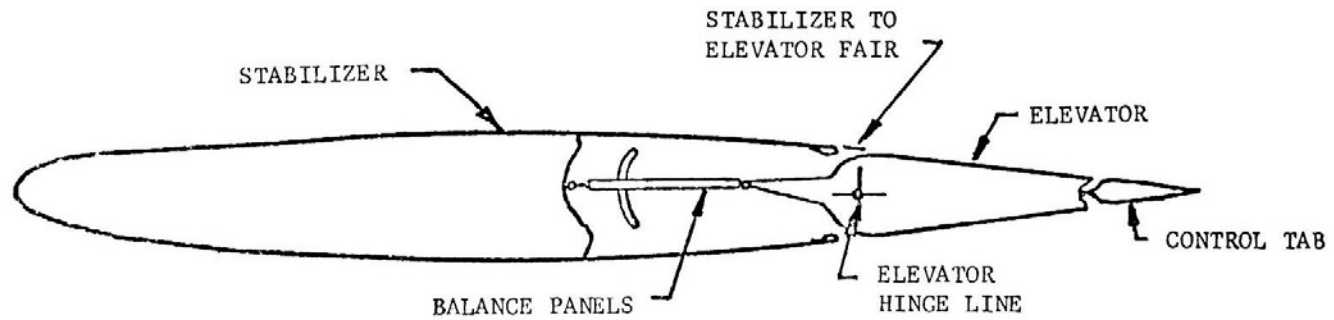
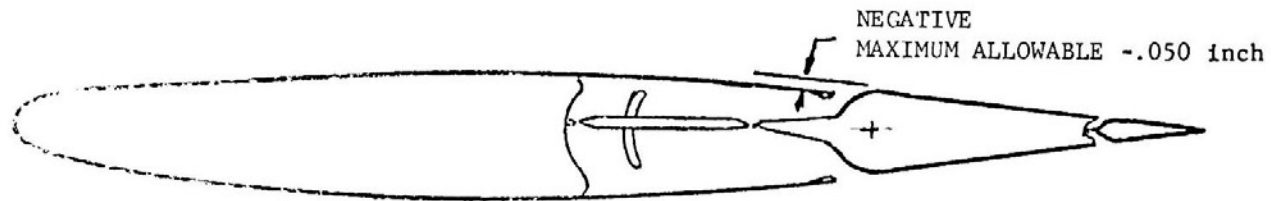
BOEING 707/720 STABILIZER-ELEVATOR CONTOUR FAIR

Boeing Company engineers theorized that the boundary layer effects caused by the upper surface skin waviness would be aggravated by the step down that was predominant at the hinge line on the left elevator.

(c) The upper nose contour of the left elevator at its hinge line was predominantly below the faired contour extension of the upper stabilizer surface. Although the alinement was within prescribed limits, the resulting step down caused further disturbance to the thickened boundary layer. The disturbed flow of air within the boundary layer affected the pressure distribution and thus the resultant lift vector acted on the elevator so that the moment about the elevator hinge caused by air loads on a deflected control surface was lower than normal.

The stabilizer to elevator contour fair was changed on both assemblies to produce a condition wherein the elevator nose contour was predominantly above the stabilizer contour extensions. The alteration was accomplished by removing shims between the stabilizer trailing edge beam and the elevator hinge support structure.
