Uncontained engine failure, National Airlines, Inc., DC-10-10, N60NA, Near Albuquerque, New Mexico, November 3, 1973

AIRCRAFT ACCIDENT REPORT

DC-10-10, N60NA

REPORT NUMBER: NTSB-AAR-75-2

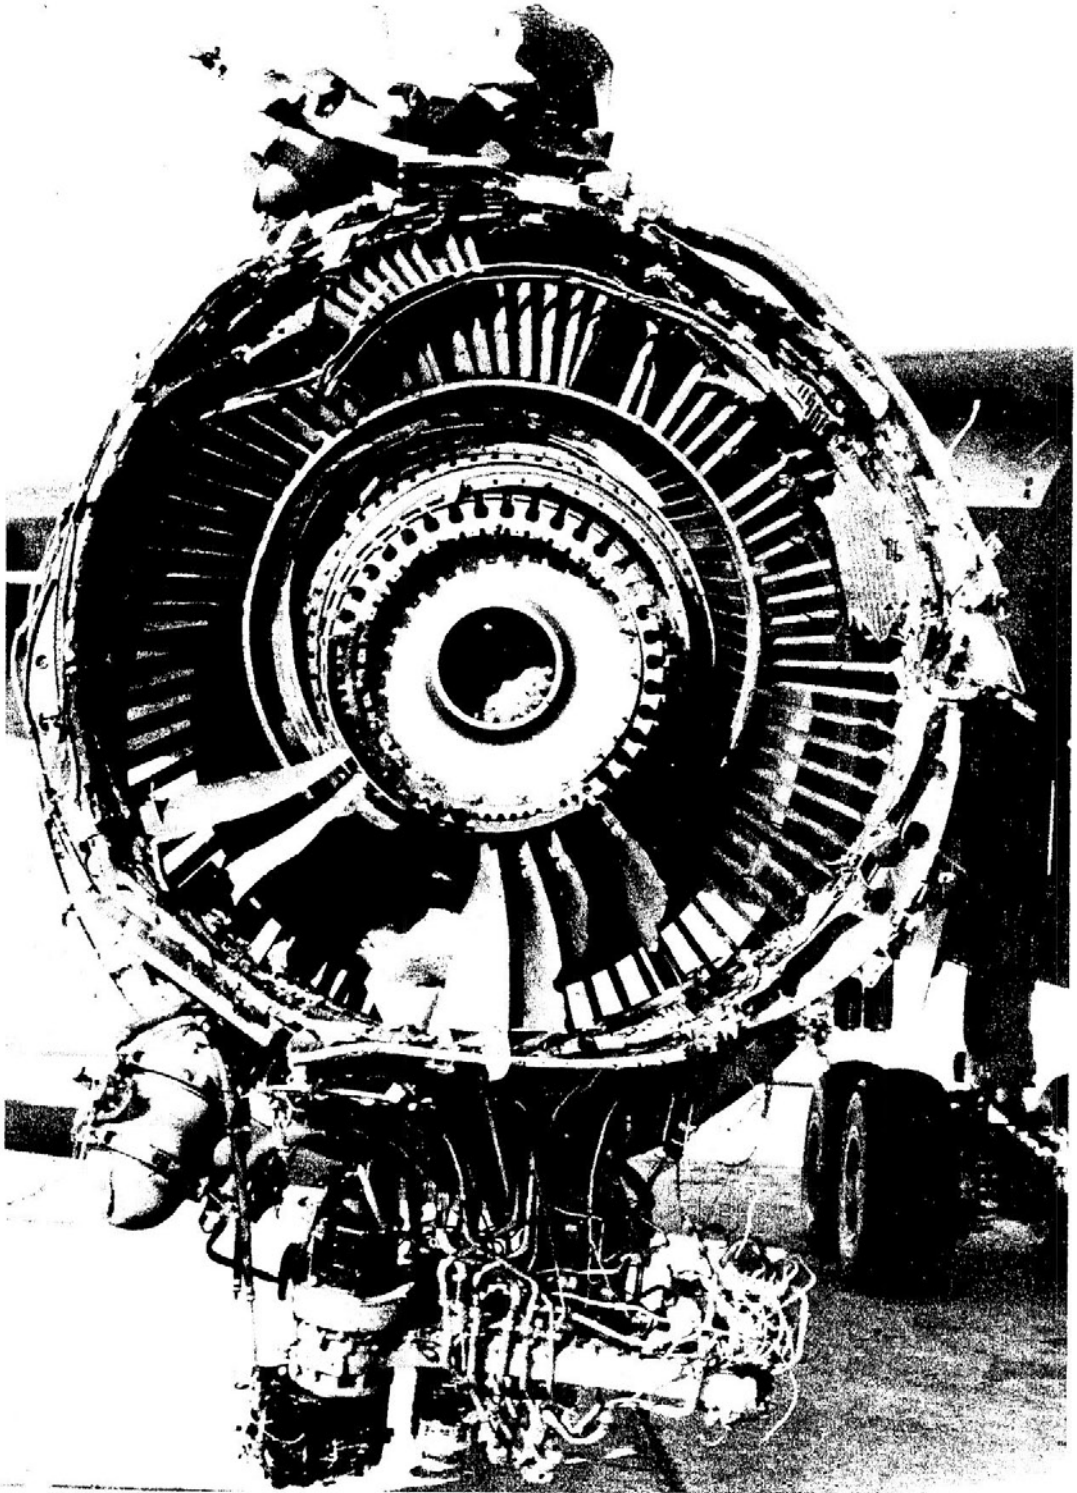
Front View No. 3 Engine

The nose cowl (inlet duct) was intact. It had broken away along the aft attach area, and the aft portion had been crushed on ground impact. Numerous blade fragments had penetrated through the inner barrel of the cowl. The outer barrel was punctured in eight locations.

The fan blade containment ring was recovered in an opened-up and twisted configuration. It separated at the 7:00 position, and the entire ring appeared torn and distorted, with considerable abrasion along the inner surface of the ring. Of the 12 bolts that attach the nose cowl to the containment ring, only portions of 5 bolts were recovered. The fracture surfaces of the bolts showed evidence of failure in shear. The 12 attachment bolt holes had deformed in various directions. The predominant forces, however, as shown on both the nose cowl and the containment ring, were in the direction of engine rotation.

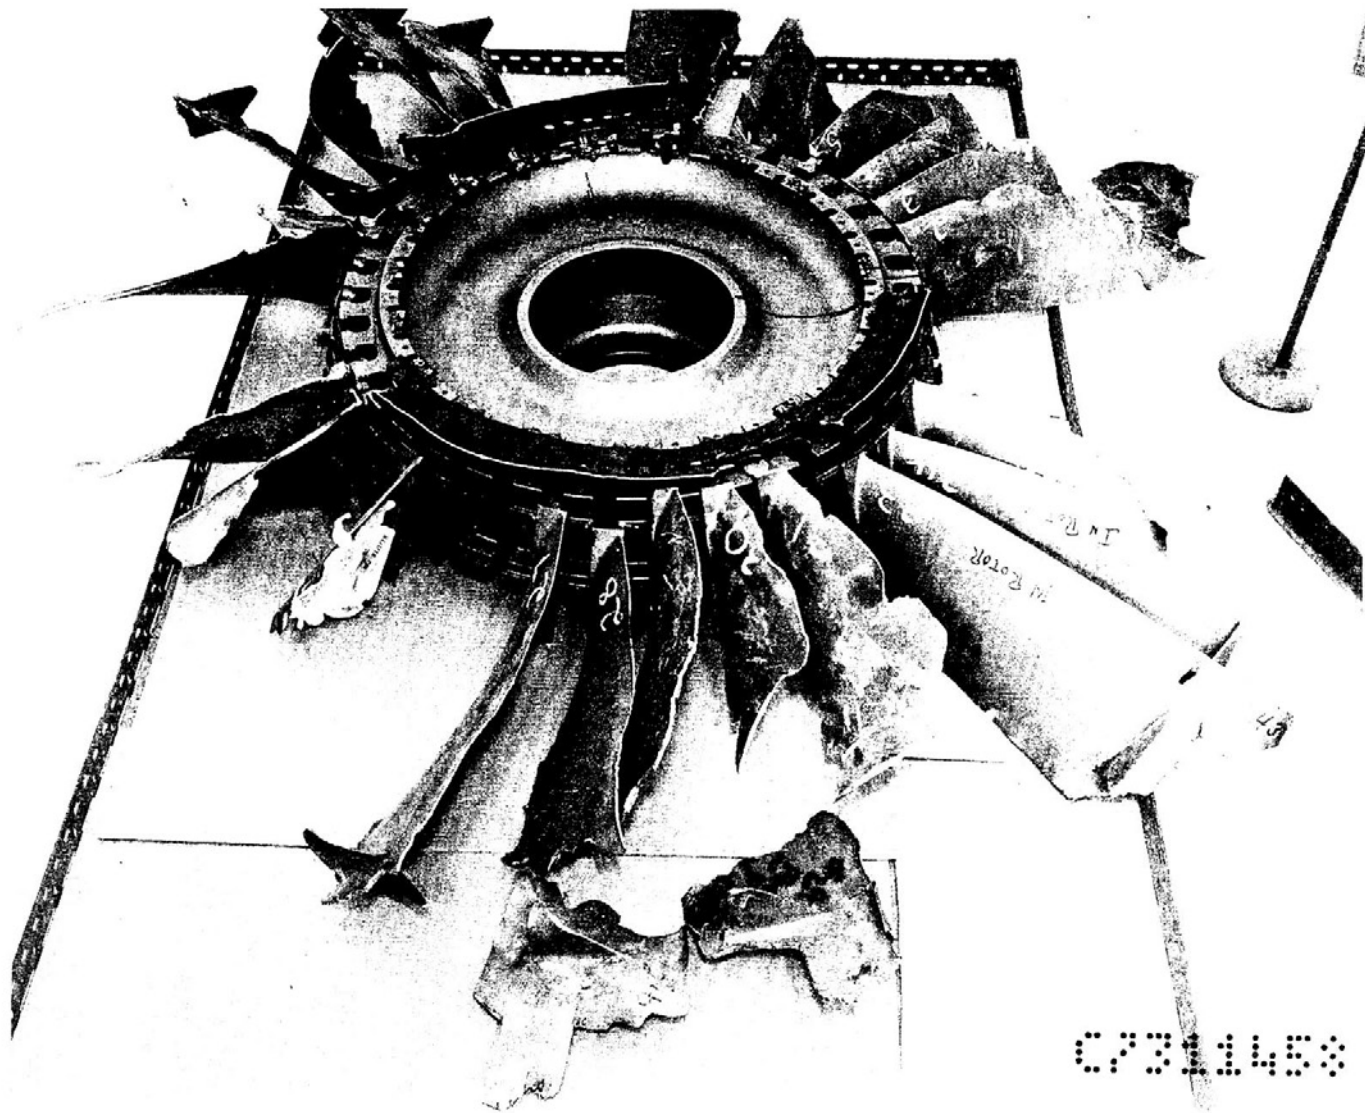
07311450

Twenty-four fan blade root sections, each with a different amount of blade remaining, including the six blades which remained in the fan disk, were recovered. Damage to the blade roots and fan disk showed forward movement past the blade restraining devices and out of the slot for each of the 18 blades which had departed the engine. For each of

the six blades that remained in the disk, the damage indicated some rearward movement in the slot.

Fan disk with recovered blade portions and spinner attachment flange segments.
