Turbulence injuries, Air France, Boeing 707-B-328B, F-BLCA, Near O'Neill, Nebraska, May 13, 1974

FILE NO. A-0003

AIRCRAFT ACCIDENT REPORT

REPORT NUMBER: NTSB-AAR-75-4

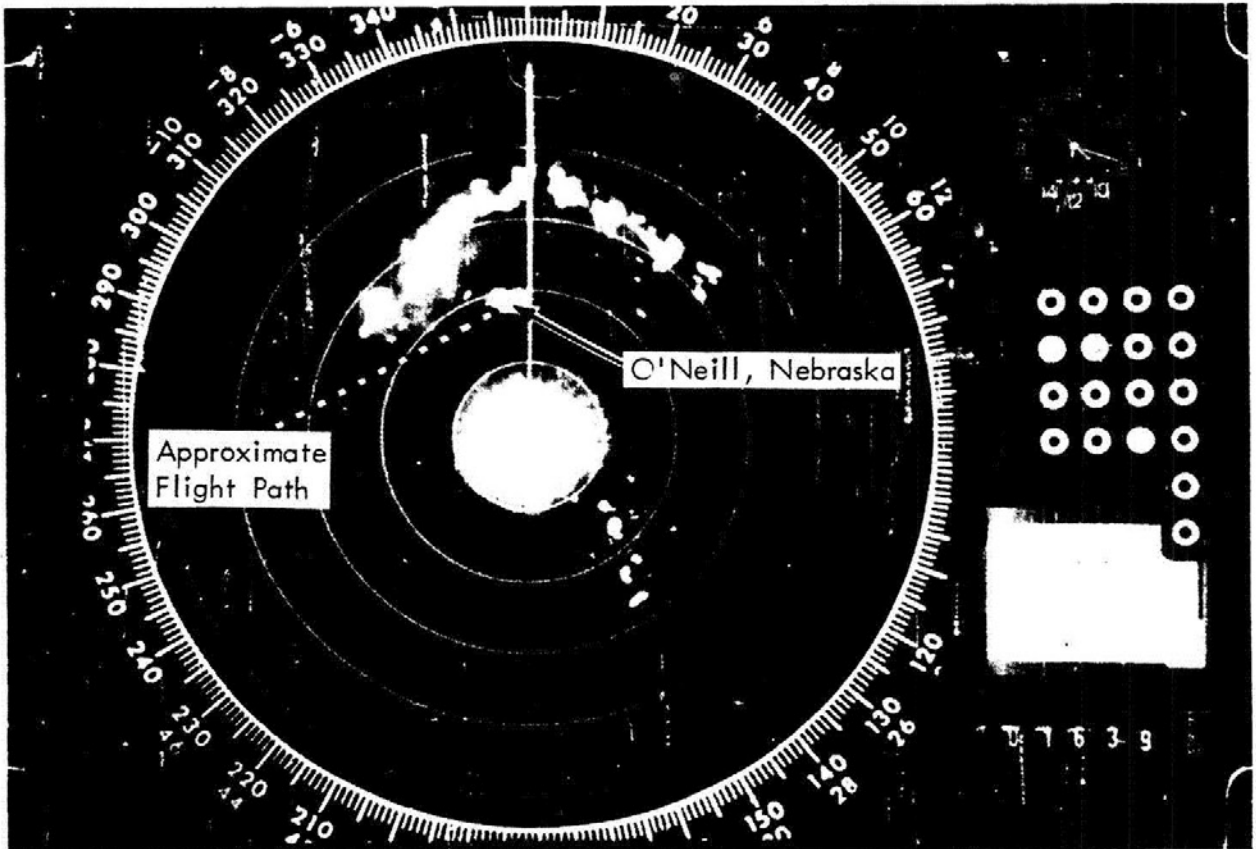
Frame No. : 1639
Date : May 13, 1974
Time : 0732Z (0232 c.d.t.)
Range : 250 n mi
Range Markers: 50 n mi
Directions : °True

Additionally, this observation (and the photographs) showed a thunderstorm cell, 20 miles in diameter, near O'Neill. The thunderstorm cell was characterized as: Very strong, hail indicated, top 42,000 feet, moving from 260° at 50 kn. (See Appendices D and E.)

Ground-based radar weather observations and radarscope photographs, showed a large thunderstorm cell in the vicinity of O'Neill at the time of the accident. There were indications of hail associated with the radar echoes. The radar meteorologist characterized the cell as being strong and reported the radar tops (tops of detectable moisture) at 42,000 feet. The actual cloud tops were probably several thousand feet higher. The cell was moving from the west-southwest at 50 kn.

The flight data recorder disclosed that at the time of the turbulence encounter, the flight was at 33,000 feet and on a heading of 052° magnetic. Considering the magnetic variation (about 10° E) and applying a true track to the radarscope photographs, it is evident that no other echoes could have masked the one near O'Neill. On such a heading and at the aircraft's altitude, the frequent and intense lightning from the cell should have been visible for many miles. Therefore, even if the radar were inoperative, the thunderstorm activity near O'Neill should have been easily visible and could have been circumnavigated without difficulty.
