Explosion in-flight, Trans World Airlines, Inc., Boeing 707-331B, N8734, in The Ionian Sea, September 8, 1974

AIRCRAFT ACCIDENT REPORT

BOEING 707-331B, N8734

REPORT NUMBER: NTSB-AAR-75-7

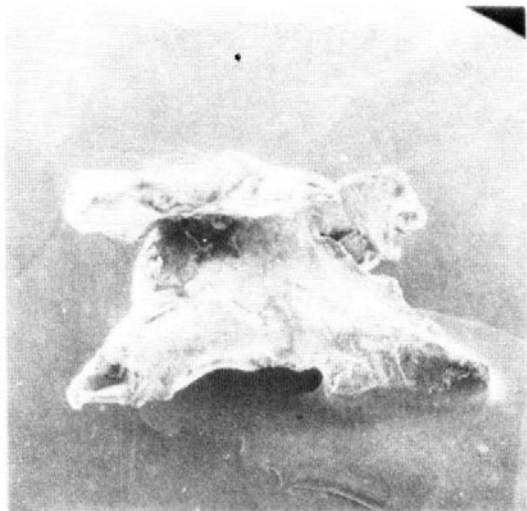
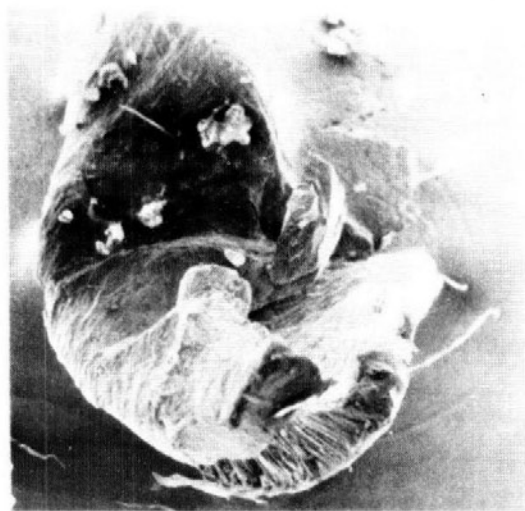
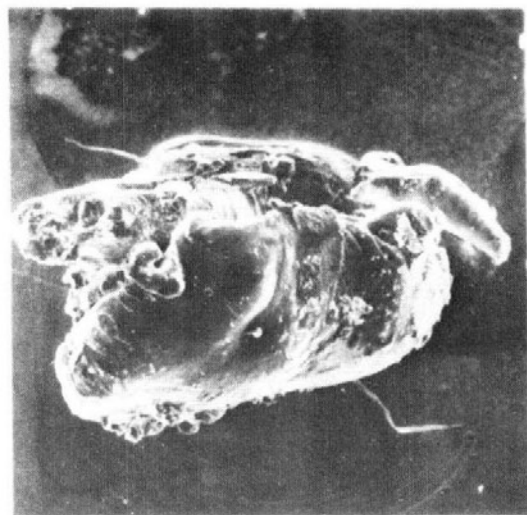
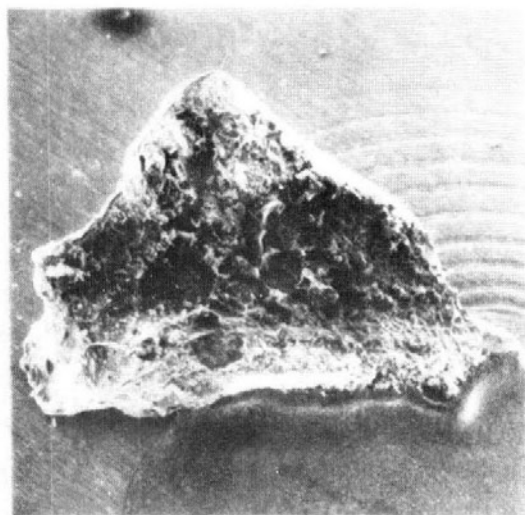
FIG 3 ALUMINIUM ALLOY FRAGMENTS

Exhibits A, E, G, and H are aluminum alloy fragments that were examined optically and in the electron scanning microscope. They showed rolled back edges, engraving, and spalling (Figure 3). These are all features typical of explosively formed fragments. The deformation of fragments E and H was extensive and "wrap around" features comparable

FIG 3a FRAGMENT A x 20

FIG 3b FRAGMENT E x 40

FIG 3c FRAGMENT G x 60

FIG 3d FRAGMENT H x 40

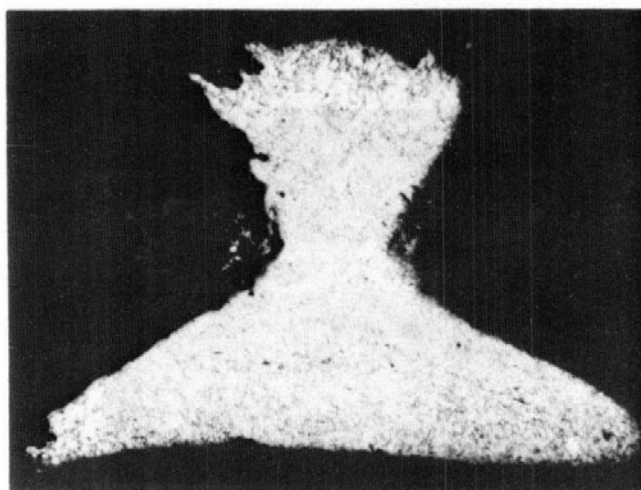
Exhibit I was polished and etched. The micro-structure is that of a low carbon iron with a grain size between 15 and 20 microns (Figure 7). This is considerably finer than that found in commercially available material and is the product of a heavily cold worked structure, recrystallizing rapidly at a high temperature but with grain growth inhibited. This structure is expected in an iron fragment which has undergone extensive deformation and heating at the source of an explosion, followed by drastic cooling on impact with suitcase. Similar structures have been produced in tests at RARDE when high explosives were detonated against iron plates. The similarities between the structure of fragment I with the structures obtained in controlled explosive trials can be seen in Figure 8. Evidence of explosive deformation is apparent in the micro-structure of the strained steel case hinge (Figure 9). The strain in the hinge was small, but deformation twins were found in a portion of the grains. These twins are effective signature of an explosive shock passing through the hinge. Twinned structures were found in the Comet fragments, though the density in these was considerably higher because the fragments suffered greater strain.

FIG 7 METALLURGICAL SECTION OF FRAGMENT I x 75

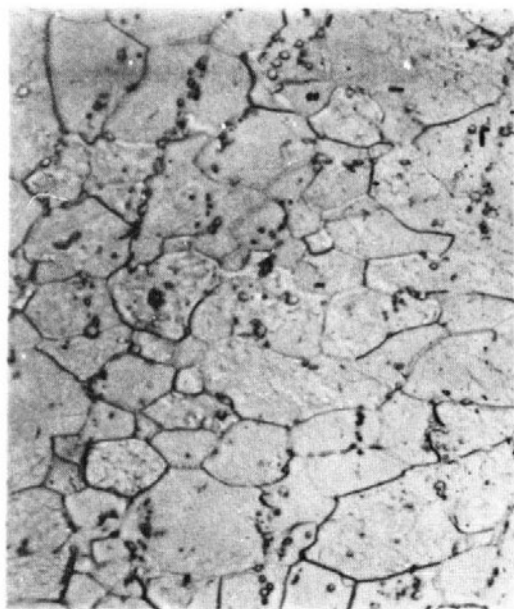
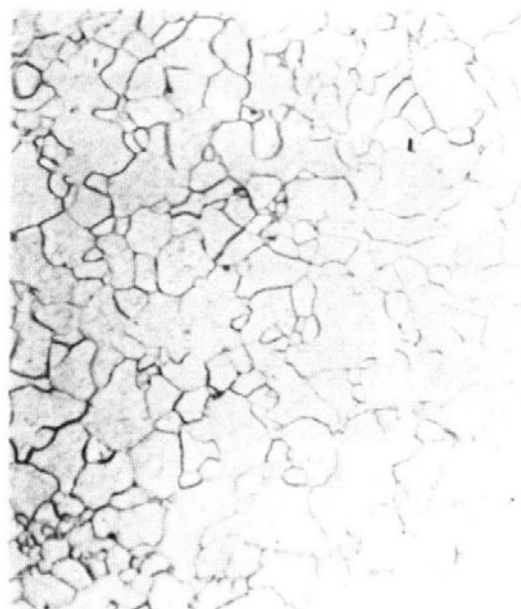
FIG 8a SECTION OF FRAGMENT I
x 1000

FIG 8b SECTION OF EXPLOSIVELY
DEFORMED IRON

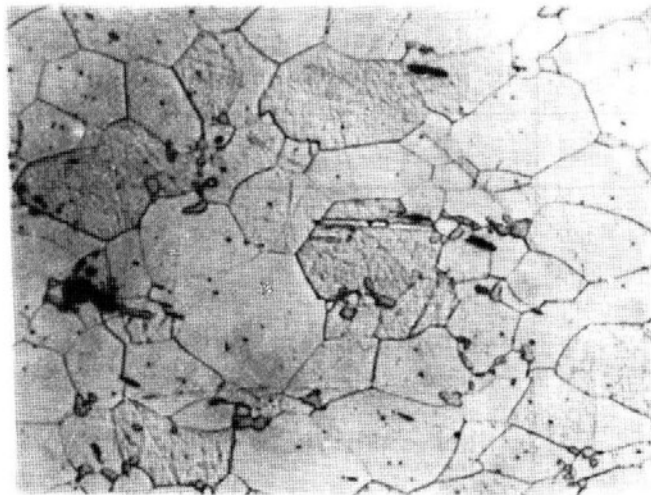
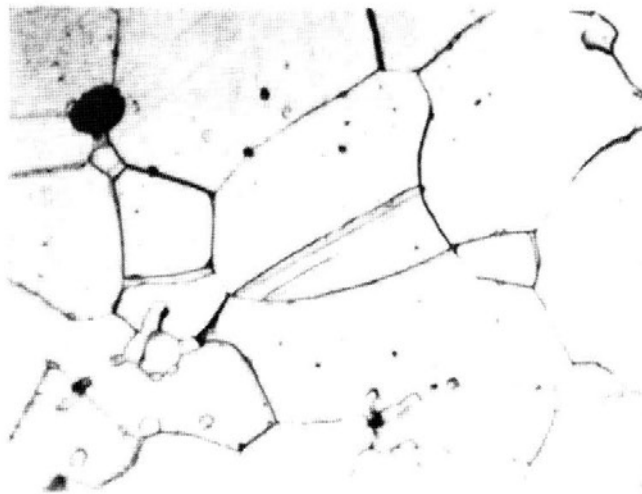
FIG 9 METALLURGICAL SECTION OF DAMAGED HINGE

microstructure of the piece of metal hinge designated as specimen Q19A, it was concluded that the objects from which these metal parts originated were damaged as a result of exposure to the detonation of a high order explosive. "
