**CFIT, Trans World Airlines, Inc., Boeing 727-231, N54328, Berryville, Virginia, December 1, 1974**

## **AIRCRAFT ACCIDENT REPORT**

BOEING 727-231, N54328

REPORT NUMBER: NTSB-AAR-75-16

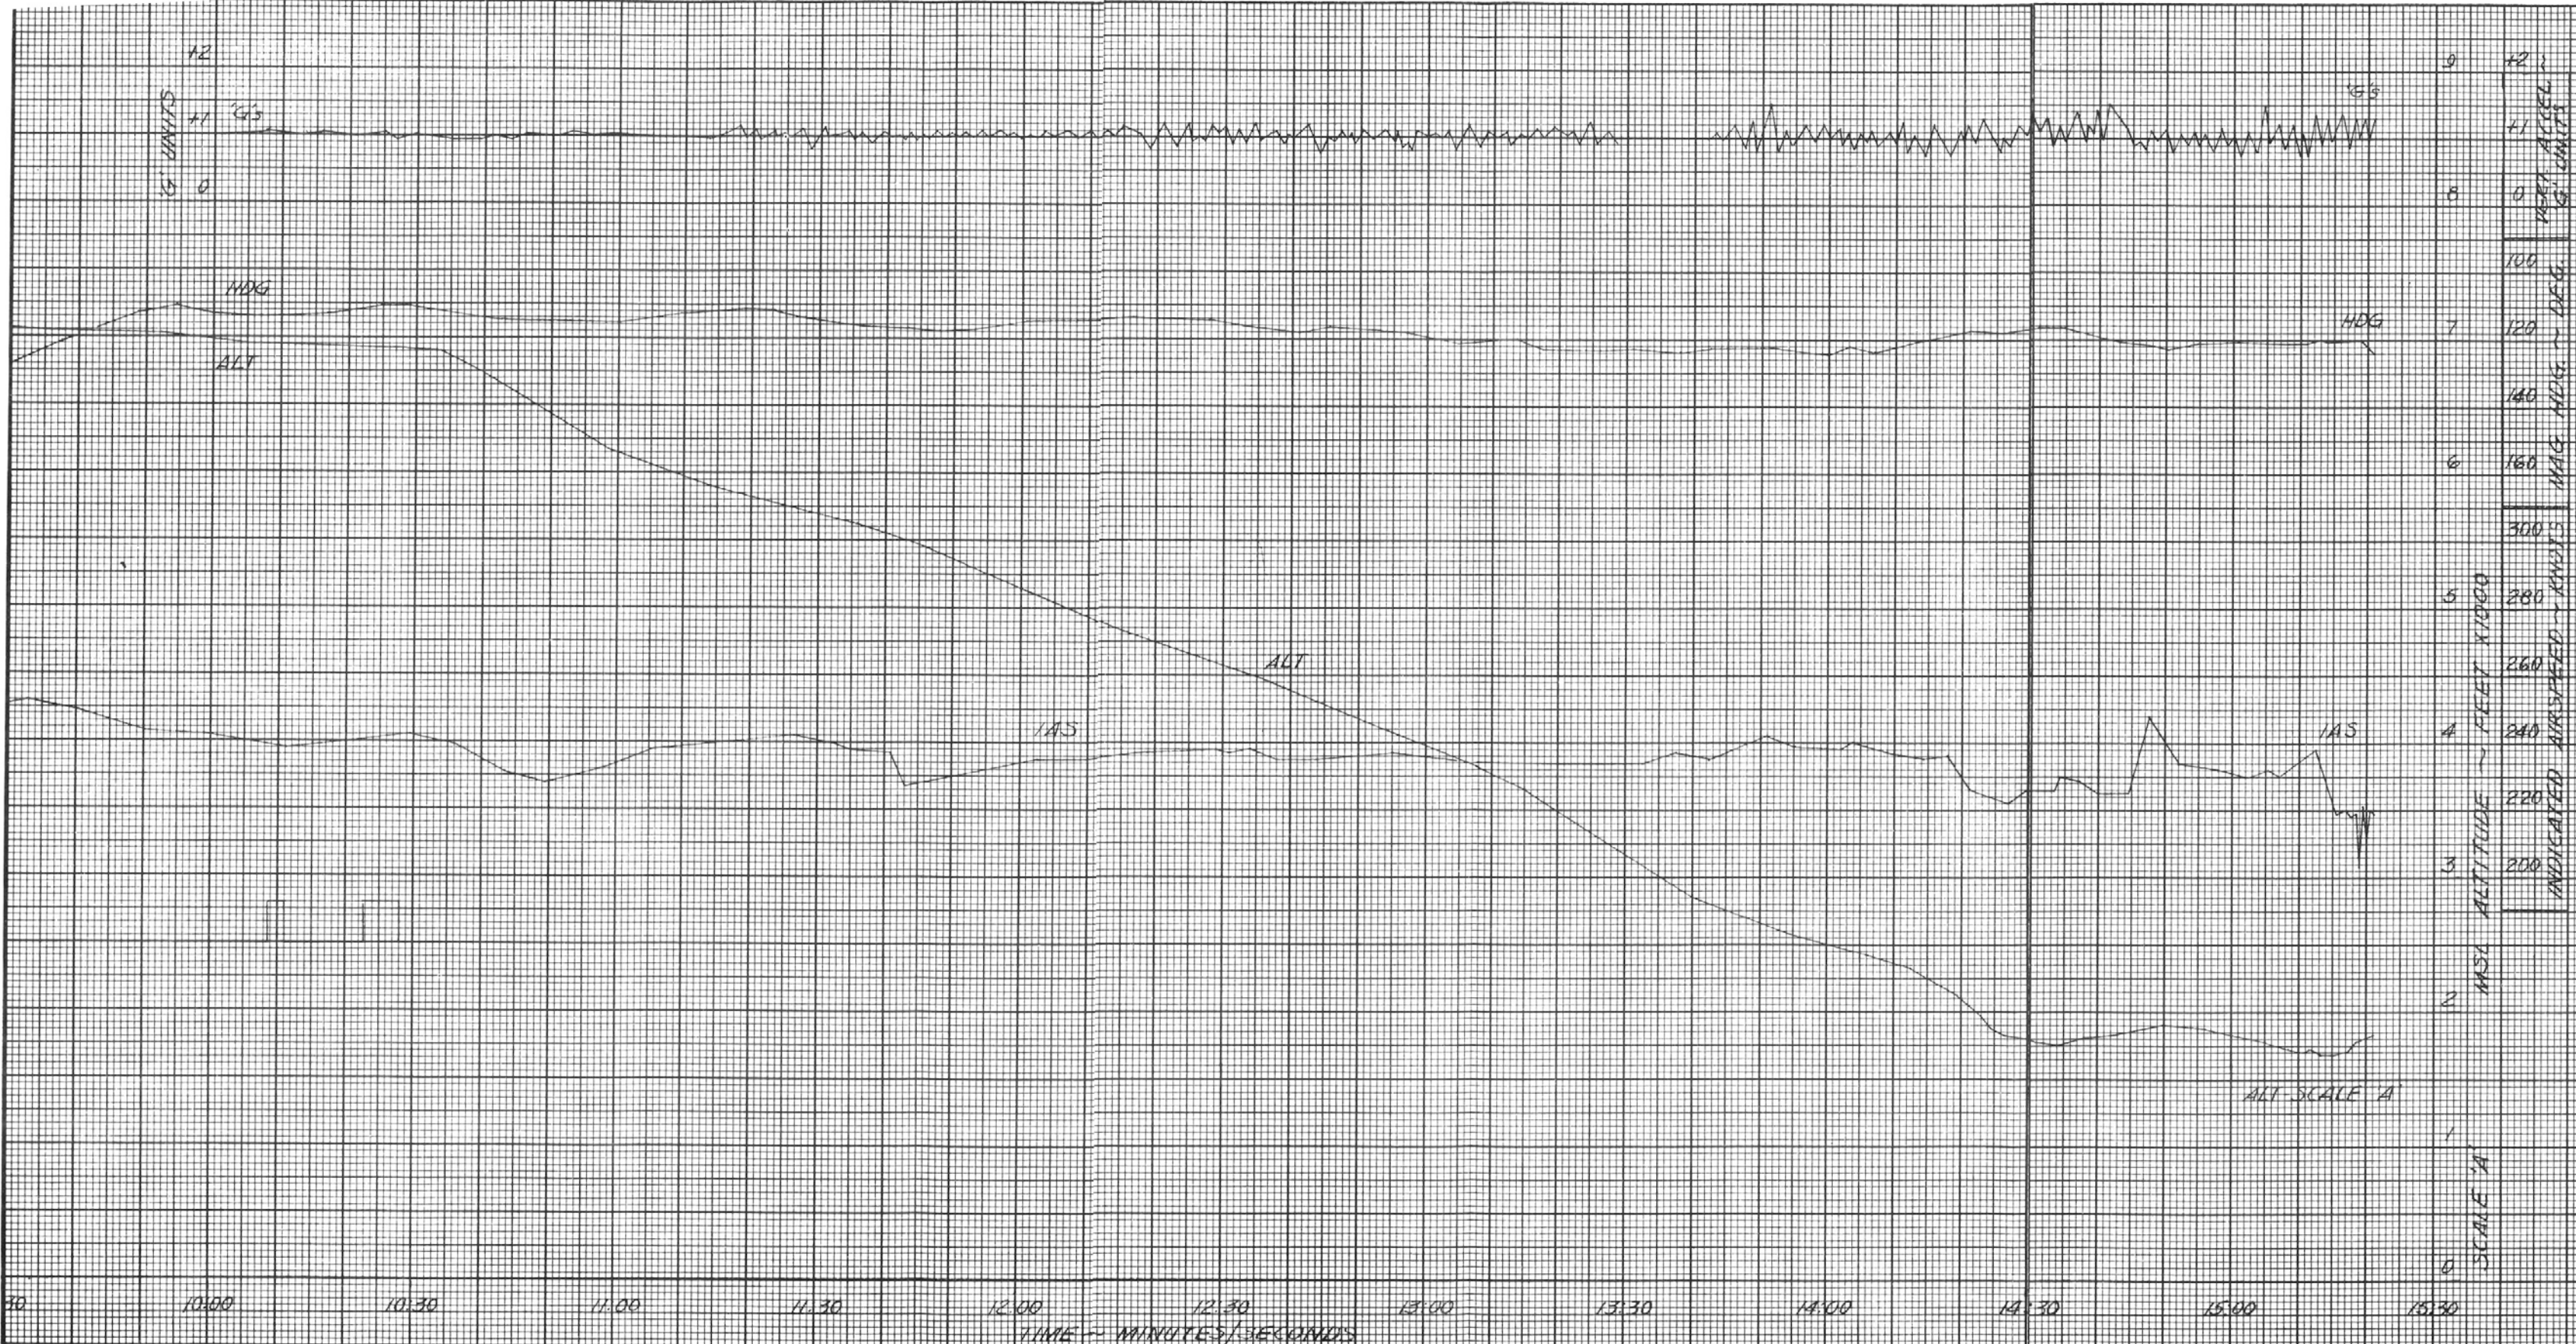
APPENDIX E

The flight data recorder parameter traces were clearly recorded. There were no recorder malfunctions. A readout was made of the last 15 minutes 25 seconds of the flight. There was a small gap in the vertical acceleration trace shown on the data graph at time 13 minutes 30 seconds because of foil damage which obliterated the trace. (See Appendix E.)
