Runway overrun, Western Air Lines, Inc., Boeing 737-200, N4527W, Casper , Wyoming, March 31, 1975

AIRCRAFT ACCIDENT REPORT

**WESTERN AIR LINES, INC.
BOEING 737-200, N4527W
CASPER, WYOMING
MARCH 31, 1975**

REPORT NUMBER: NTSB-AAR-75-15

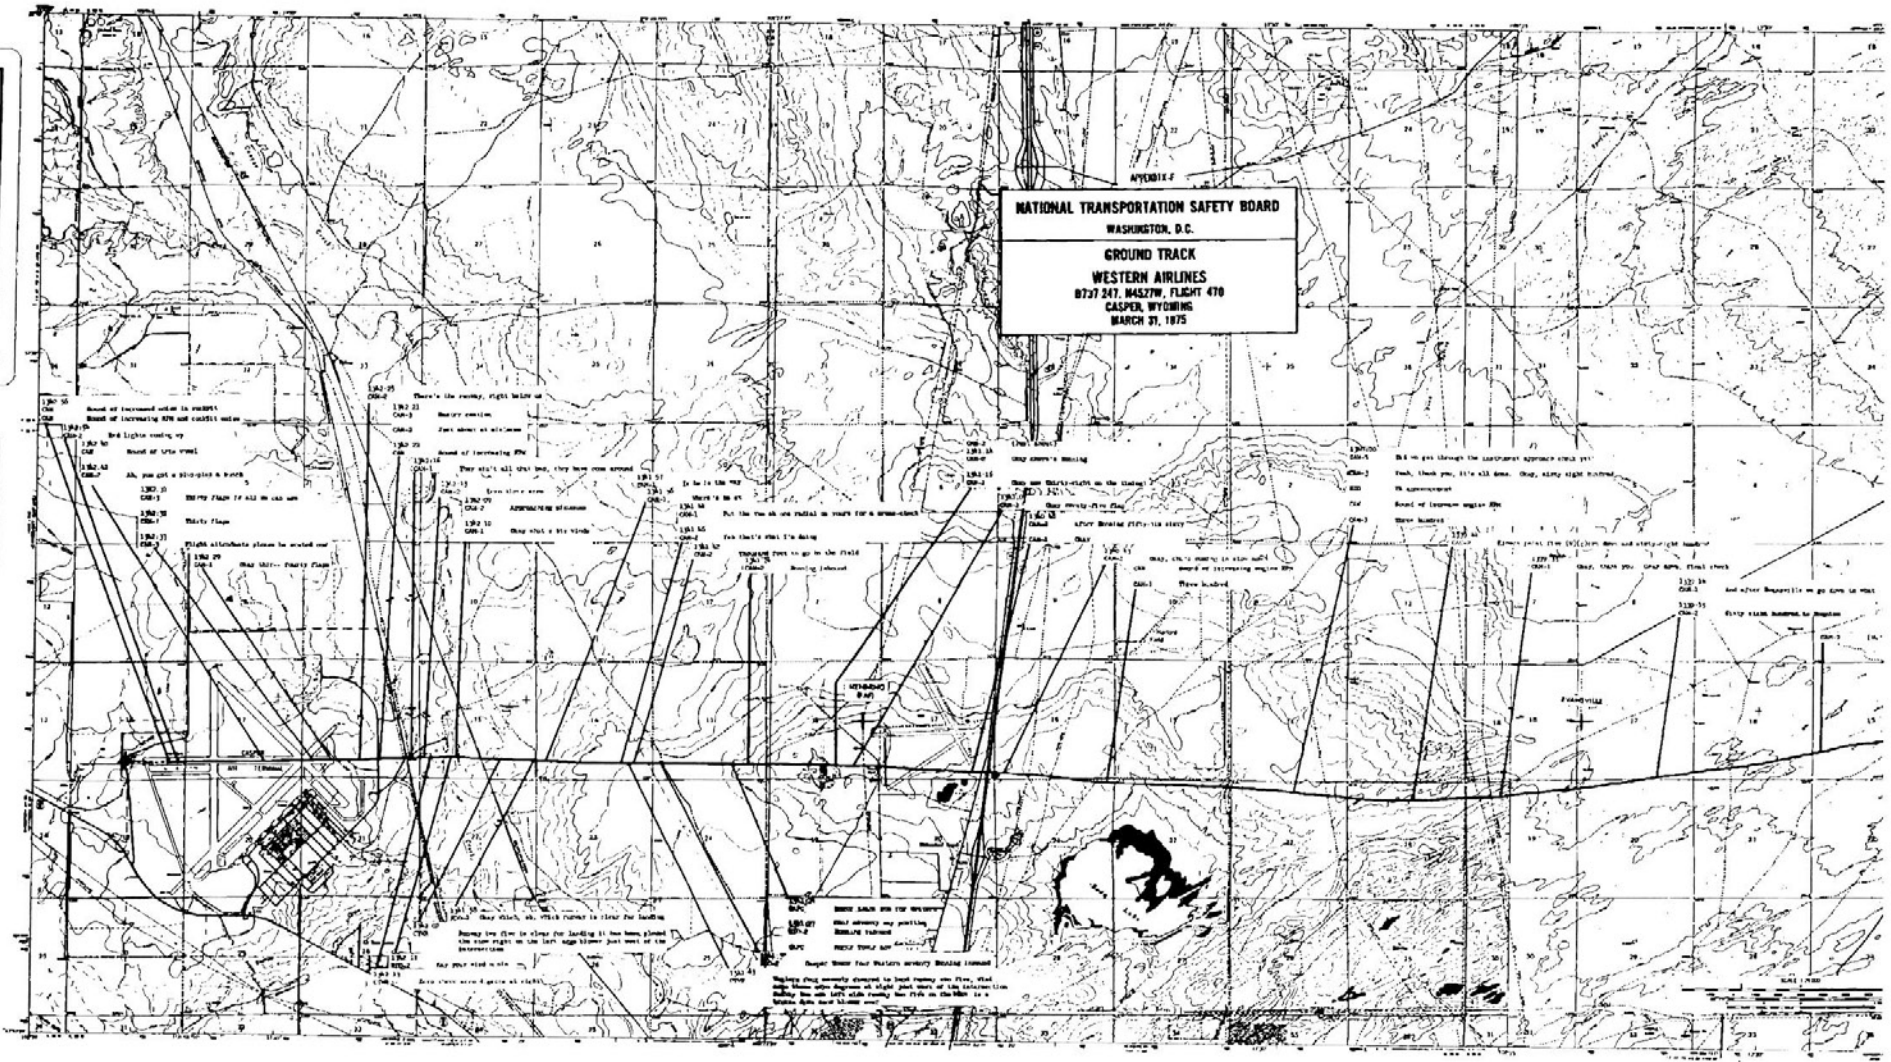
NATIONAL TRANSPORTATION SAFETY BOARD
WASHINGTON, D.C.
GROUND TRACK
WESTERN AIRLINES
N737-247, N4527N, FLIGHT 470
CASPER, WYOMING
MARCH 31, 1975

The aircraft went off the departure end of the runway to the right of the centerline. The pilot stated that the nose wheel steering was adequate to take the aircraft to the right of the approach light structures. After striking several metal stanchions in the first row of terminal bar lights, which were located 200 feet off the end of the runway, the aircraft struck a shallow irrigation ditch 280 feet off the runway end. The aircraft veered farther to the right and stopped about 800 feet beyond the departure end of the runway on a magnetic heading of about 008°.

The aircraft ran off the runway to the right of the centerline and destroyed three approach lights on stanchions 200 feet off the end of the runway. The aircraft then collided with an irrigation ditch, and the right main landing gear assembly and the right powerplant separated from the aircraft. They were found 460 and 580 feet, respectively, off the end of the runway. The left main landing gear assembly separated partially and rotated aft. The left powerplant remained attached to the aircraft. The nose gear assembly collapsed rearward. The left and right wing trailing edge flaps were in the 30°, extended position. The flap indicator in the cockpit also indicated this position.
