Landed short, Eastern Air Lines, Inc., Boeing 727-225, N8845E, John F. Kennedy International Airport, Jamaica, New York, June 24, 1975

AIRCRAFT ACCIDENT REPORT

**EASTERN AIR LINES, INC.
BOEING 727-225, N8845E**

**REPORT NUMBER: NTSB-AAR-76-8
UNITED STATES GOVERNMENT**

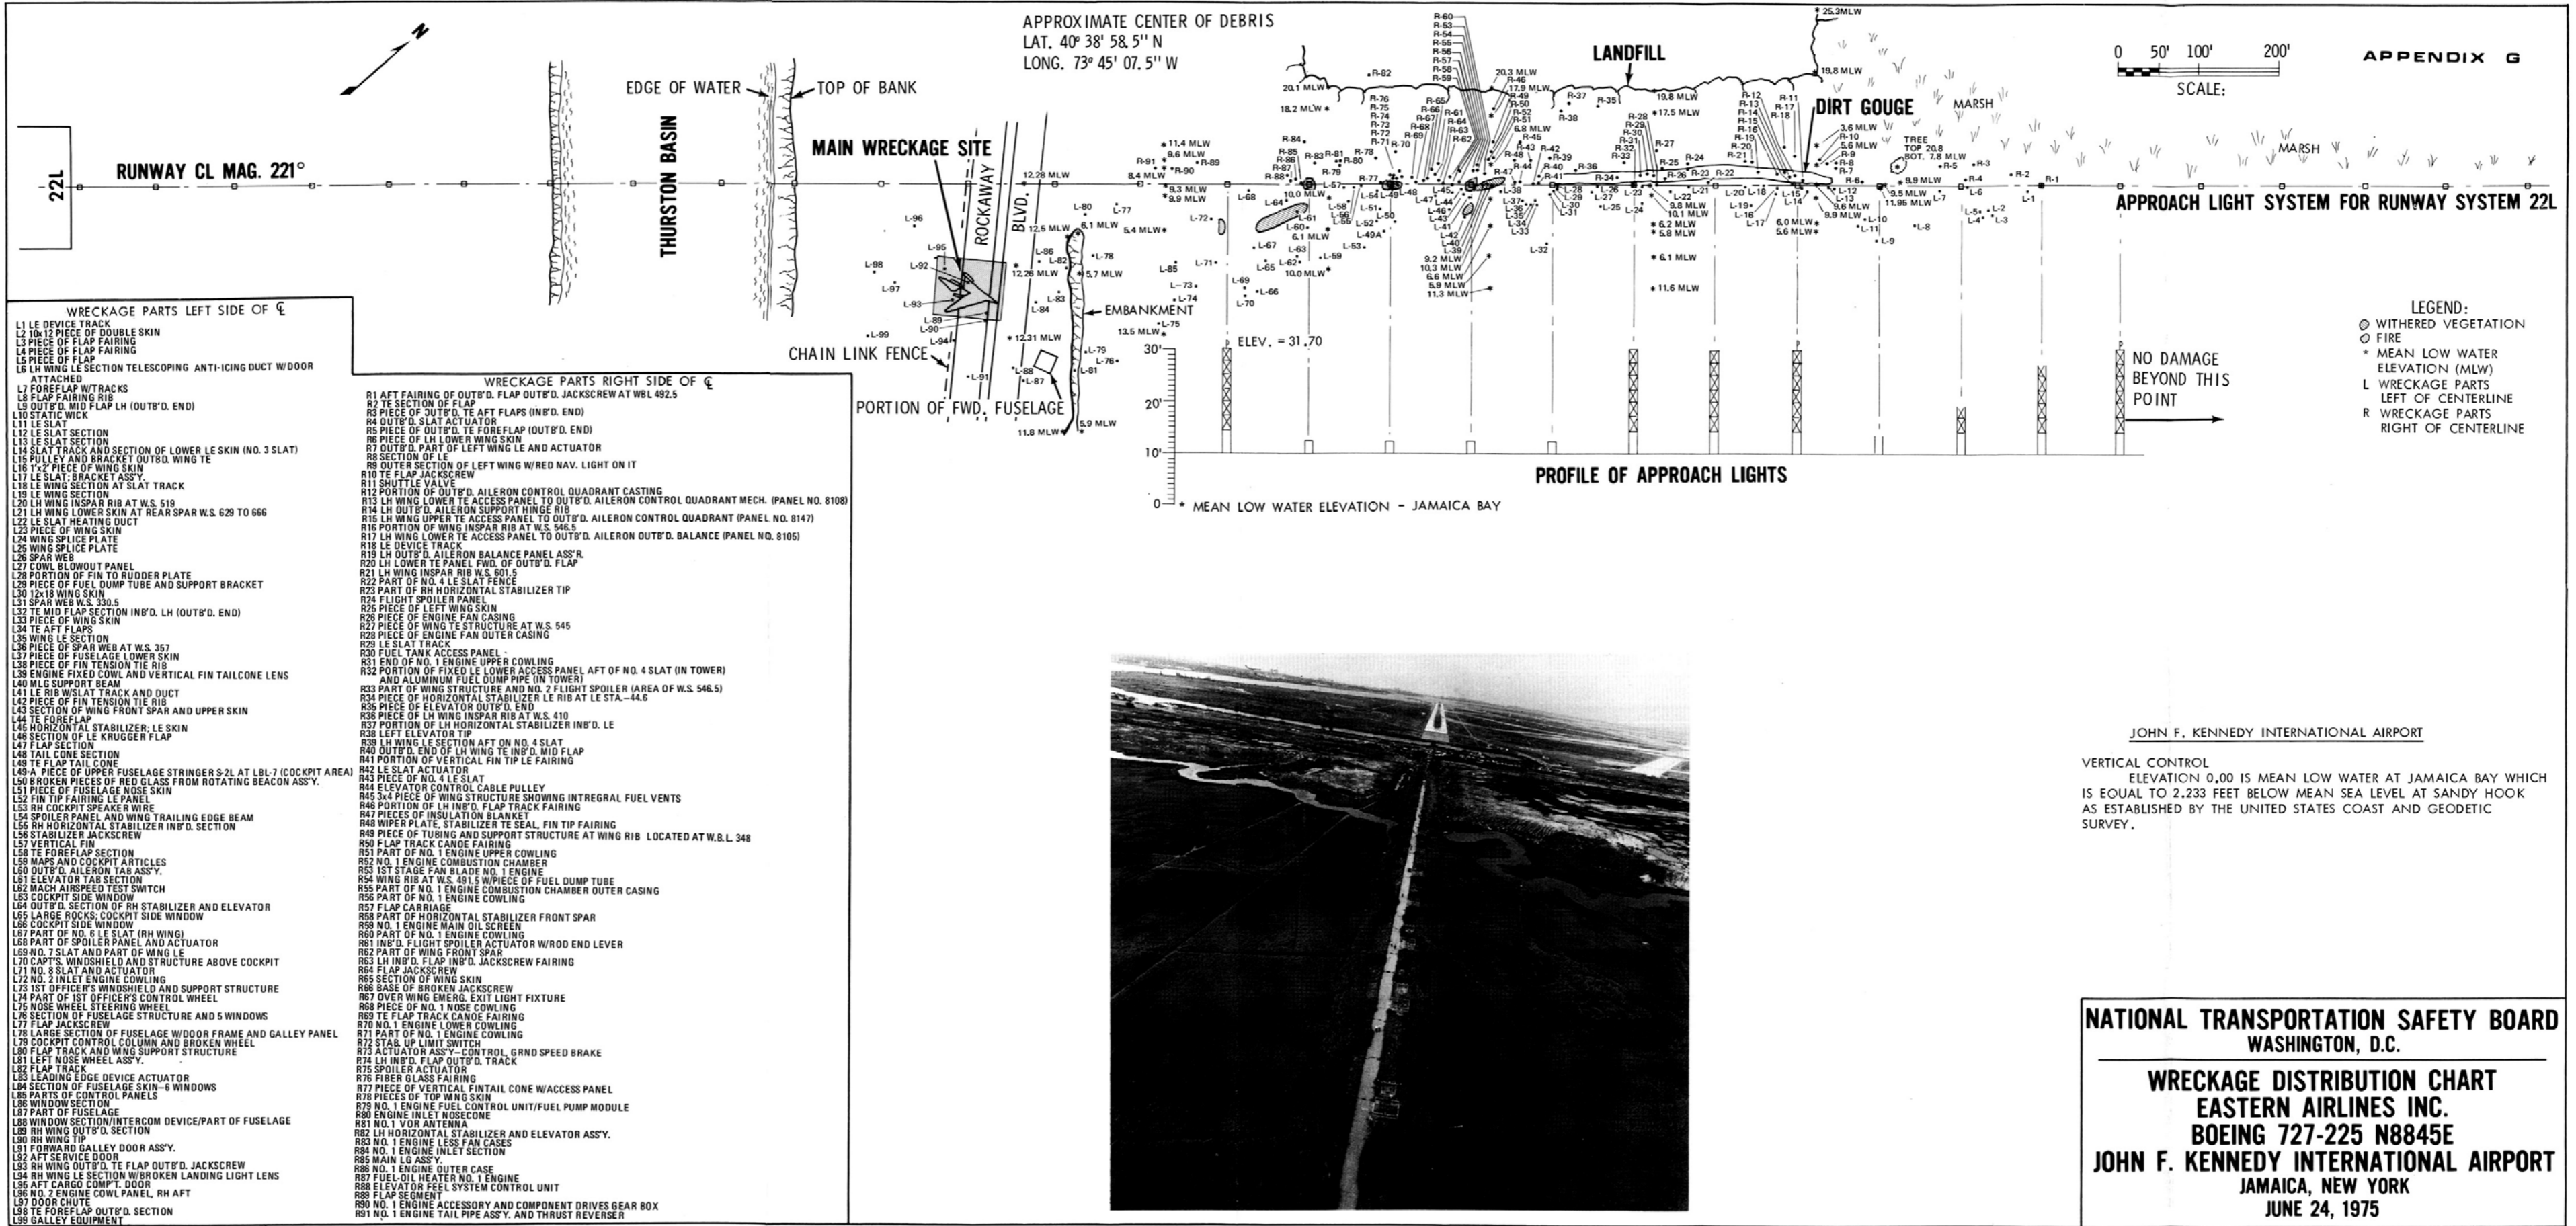
Eastern 66 first contacted the top of the No. 7 approach light tower at an elevation of 27 feet above the mean low-water level and 2,400 feet from the threshold of runway 22L. The aft end of the jack-screw fairing for the left, outboard trailing edge flap lodged in the tower. The aircraft continued and struck towers 8 and 9. The aircraft's left wing was damaged severely by impact with these towers-- the outboard section was severed. The aircraft then rolled into a steep left bank (well in excess of 90°) between towers 9 and 10, where it first contacted the ground. Its descent angle between the No. 7 tower and the beginning of the ground mark was 4.5°. It missed towers 10, 11, and 12; a gouge in the earth, about 340 feet long, paralleled the approach light towers on the northwest side from near tower No. 10 to tower No. 13. Three large outboard sections of the left wing were located near the beginning of the gouge.

Near the No. 13 tower, the aircraft's direction of travel changed from a magnetic heading of 220° to 205°; the fuselage struck towers 13, 14, 15, 16, and 17. The aircraft then continued to Rockaway Boulevard, where it came to rest. The approach light towers and large boulders along the latter portion of the path caused the fuselage to collapse and disintegrate. (See Appendix G.)

Parts of the No. 1 engine were located near tower No. 12; the engine was damaged severely. The No. 2 engine was found beside the tail section, and the No. 3 engine remained attached to the tail section.
