Crash on takeoff in wind shear, Continental Air Lines, Inc., Boeing 727-224, N88777, Stapleton International Airport, Denver, Colorado, August 7, 1975

AIRCRAFT ACCIDENT REPORT

REPORT NUMBER: NTSB-AAR-76-14

CONTINENTAL AIR LINES, INC.
BOEING 727-224, N88777
STAPLETON INTERNATIONAL AIRPORT
DENVER, COLORADO
AUGUST 7, 1975

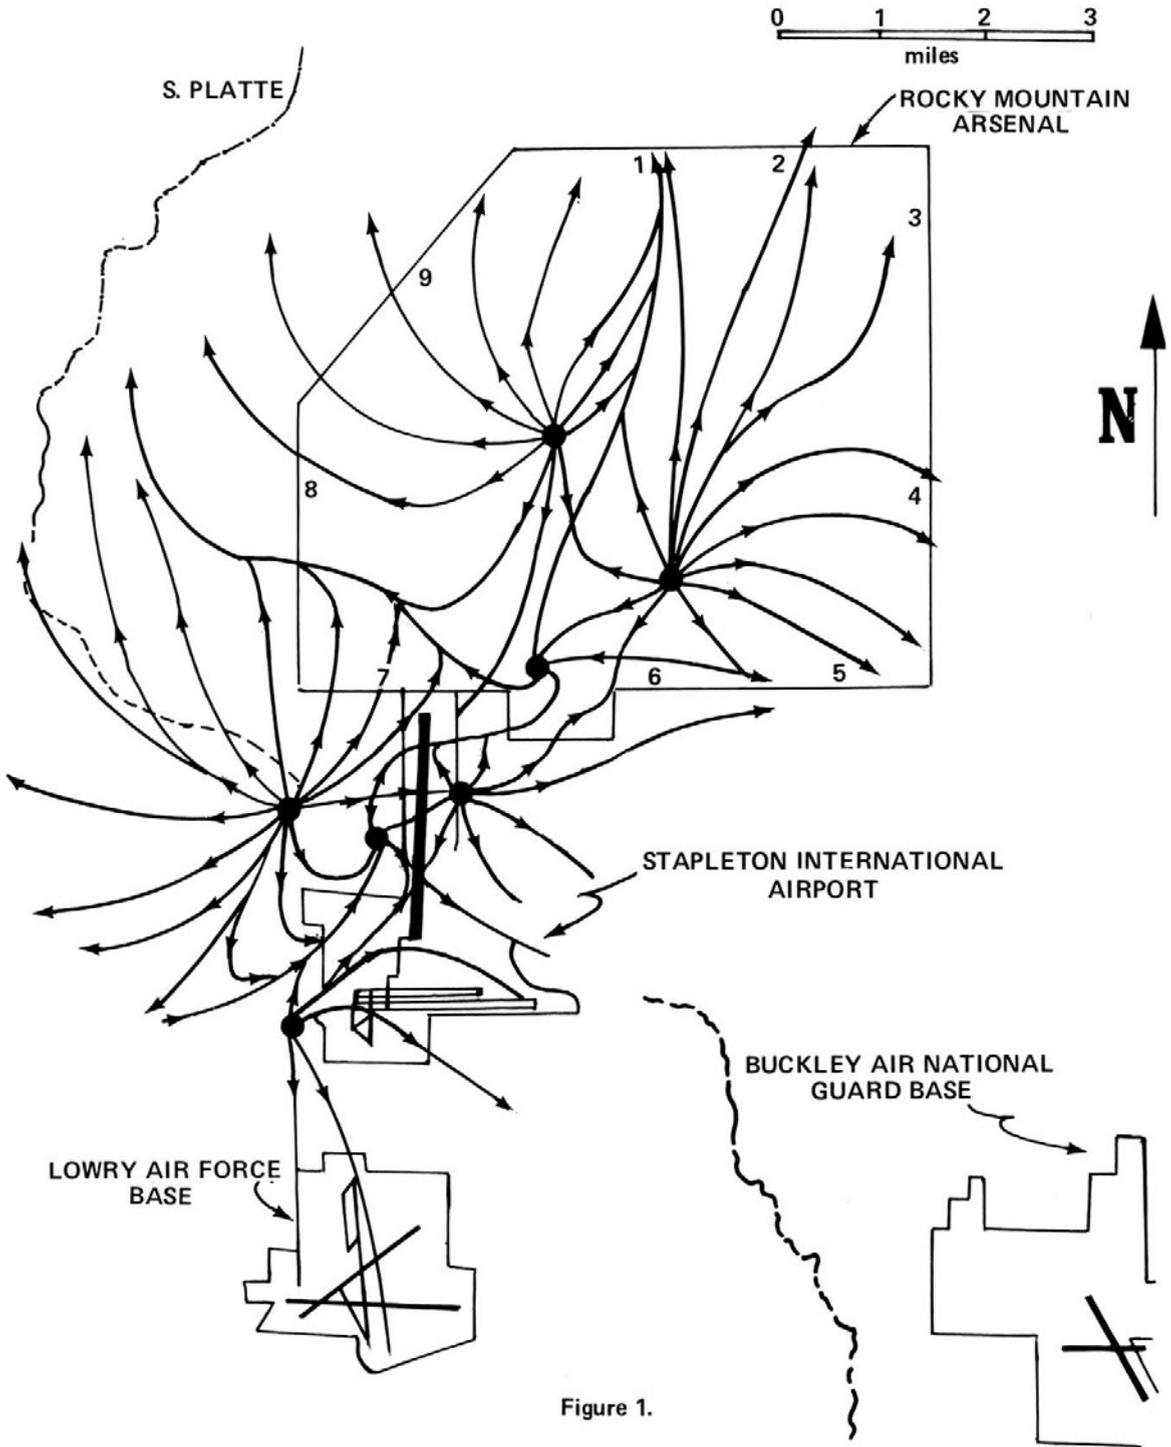
Figure 1.

Streamlines drawn from time-space conversion/isogon analysis superimposed on runway 35L at Stapleton Airport showing the probable runway and surface wind relationship at 1605:30 m.d.t.

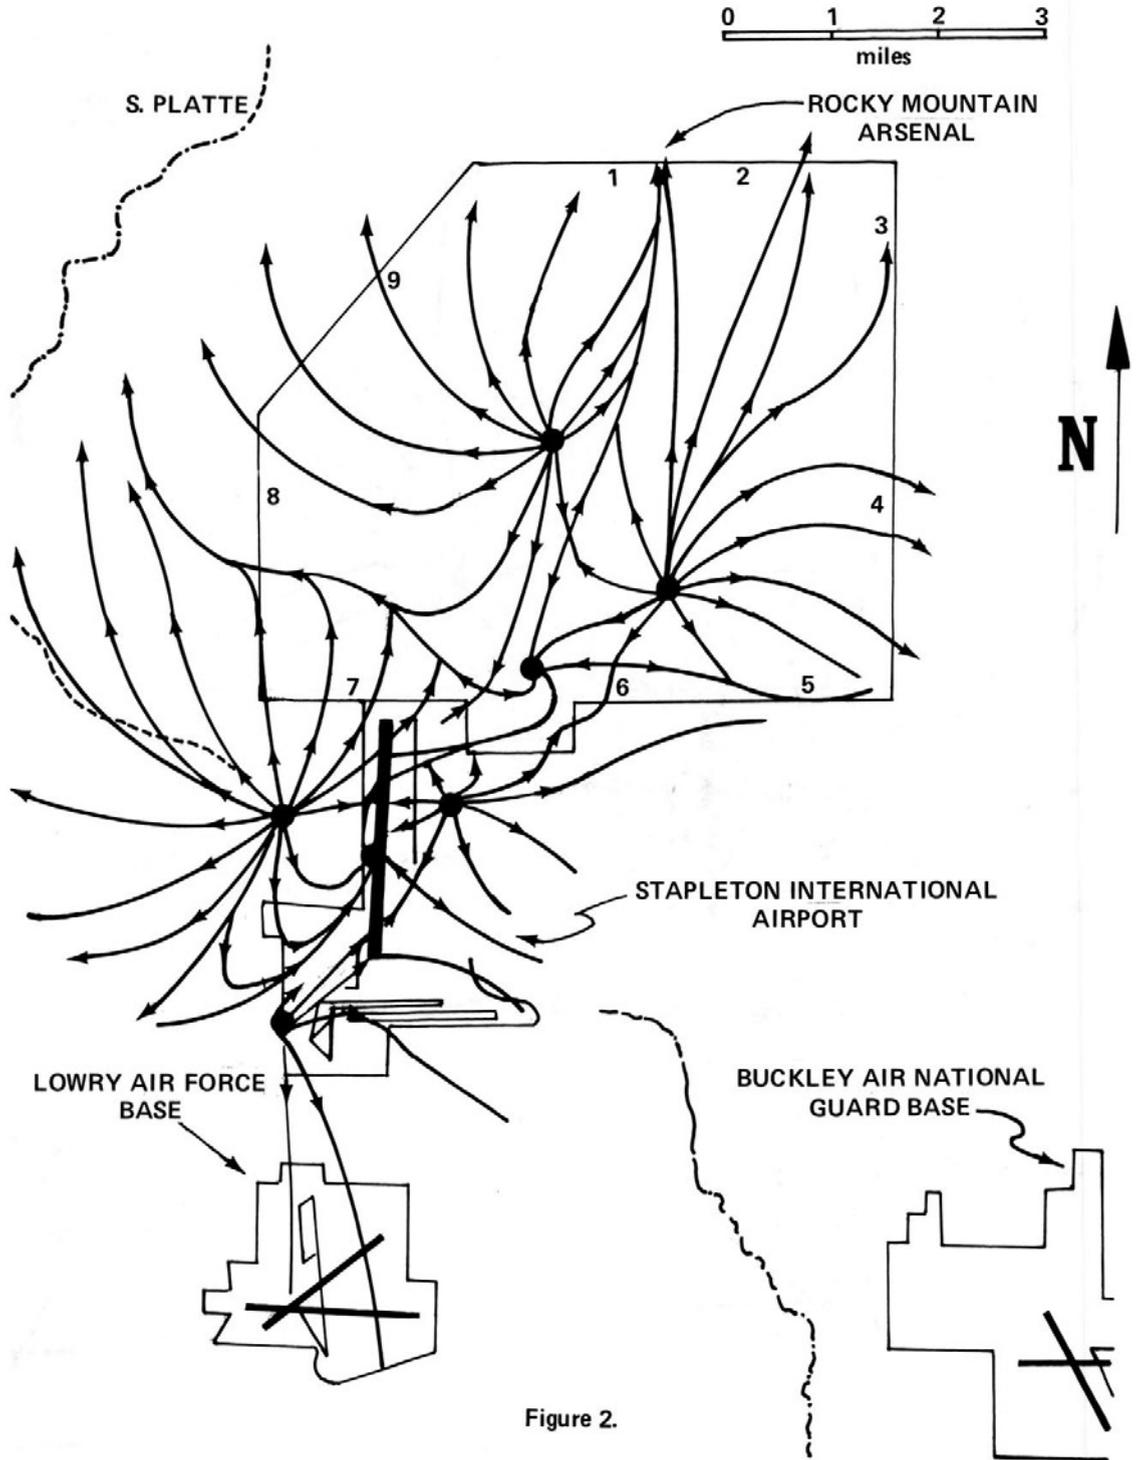
Figure 2.

Streamlines drawn from time-space conversion/isogon analysis superimposed on runway 35L at Stapleton Airport showing the probable runway and surface wind relationship at 1607 m.d.t.

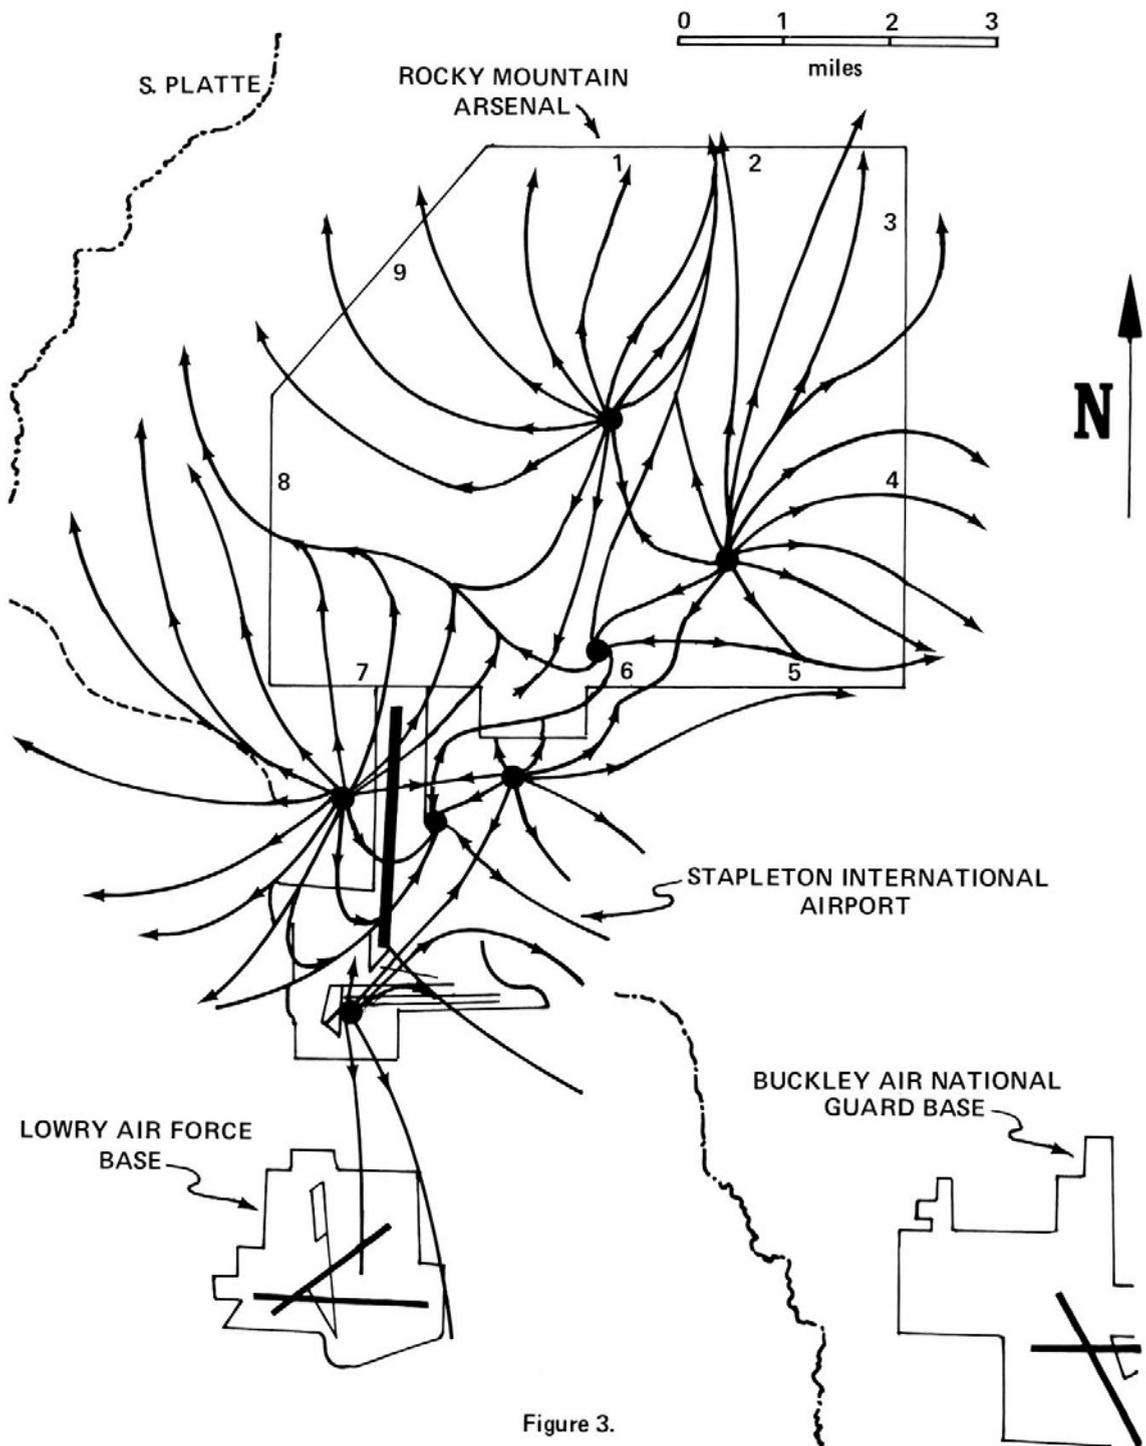
Figure 3.

Streamlines drawn from time-space conversion/isogon analysis superimposed on runway 35L at Stapleton Airport showing the probable runway and surface wind relationship at 1610 m.d.t.

About 1600, the most influential center of divergence was probably located west of the center of runway 35L; and it was moving east-northeast at about 9 kn. As the thunderstorm expanded and moved east-northeastward, this center of divergence began to strongly affect the wind conditions on Stapleton Airport because of its strong horizontal outflow.

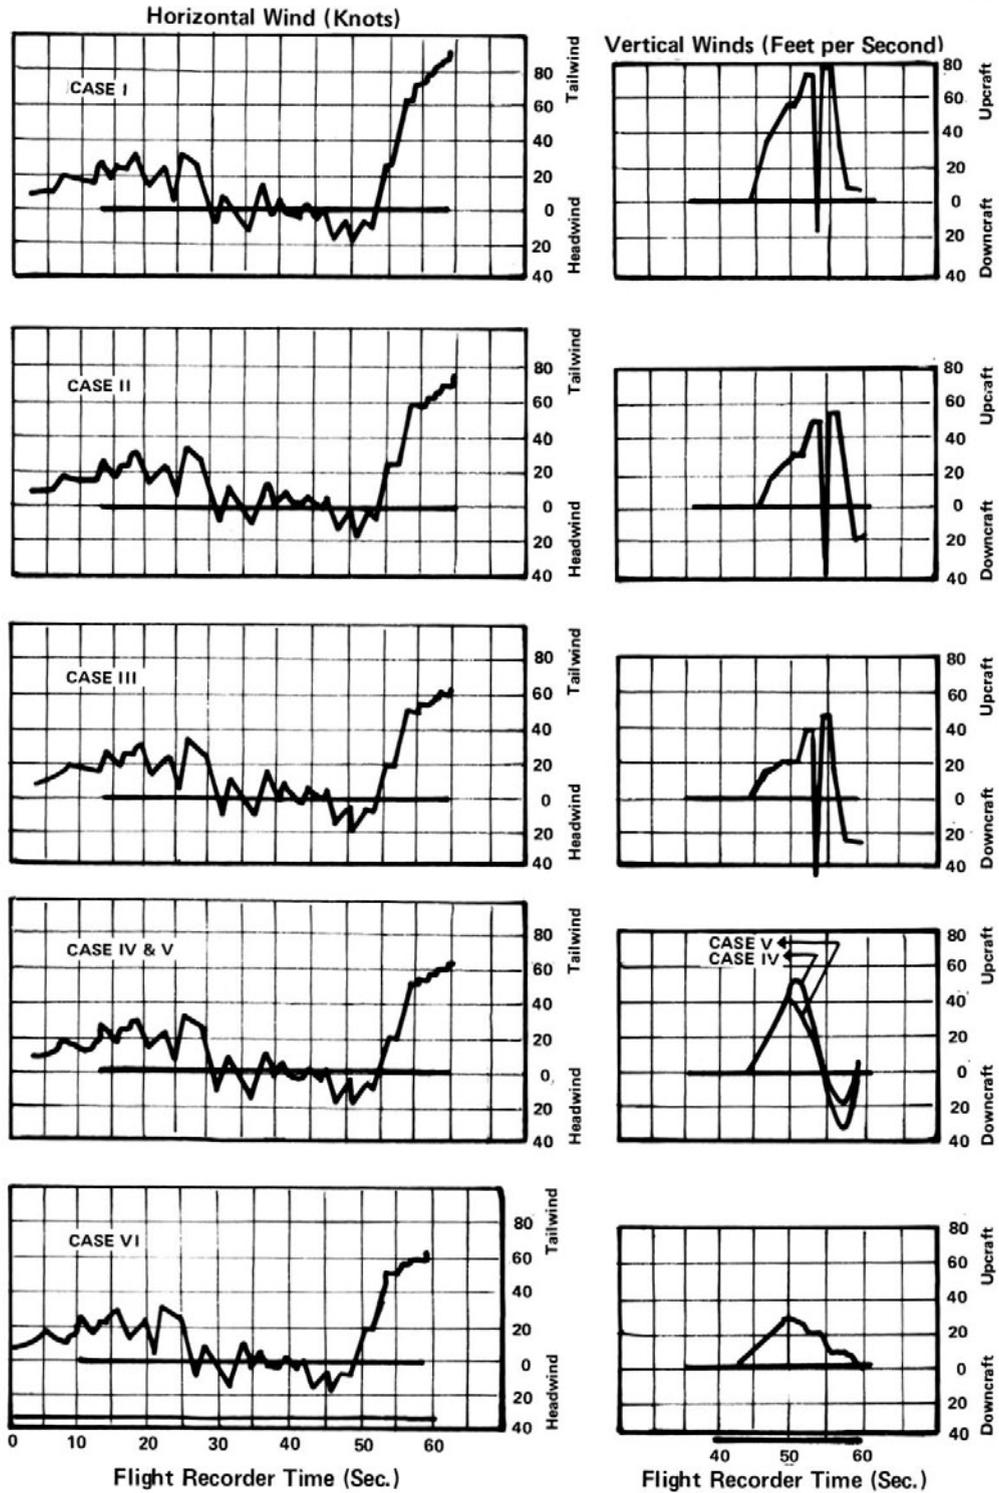
Figure 4.

Case V: Maximum takeoff thrust; brakes released 300 feet from beginning of runway; altitude profile above 35 feet arbitrarily faired to 100 feet above the ground and back to impact.

HORIZONTAL AND VERTICAL WINDS DERIVED FROM AIRCRAFT PERFORMANCE ANALYSIS
