**Uncontained engine failure, Overseas National Airways, Inc., Douglas DC-10-30, N1032F, John F. Kennedy International Airport, Jamaica, New York, November 12, 1975**

## **AIRCRAFT ACCIDENT REPORT**

**OVERSEAS NATIONAL AIRWAYS, INC.  
DOUGLAS DC-10-30, N1032F**

**REPORT NUMBER: NTSB-AAR-76-19**

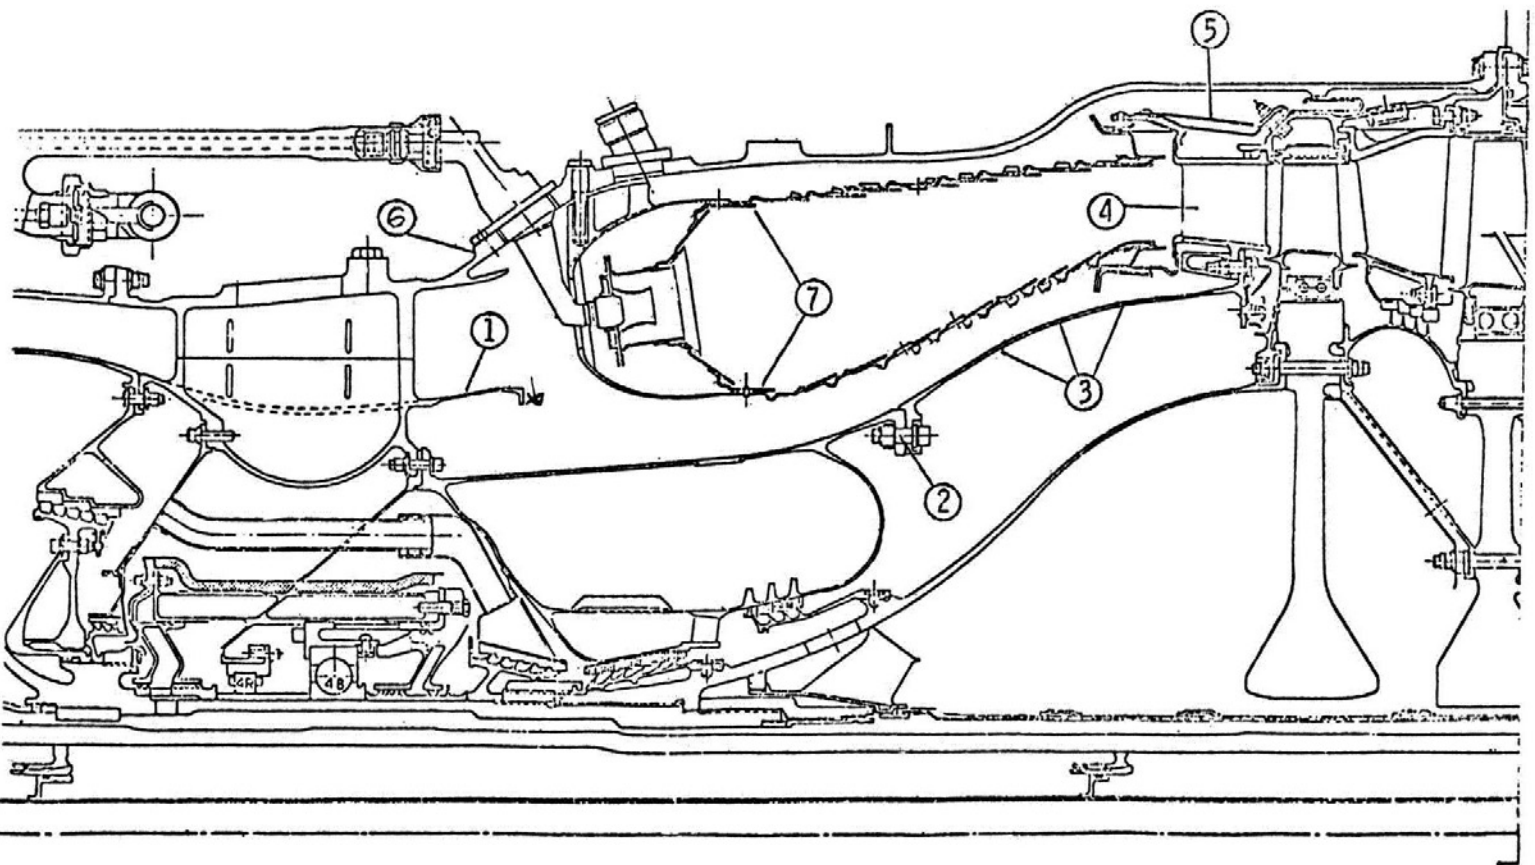
DEFORMATION LOCATION

7. Combustor Liner  
Inward and aft buckling of shell  
Normal differential pressure is 15 PSI  
Pressure required for buckling is 192 PSI differential pressure
